Toyota Advanced BSM System Sensor and Bracket Location Diagnosis

Are the sensor and bracket location damaged?

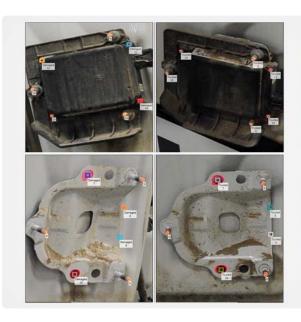
This 2013 Toyota Avalon was hit in the left rear corner by the sensor location. The bumper cover was repairable, but there was a concern that the sensor bracket may have been misaligned from the impact.

Using the Matrix Wand $^{\text{TM}}$, a 3-D analysis was performed by using the opposite side sensor and sensor bracket as a comparative reference. The Matrix Wand $^{\text{TM}}$ 3-D analysis ability revealed that the sensor and sensor bracket on the impact side were still properly aligned.

Id	Control	Point Name	Delta Length (ΔX)	Delta Width (ΔY-Depth)	Delta Height (ΔZ)
12			0	2	0
15			0	1	1
14		i i	1	2	1

Id	Control	Point Name	Delta Length (ΔX)	Delta Width (ΔY-Depth)	Delta Height (ΔZ)
8			1	1	0
9			1	1	0
7			0	1	1
10			0	3	2
