**EnviroPod NZ Ltd
E.T.S.
Management Plan**

**North Shore City Council
EnviroPod Trial
Contract No. 00/19**

June 2001
Issue B

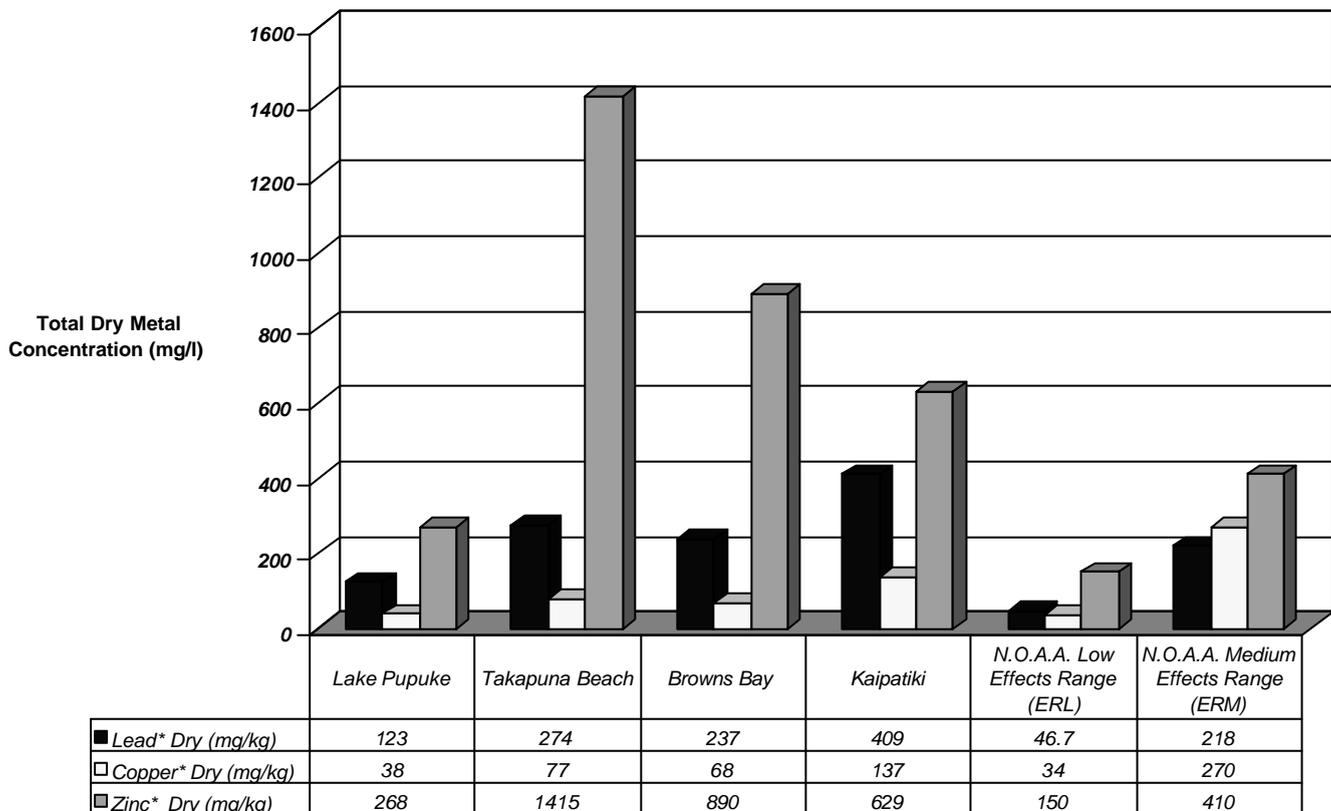
Chart 1: Metal Concentrations in Retained Sediments

Concentrations of heavy metals in the retained sediments varied greatly from catchment to catchment. All retained sediments had concentrations that will, at least cause low-level effects in the receiving environment. The retained sediment from the Lake Pupuke catchment had the least heavy metal contamination. This is probably because of the low traffic loading in the catchment and the discharge of roading material from resealing into the Enviropod Filters. Of particular concern are the concentrations of Lead and Zinc in the Takapuna, Browns Bay and Kaipatiki Catchments. Lead was removed from petrol in 1996 yet high concentrations are consistently found in sediments retained in Enviropod Filters (Waitakere City Council, Auckland City Council & North Shore City Council results, Chart 2).

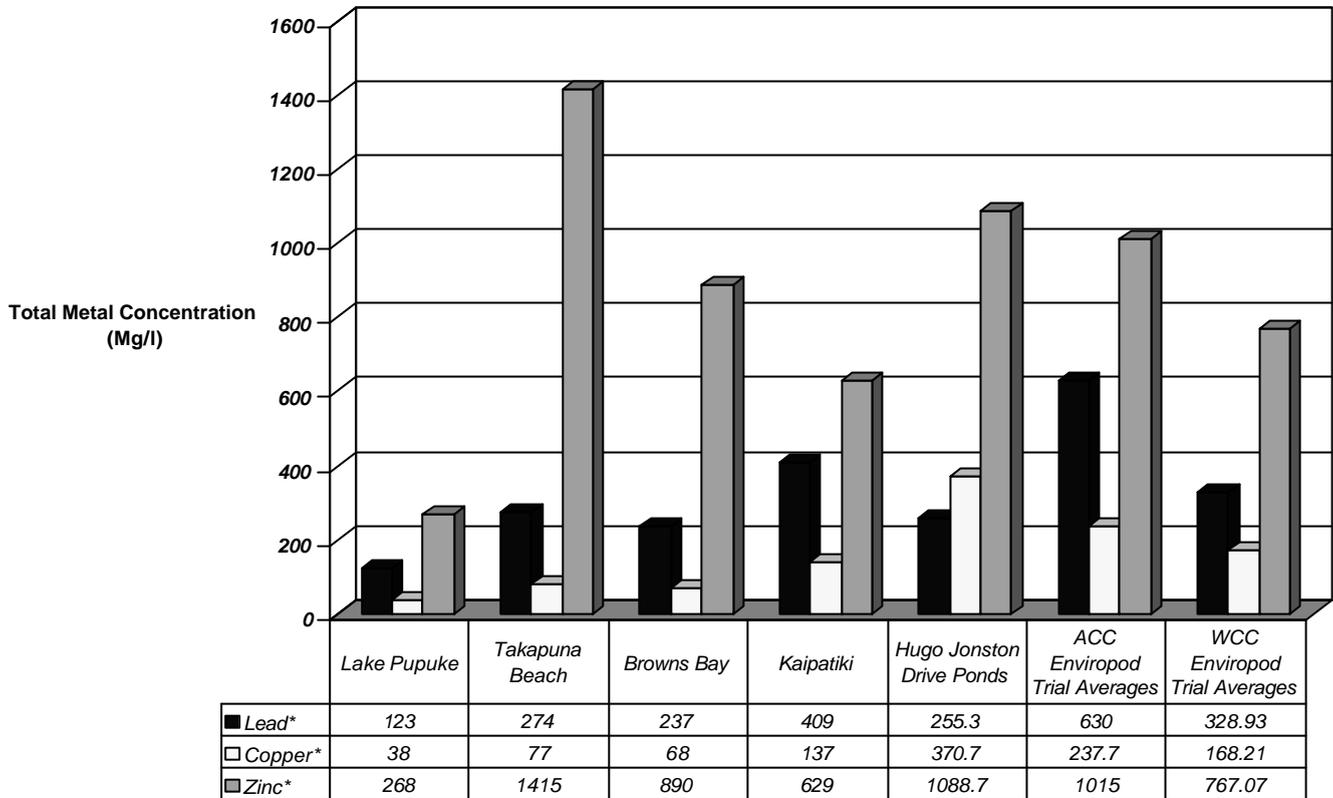
Chart 2: Metal Comparison of Retained Stormwater Sediments

Chart 2 compares the Concentrations of North Shore Sediments with those retained in a Stormwater treatment pond and with results from other trials in the Auckland Area.

The concentrations of heavy metals in the North Shore sediments were generally lower than the concentrations found in the Auckland City Council Enviropod Trial. This can be expected as the ACC Enviropod trial was held in the Viaduct area, which has a very high traffic loading and the land use is predominantly industrial.

The Waitakere City Council trial was located along Lincoln Rd which has a mixed land use of residential and commercial with a high traffic loading, similar to the trial areas of Takapuna Beach, Browns Bay and Kaipatiki. The heavy metal concentrations were consistent with the exception of Copper, which was generally low in the North Shore catchments. One of the principal sources of Copper in stormwater sediments is wear of vehicle brake pads. The trial areas were predominantly flat with the exception of Kaipatiki (which had the highest Copper concentrations). Vehicles tend to brake less in flatter areas.

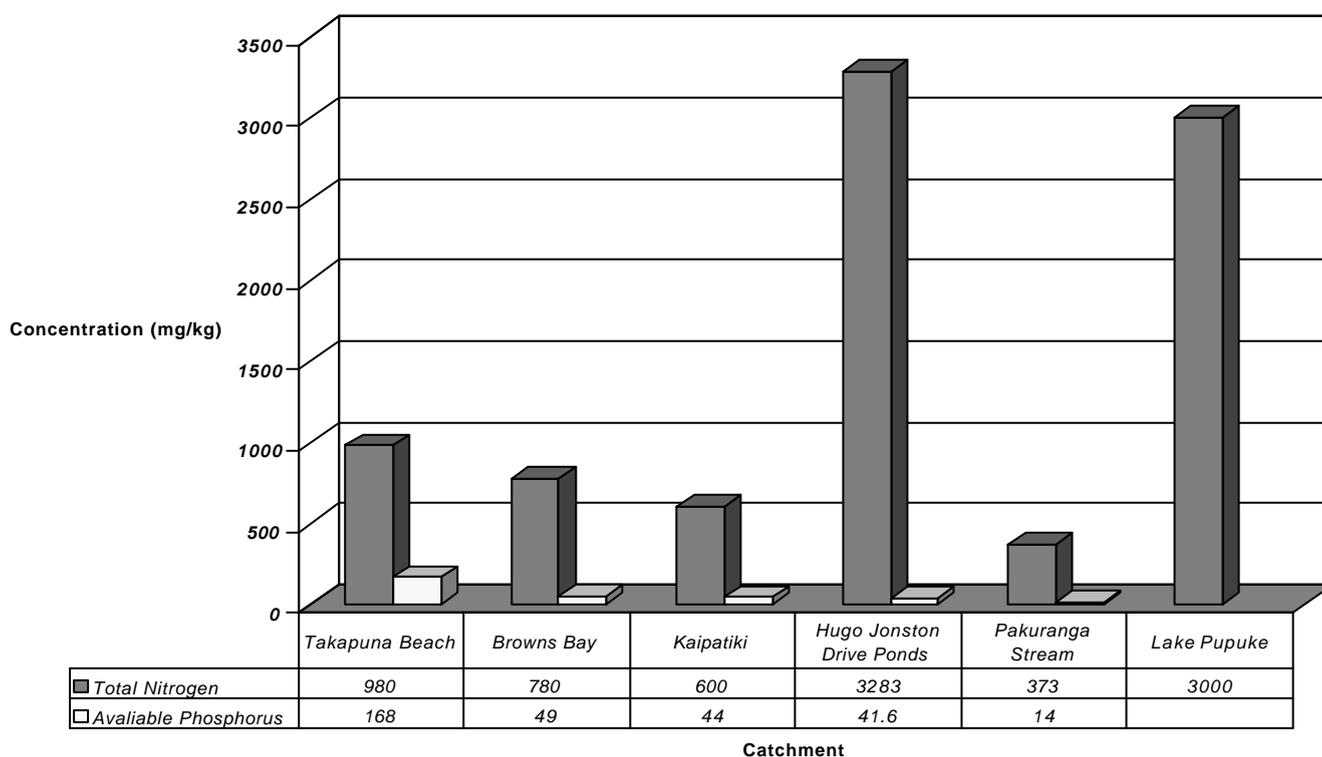
Chart 3: Comparison of Nutrients in Sediments retained in NSCC Enviropods

Samples were also analysed for Nitrogen and Phosphorous and compared with results from other studies in the Auckland Region⁵ (Chart 3). The results show high levels of nitrogen in the retained sediments from the Lake Pupuke catchment, similar to the levels in retained sediment in the Hugo Johnston Ponds. The levels of Phosphorous were also high in all catchments especially Takapuna Beach.

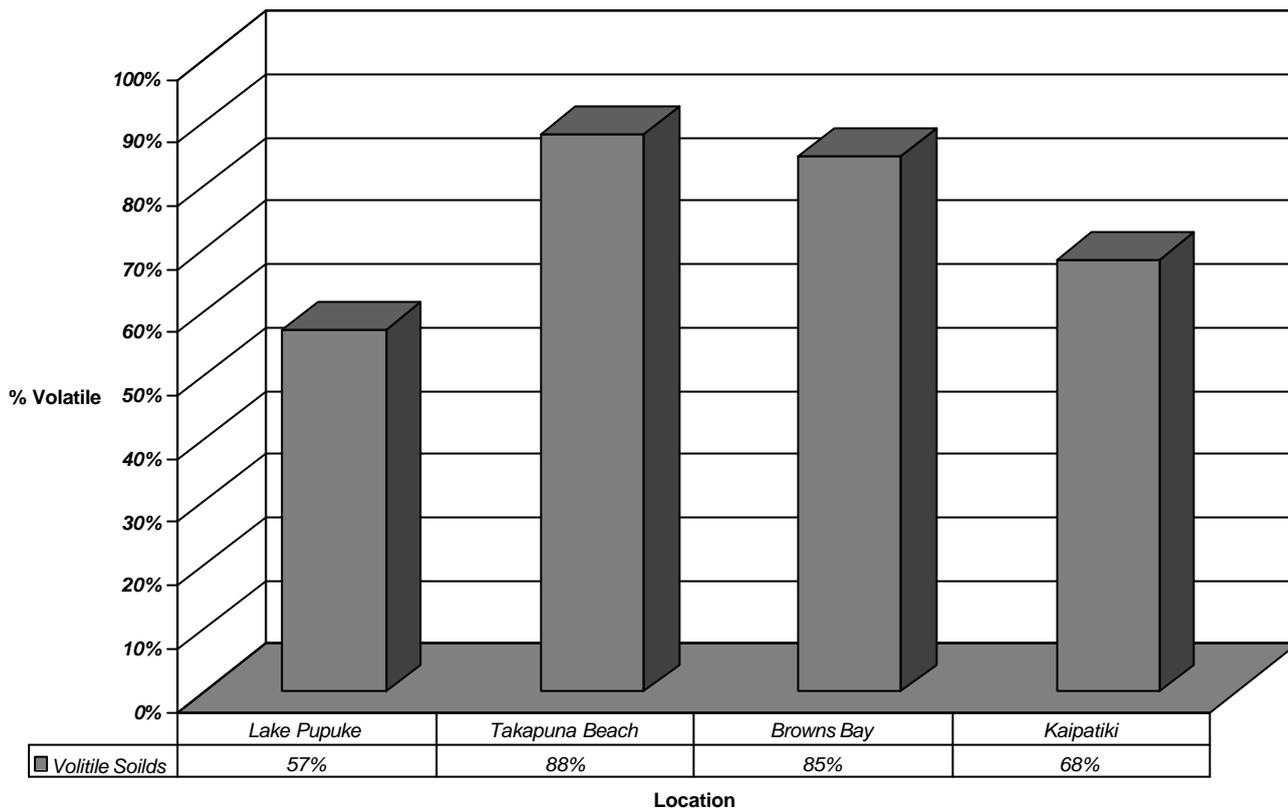
Chart 4: Percentage of Volatile Solids in Sediments retained in NSCC Enviropods

Chart 4 shows the level of volatile solids in the retained sediments. Volatile is an indication of the organic component of the samples. The levels for Lake Pupuke were lower than expected. The Lake Pupuke Catchment has a high organic loading because of the large number of trees in the catchment, however there was resealing of many of the roads during the monitoring period resulting in discharge of roading material into the Enviropods. This is a possible explanation for the lower than expected readings. The level of volatile solids in the sediments retained in the Takapuna catchment was higher than initially estimated in the site assessment.

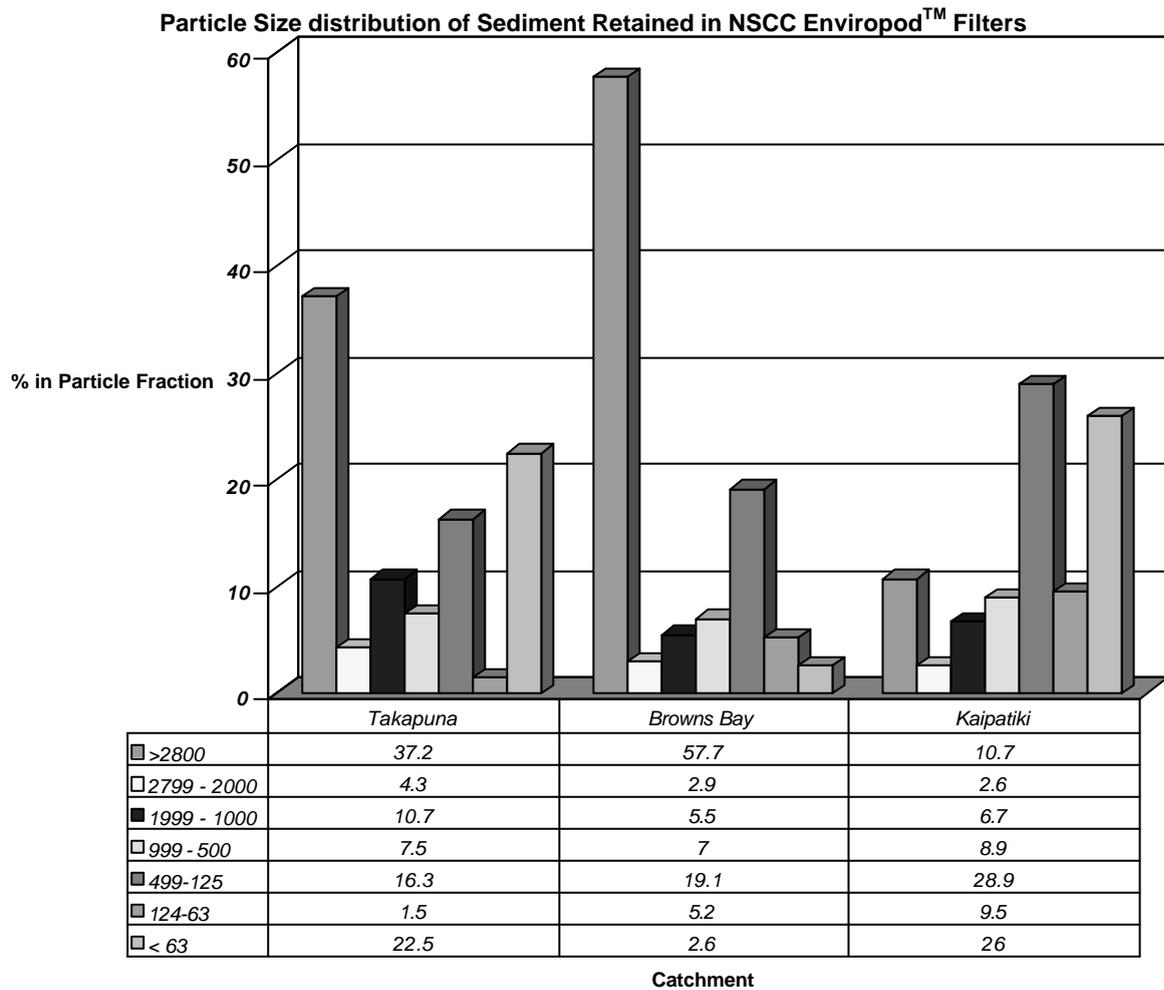
Chart 5: Particle Size Analysis of Material retained in NSCC Enviropod™ Filter

The particle size distribution was varied for the retained sediments from each catchment. The samples from the Browns Bay and Takapuna catchment had a high percentage of particles greater than 2800 microns. This correlates with the high organic loading for these catchments shown in the volatile solids analysis i.e. leaves will have a larger particle sizes. The particle size analysis also shows the ability of the Enviropod filter to remove silt size particles with the high percentage of particles below 63 microns in the samples obtained from the Takapuna and Kaipatiki catchments. Chart 5 below details the results.
