# Avoiding Surprises in Slope Stability

By Timothy D. Stark, Ph.D., P.E., D.GE, F.ASCE, Brian H. Queen, and Hangseok Choi, Ph.D., P.E.

## A Unique Case History

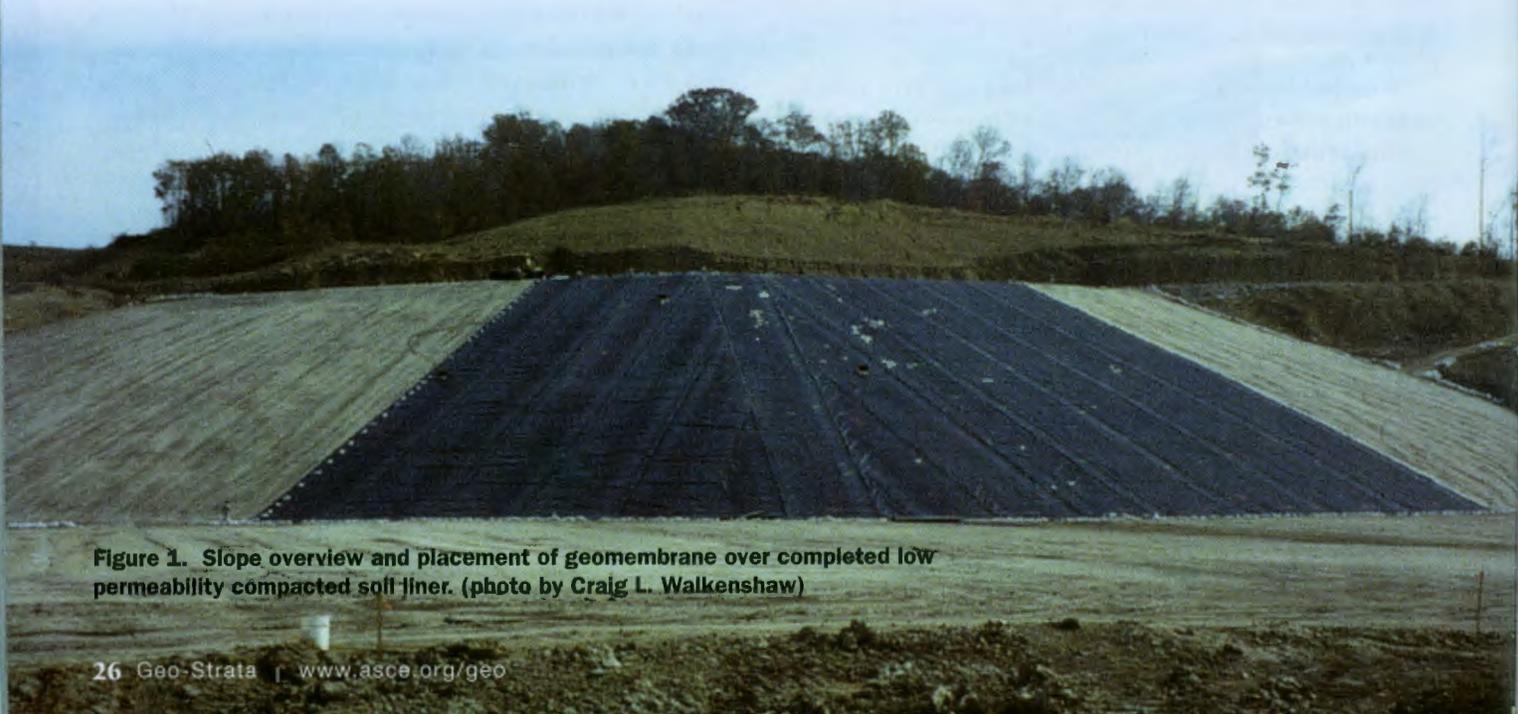
Figure 1. Slope overview and placement of geomembrane over completed low permeability compacted soil liner. (photo by Craig L. Walkenshaw)

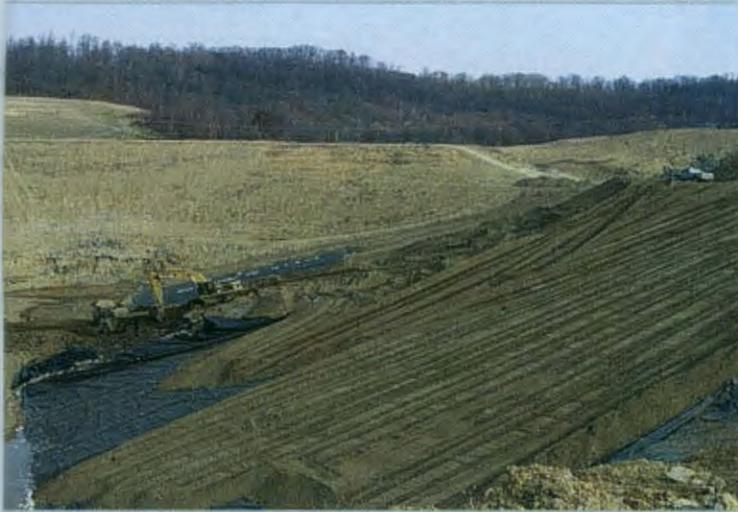
who were constructing the liner system, decided to save time by spreading the granular drainage layer (GDL) from the top of the slope to the bottom on the completed geomembrane (Figure 2). Landfill personnel who were performing the construction decided to spread the GDL from slope top to bottom because there was easy access for gravel trucks to unload at the top of the slope instead of accessing the bottom of the slope.

**Figure 2. Overview of sideslope and protective sand placement on geomembrane from top of slope to bottom.**

The granular drainage layer (GDL) was placed during sideslope construction from the top of the slope to the bottom. This placement practice is not recommended because the GDL is unbuttressed and imparts shear stresses in the liner system due to the weight of the GDL and equipment operating on the inclined slope. Thus the recommended practice is to place the GDL from the bottom to the top of a slope so the GDL buttresses itself and reduces the shear stresses and shear displacement applied to underlying liner system interfaces. Even though placement from top to bottom is not recommended, it is used because of easy access and ease of pushing material downslope versus upslope.

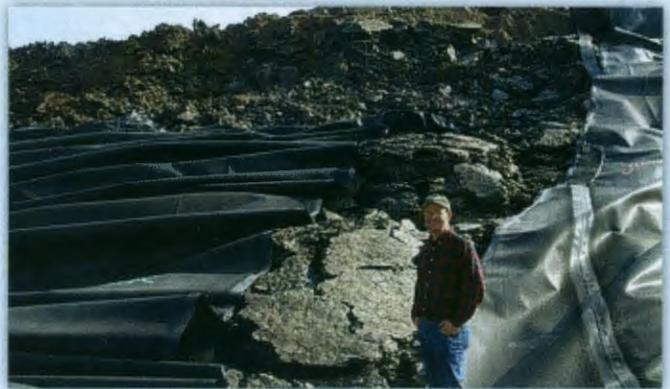
Figure 3 shows the damaged geomembrane near the toe of the slope due to the slope movement. This type of geomembrane damage is typical when slope movement occurs because the geomembrane and other geosynthetics easily tear under the applied shear and normal stresses. A view from upslope of the slide movement shows the drainage material overlying the torn geomembrane and the sliding surface below the torn geomembrane (Figure 4). The failure surface is located at a depth of 75–150 mm into the CSL and not at the geomembrane/CSL interface.

**Figure 3. Failed slope and damaged geomembrane.**

The repair of this slope failure delayed the construction for over a month and cost the facility hundreds of thousands of dollars. The slope was repaired by removing the GDL, the geomembrane, and the CSL down to a firm base, which involved the subgrade in some areas. Afterwards, the sideslope liner system was reconstructed, consisting of the CSL and the geomembrane, and then placing the GDL from the bottom to the top of the slope. A different on-site borrow source with a lower plasticity and in situ moisture content was used for the CSL. The CSL was placed in loose lifts a maximum 0.2 m thick with compaction to 95 percent of maximum Standard Proctor dry density. Each lift was kneaded into the underlying lift to help ensure integrity between the lifts.

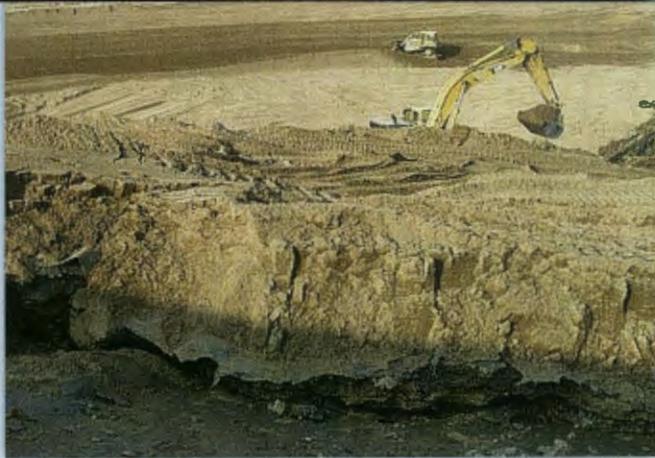
More importantly, Figure 4 shows that the failure surface extends the entire length of the slide because the GDL and geomembrane are missing from upslope of the slide mass to where the slide block stopped. A close look at the torn geomembrane (Figure 5) clearly shows the slide surface occurring below the torn geomembrane, from which it may be concluded that sliding occurred in the compacted CSL first and then the geomembrane tore as a result of this movement.

Figure 4. Slide surface and torn geomembrane.

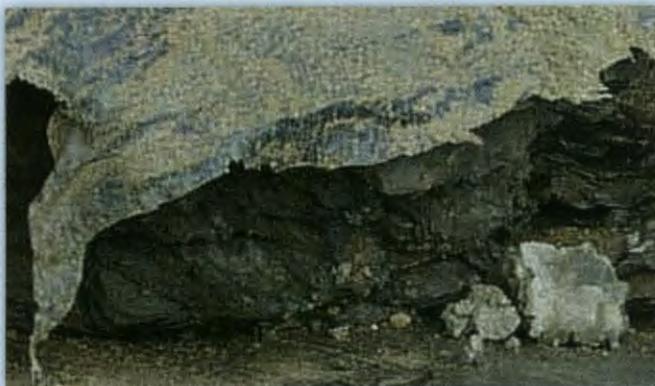
Figure 5. Close-up of torn geomembrane which shows slide surface is below geomembrane/CSL interface.

because the sliding surface was only about 75-150 mm below the top of the compacted CSL. Generally, a lift interface is deeper than that at the top of the compacted CSL, unless some additional material was placed on the top of the last lift so the final CSL thickness meets the regulatory requirement of about 1.5 m or final grade. Figure 5 shows the failure surface is slickensided, having a polished appearance, caused by clay particle reorientation into face-to-face/parallel arrangements. Slickensides occur when large strains or displacements are experienced along a well-defined failure surface.
