Highway Embankment Contract Specifications

Abstract: This four-year project was extremely successful and well executed, even though a number of changed conditions developed during the project. Of these changed conditions, only one resulted in a claim that is discussed herein. This claim involved responsibility for repairing a failed 7-m-high embankment that was widened as part of the contract. This paper discusses the slope movement mechanism, presents the relevant contract provisions and State of Ohio Construction and Material Specifications (C&MS), summarizes the various contract interpretations that developed, and the recommendation of the Dispute Resolution Board (DRB) to resolve this claim. Based on the case study, recommendations for clarifying project plans and specifications for future embankment construction are also presented. DOI: [10.1061/\(ASCE\)LA.1943-4170.0000136](https://doi.org/10.1061/(ASCE)LA.1943-4170.0000136). © 2013 American Society of Civil Engineers.

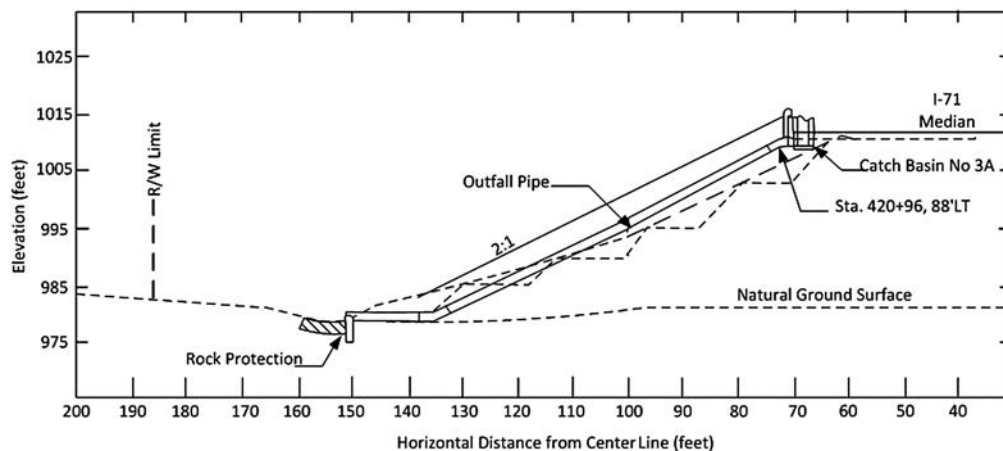
Fig. 2. Plan drawing for I-71 Southbound embankment from Station 420 + 00 to Station 421 + 00 showing sliver fill for lane widening on I-71 Southbound on ODOT Construction Sheet 254 of 1120 (adapted from State of Ohio 2004)

Sheet 254 of 1120, shown in Fig. 2, clearly indicates a cross section, or cut-fill diagram, with lines that indicate the existing slope, slope benching, and final slope grade lines, which overrides C&MS 203.05. In addition, the cross section identifies the specific station, 420 + 96, where the cross section and benching must be

applied. Thus, the cross section on Sheet 254 of 1120 is more specific than C&MS 203.05 because the cross section shows specific elevations for each bench and the width of each bench, whereas C&MS 203.05 does not. C&MS 203.05 provides no details for continuing benching from one station to another, and neither do the station-specific cross section shown on Sheets 254 and 255 of 1120 with linear interpolation between the cross sections.

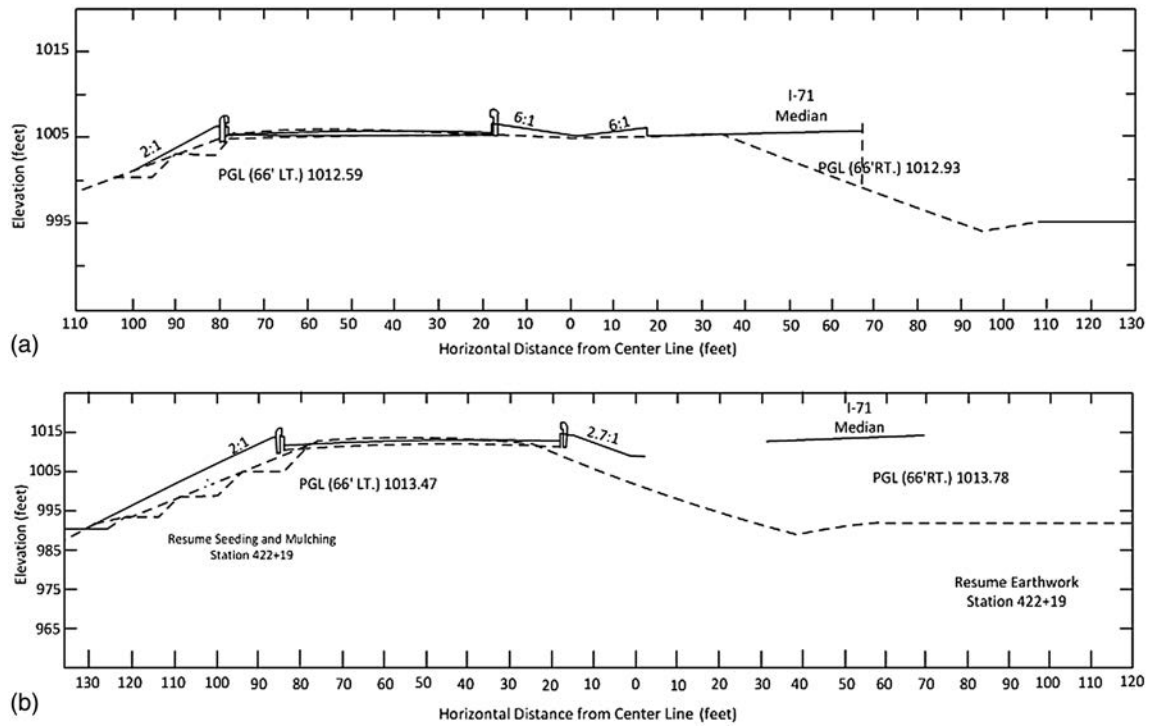
Figs. 2 and 3 present the contract drawing for the widening of the I-71 embankment at Stations 422 + 00 and 423 + 00, respectively. These two drawings illustrate the sliver fill required to widen I-71 Southbound between Stations 420 + 80 and 421 + 80 LT. These diagrams show that the new fill should be benched into the existing embankment to create the new 2H:1V slope on the west side of the embankment.

Fig. 3. Plan drawing for I-71 Southbound embankment at (a) Station 422 + 00; (b) Station 423 + 00, showing sliver fill for lane widening on I-71 Southbound on ODOT Construction Sheet 255 of 1120 (adapted from State of Ohio 2004)

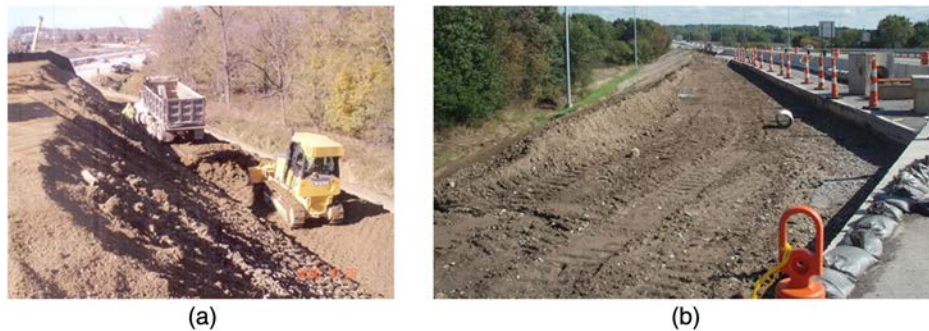
In September and October 2008, the contractor widened the existing 7-m-high embankment at the northern approach to the I-71 Southbound bridge over I-76, as shown in Fig. 4. By March 2009, about a 30-m length of the embankment started showing signs of down-slope movement (see Fig. 5 for the location of the slope movement). This movement continued and enlarged. Fig. 6 shows the movement on August 31, 2009, which corresponds to one of the quarterly site visits of the DRB. The slope movement was discussed during the prior quarterly DRB meeting but was not of great concern at that time. During the August 31, 2009, meeting, the owner and contractor expressed concern about the slope movement.

Fig. 4. Construction of sliver fill for lane widening on I-71 Southbound between Stations 420 + 80 and 421 + 80 LT looking (a) southbound with I-76 in the foreground; photograph used with permission from Ruhlin Company; (b) northbound along I-71 (photograph used with permission from ODOT)

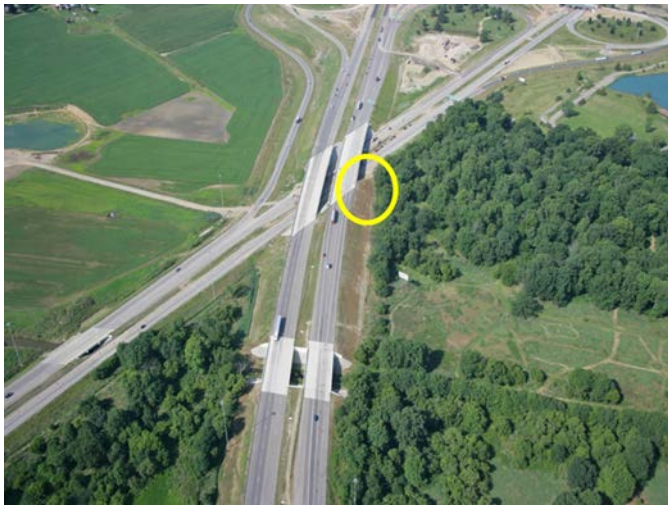
Fig. 5. Aerial view of I-71 Southbound between Stations 420 + 80 and 421 + 80 LT with I-76 crossing below it after remedial measures; circle shows the area prior to subject slope movement (photograph used with permission from ODOT)

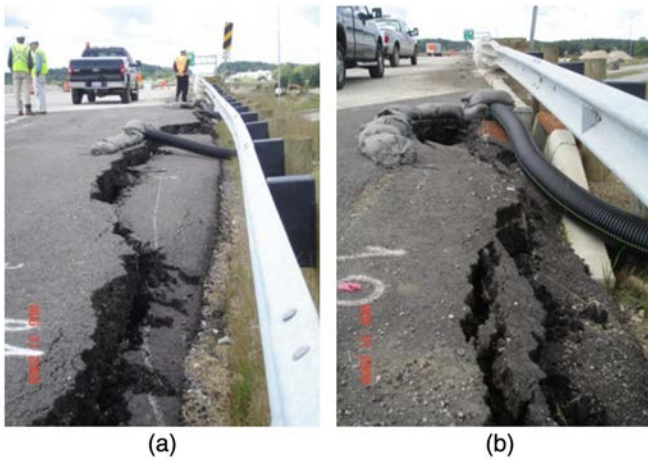
slopes in the vicinity of Stations 422 + 00 to 423 + 00 were flattened to approximately 2.5:1, possibly by ODOT maintenance forces. It appears now that some of this embankment work was uncontrolled, while it incorporated some organic materials and soft clays into the embankment, and without employing proper benching techniques. This created a weak interface at this embankment location. Other than the final slope geometry, the designer was unaware of the later embankment work. This undetected, weak interface was a contributing factor of the slope failure described next.

Fig. 6. (a) Overview of distress at the top of the new embankment on I-71 Southbound between Stations 420 + 80 and 421 + 80 LT; (b) close-up of pavement distress and damage to storm water Catch Basin No. 3A (photographs by T. D. Stark)

Based on the DRB's analysis, the ruling stated that the contractor was entitled to the costs associated with constructing the initial embankment and costs to remove two isolated tree deposits that were encountered during the slope failure investigation and slope reconstruction. The DRB also concluded that the contractor was not entitled to additional compensation for removing high-moisture content material below the "special benching" required by the scaled cross sections on Plan Sheet 254 and 255 (State of Ohio 2004), because the slope failure probably allowed some water to infiltrate the embankment fill through tension cracks at the top of the slope and the damaged catch-basin (see Fig. 6) after slope movement started. The final value of the claim, as agreed to by ODOT and the contractor, was \$66,232. The initial amount of the claim was about \$150,000. The specific amounts awarded were as follows:

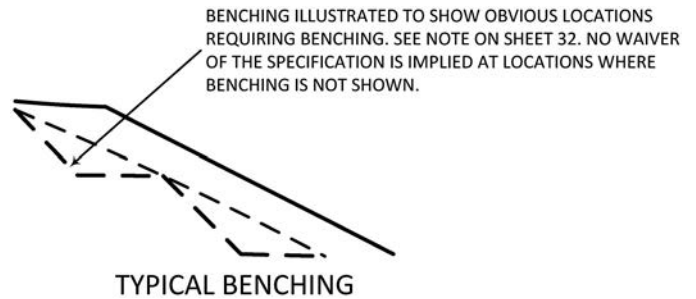
Fig. 7. Typical Benchng Detail from ODOT Construction Plan Sheets 254 and 255 of 1120 (adapted from State of Ohio 2004)

The “Typical Benching” sketch on Sheet 254 of 1120 clarifies the lines shown in the station specification cross sections on Sheets 254 and 255 (Figs. 2 and 3, respectively). The accompanying note states that the cross sections show “obvious locations requiring benching,” and the Note on Plan Sheet 32 (State of Ohio 2004) should be consulted for additional directions. However, no waiver of C&MS 203.05 is implied or allowed “where benching is not shown.” Thus, if benching is not shown on a station specific cross section, the contractor must use C&MS 203.05. Such an example is illustrated in Fig. 8 for Station 376 + 00 to Station 377 + 00 on Sheet 227 of 1120 where no benching is shown, so the contractor must use only C&MS 203.05 benching to construct the final slope shown.

The second recommendation is to change the label of the schematic benching detail shown on Construction Plan Sheets 254 and 255 (State of Ohio 2004) to "Legend: Slope Benching," as shown in Fig. 9, instead of "Typical Benching." This should provide clarity that the lines shown in Fig. 9 are used for definition purposes only.

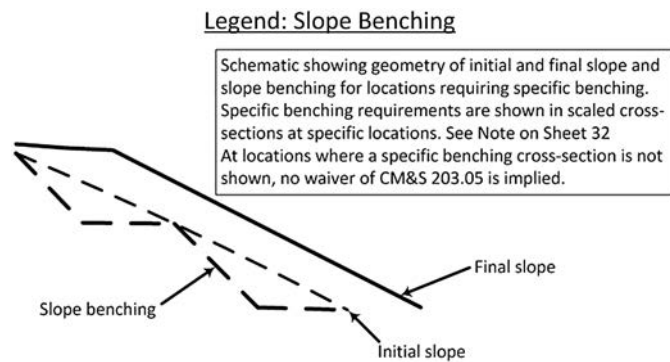
Fig. 9. Proposed legend for benching diagrams

The third recommendation involves the Note on Plan Sheet 32 (State of Ohio 2004) referenced in Fig. 9, which could be changed to the following:
