# BRE Test Report

## WikiHouse Structural Testing

Prepared for: Clayton Prest  
Date: 12 July 2021  
Report Number: P120099-1000 Issue: 1

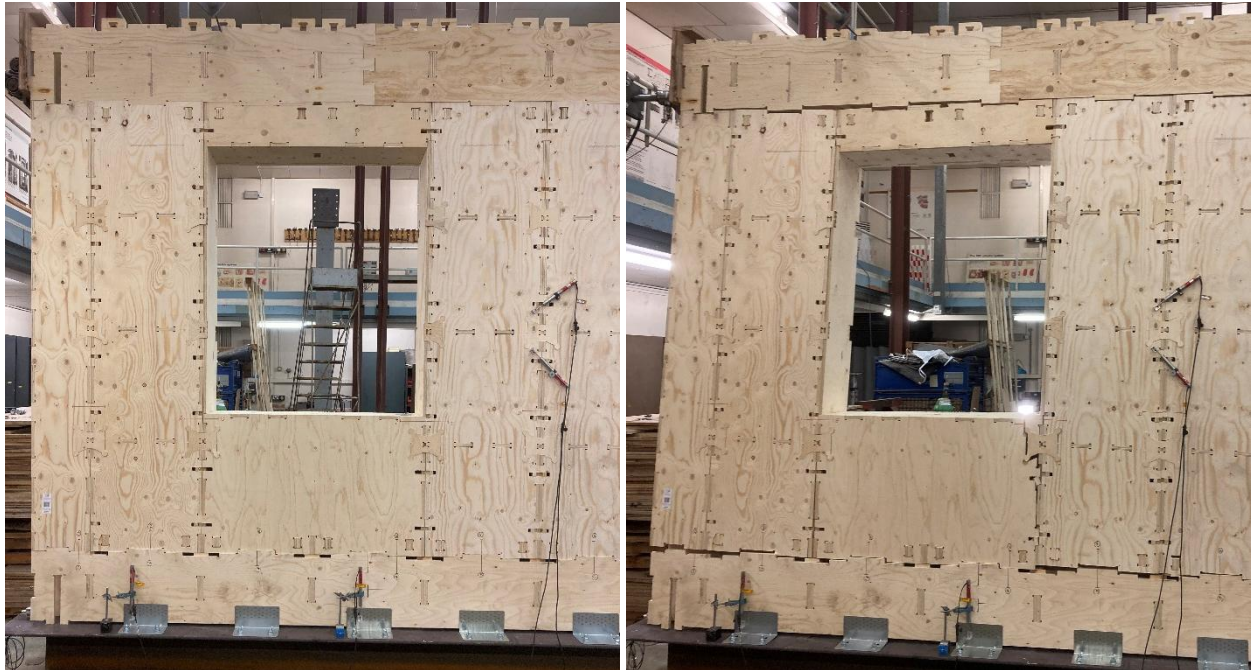
The third cycle was to 0.4F then failure, the load was raised to 32kN as for previous cycle and held for at least 30 seconds then increased until failure. There was eventual failure of the bow tie plates between the wall elements at bottom right corner of window 1 and between the two full height units between windows. At approximately 47 kN there appeared to be a drop in the load sustained by the specimen. Loading continued, however a significant increase in the magnitude of the applied load was not achieved and so the load was removed. The through wall peg between the wall units and foundation beam almost disengaged at the loaded end of wall due to uplift induced movement between units. This failure can be seen in Figure 9 - Figure 12.

Figure 9 – LHS of Window Wall without Vertical Load Before (L) and After (R) Test

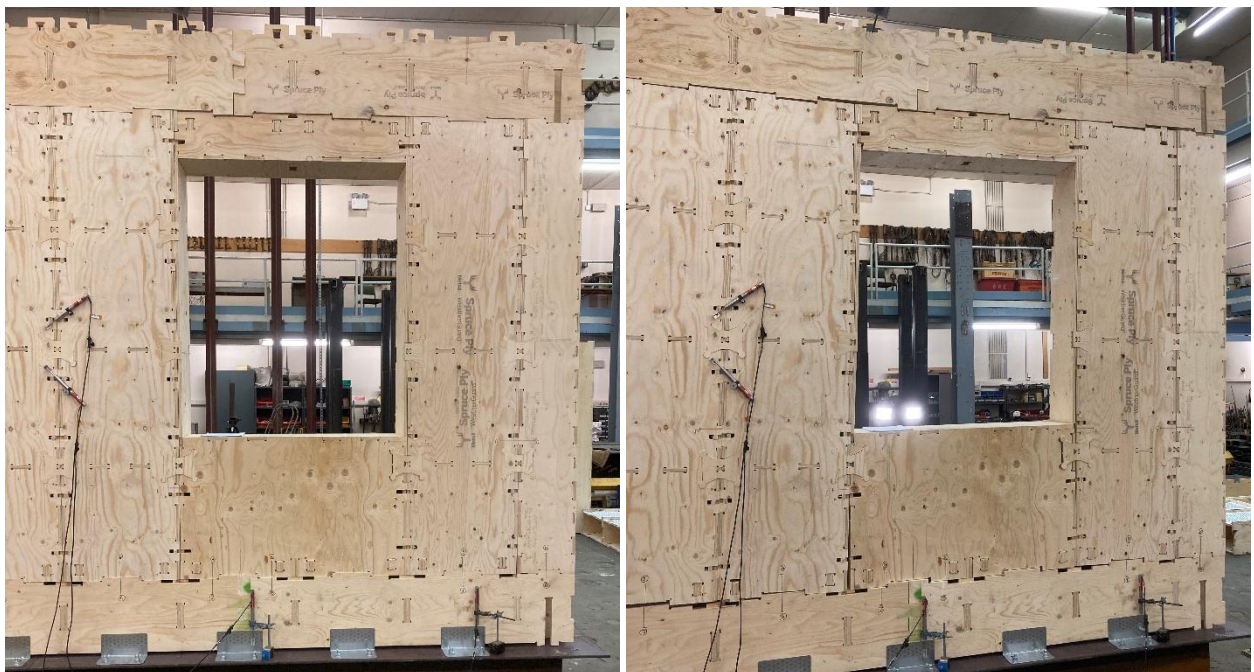
Figure 10 – RHS of Window Wall without Vertical Load Before (L) and After (R) Test

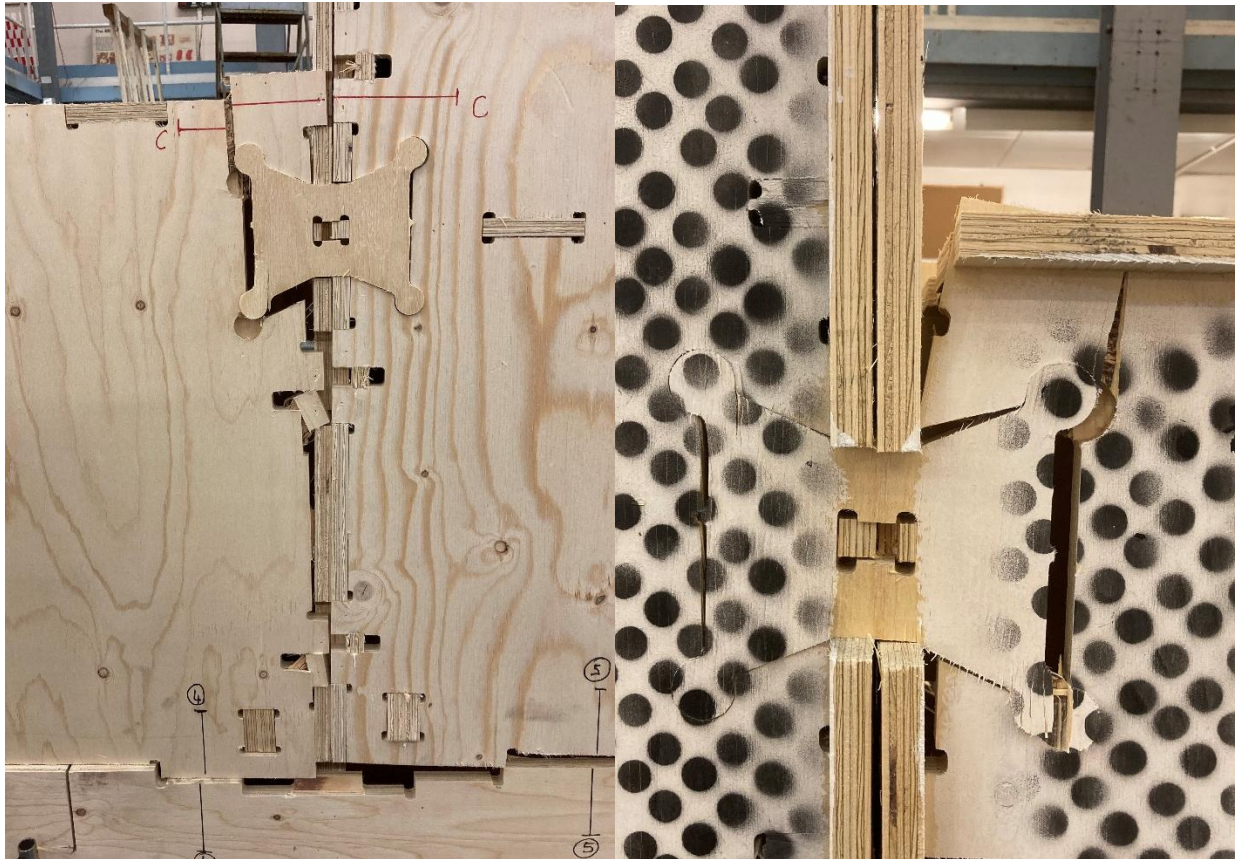
Figure 11 - Failure of the Bow tie plates

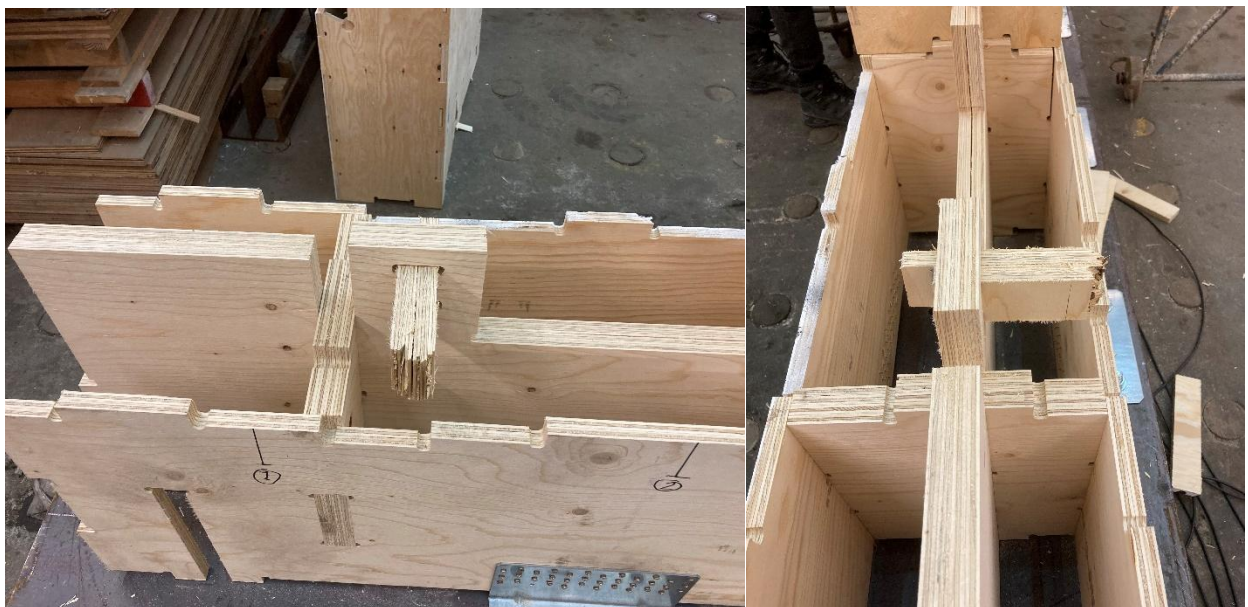
Figure 12 - Broken Pin at the Through wall peg

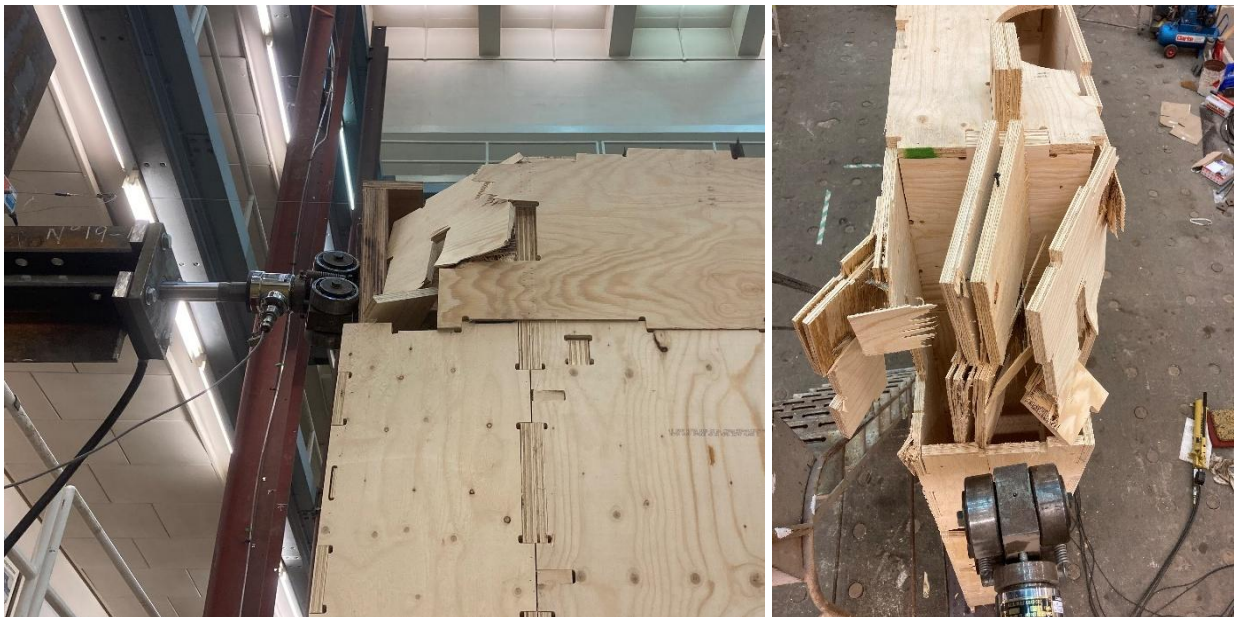
The third cycle was to 0.4F then failure, the load was raised to 32kN as for previous cycle and held for at least 30 seconds then load reduced to 0.1F before increase until failure. This final cycle led to localised compressive failure of the wall under the racking load. This failure can be seen in Figure 14 and Figure 15.

Figure 15 - Localised Compressive Failure of the Wall at the Loading Point on Attempt 1

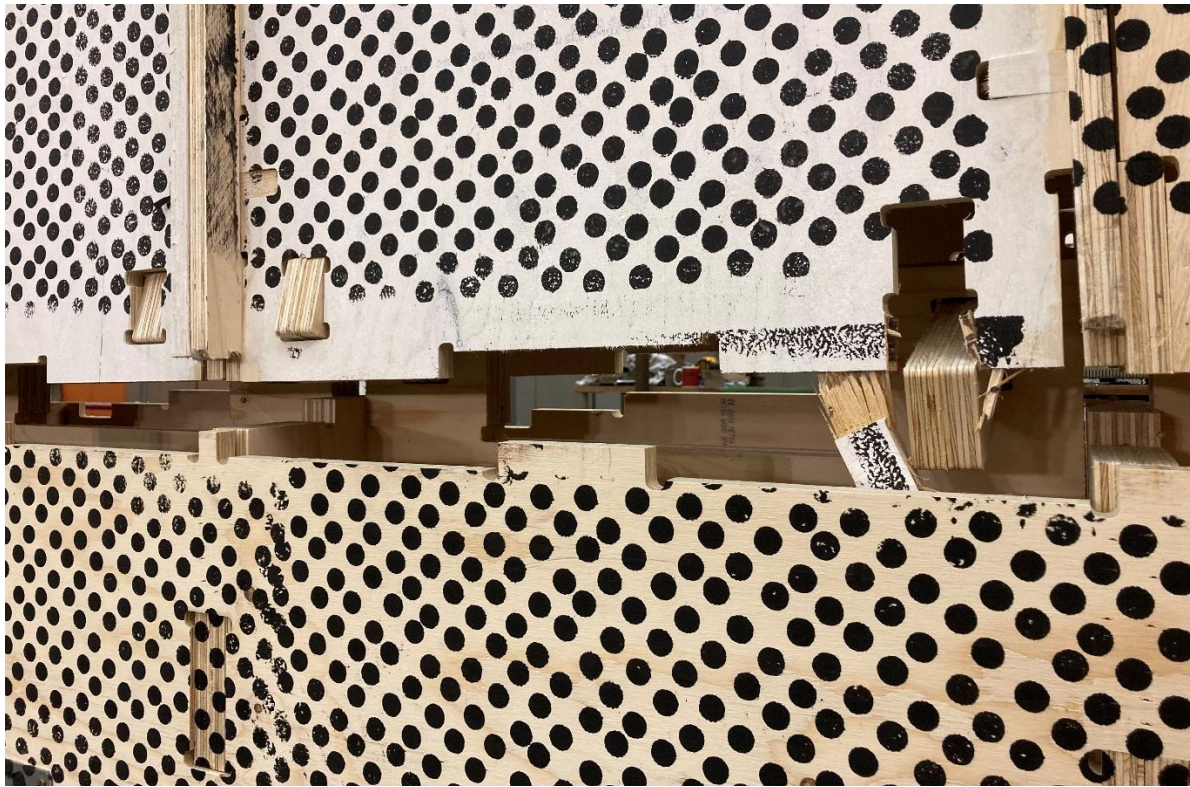
After attempt 2, the wall as repaired at the loading point with components from the previously tested window wall and then loaded direct to failure without the intermediate steps outlined above. There was no reset of datums after first failure attempt. During attempt 3, there was abrupt failure of the wall to foundation beam uplift connection and bow tie plates.

Figure 16 - Failure of the Wall to Foundation Beam Uplift Connection

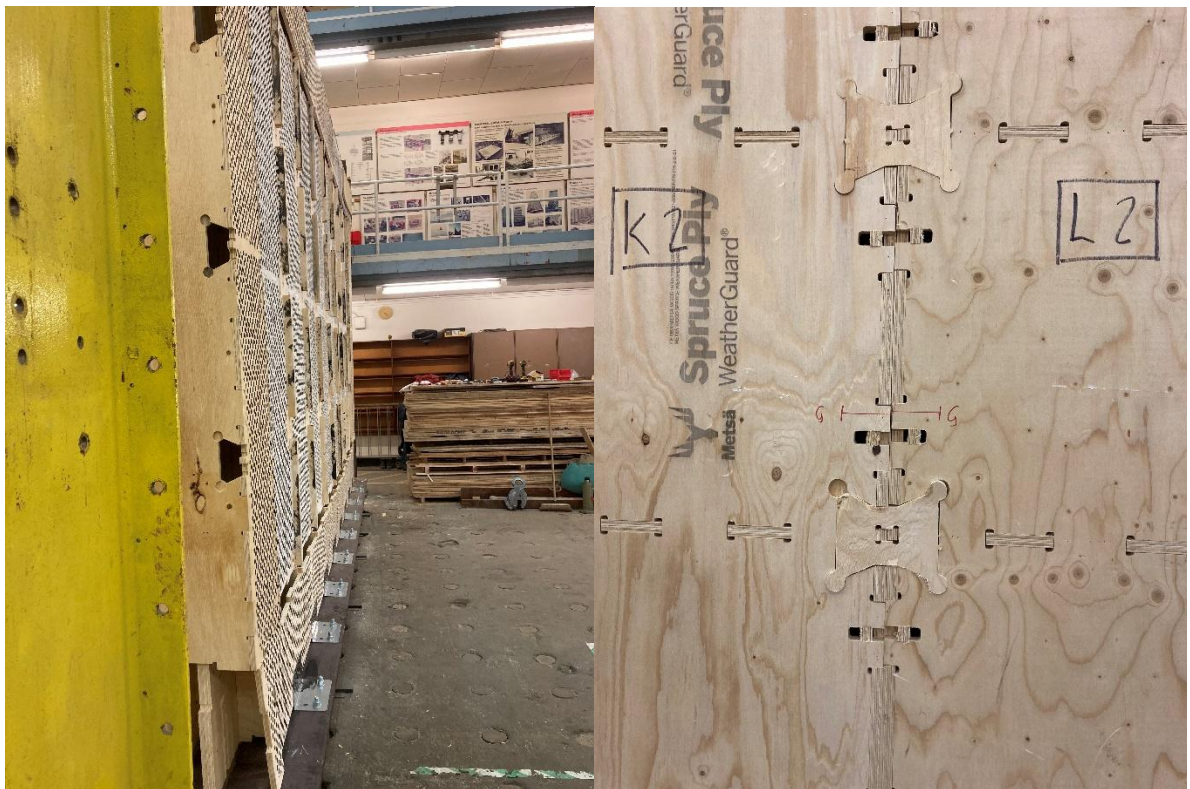
Figure 17 – Failure of the Wall to Foundation Connection (L) and of the Bow Tie Plates (R)

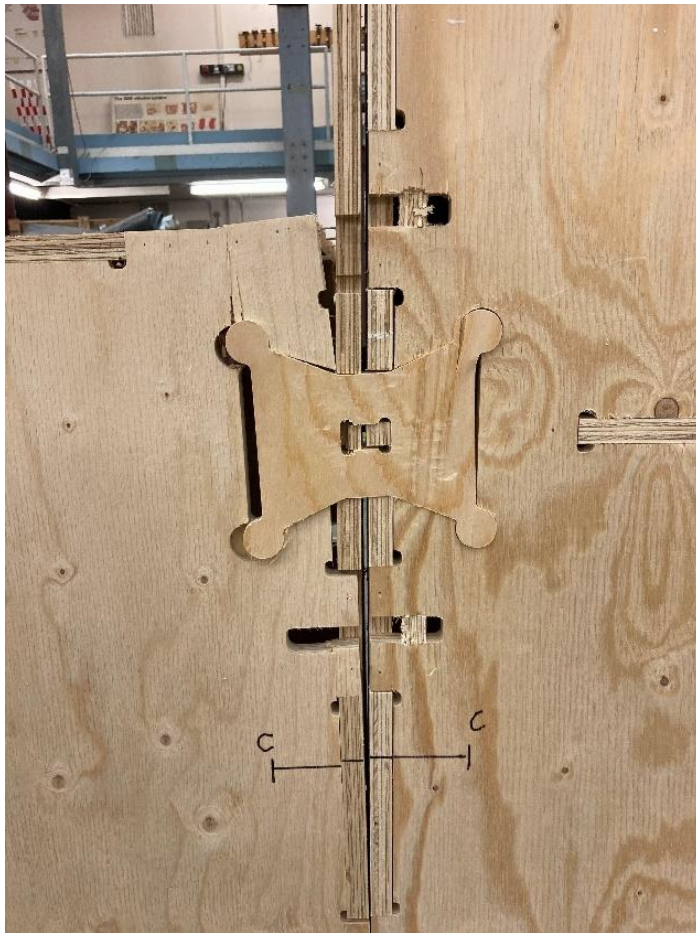
The third cycle to 0.4F then failure, the load was raised to 32kN as for previous cycle and held for at least 30 seconds then increased until failure. At approximately 72 kN horizontal load there appeared to be a drop in the load sustained by the specimen. Loading continued, however a significant increase in the magnitude of the applied load was not achieved and so the load was removed. There was eventual failure of the bow tie plates between the wall elements at the bottom right corner of window 1 and between the two full height units between windows. This failure can be seen in Figure 19.

Figure 19 - Failure of the Bow tie plate

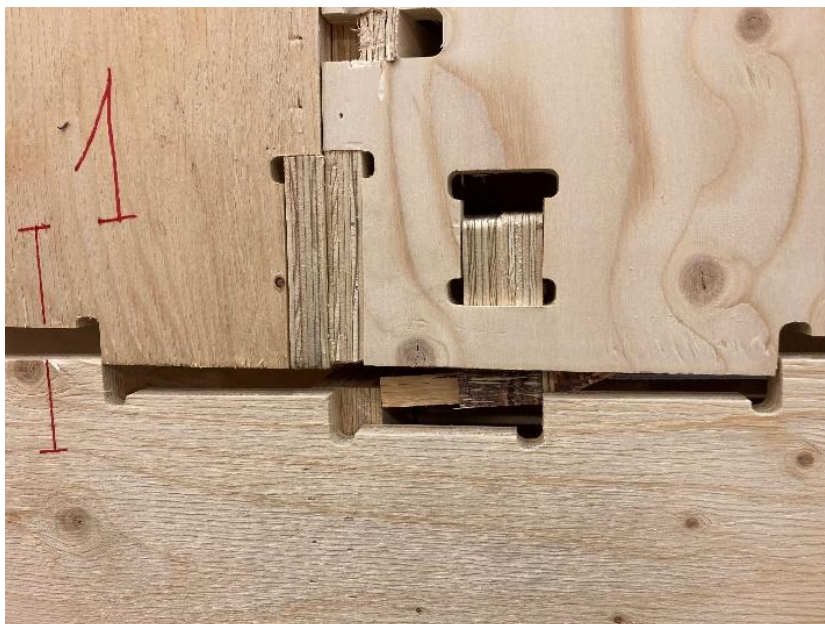
Figure 20 - Movement in Through wall peg

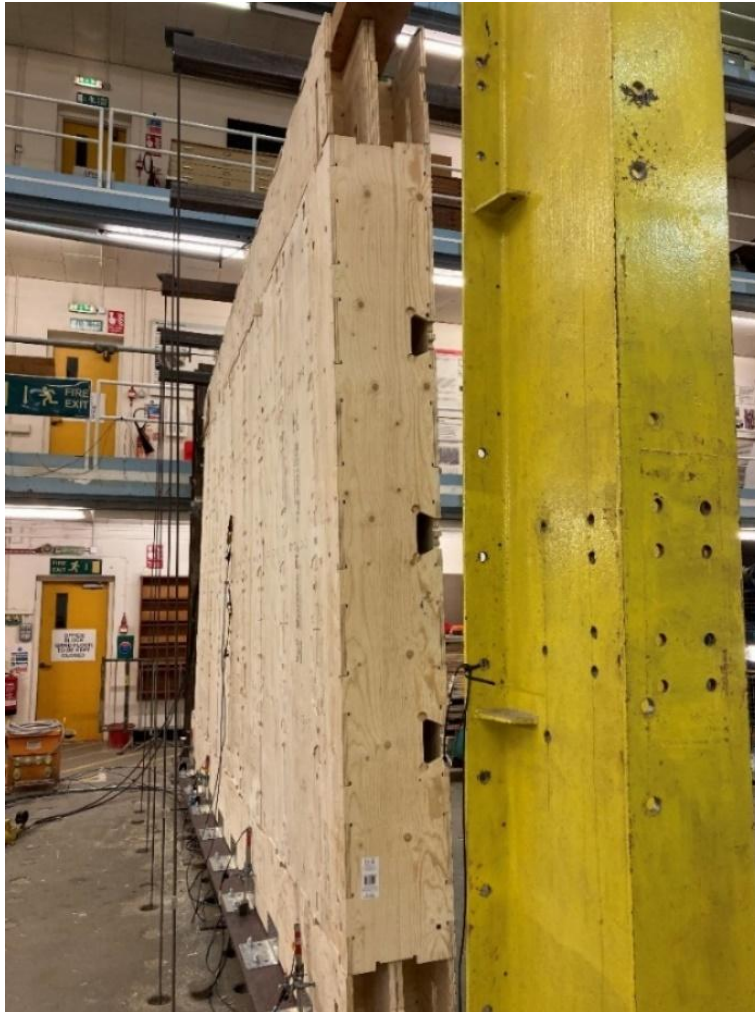
The third cycle to 0.4F then failure, the load was raised to 32kN as for previous cycle and held for at least 30 seconds then increased until failure. The test was stopped due to the wall twisting out of plane as the installed lateral restraints buckled. There was also differential movement between the base and the wall beams, which can be seen in Figure 23.

Figure 22 - Solid Wall Twisting Out of Plane

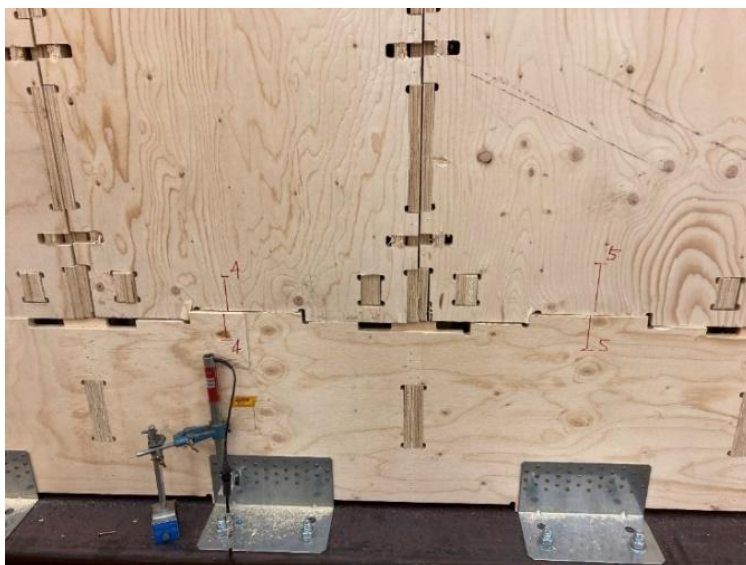
Figure 23 – Differential Movement between the Base and the Wall Beams

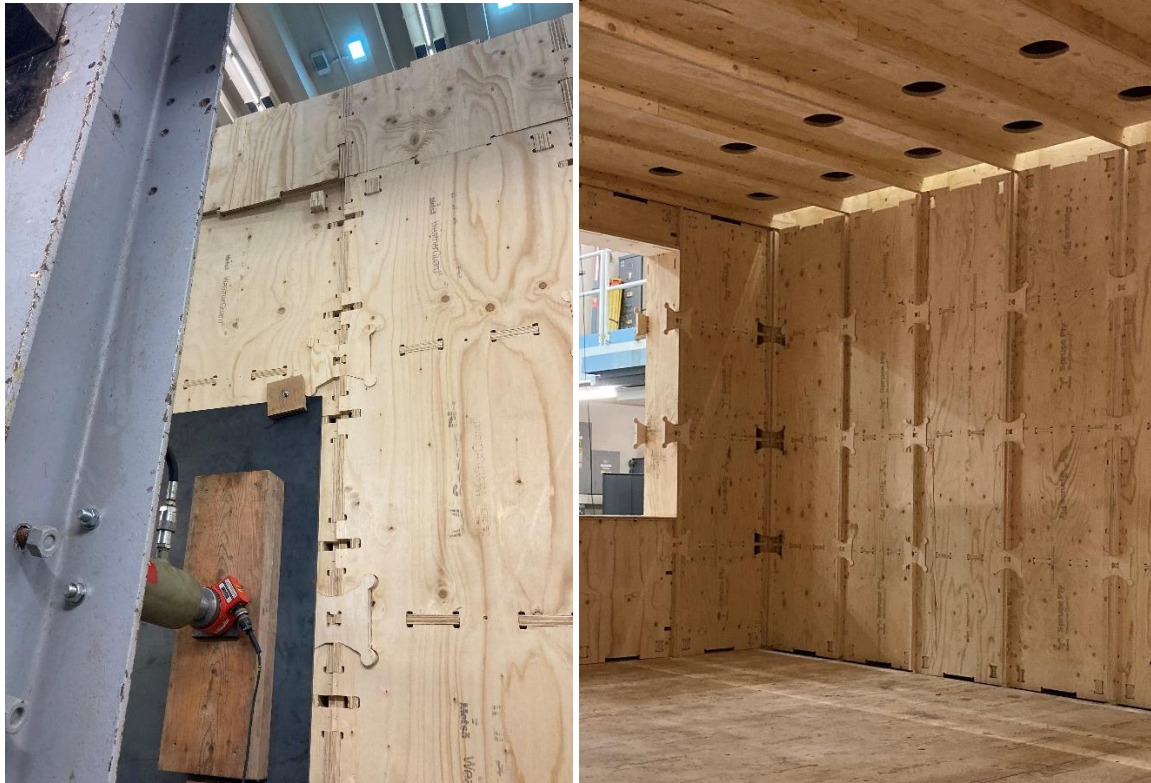
The second cycle was to 0.4F, or 20kN per jack, but stopped at ~0.3F as a shear tie near the top right of the steel spreader plate snapped and there was concern about the plate punching through the wall. At this point the load applied to the wall was gradually allowed to decay. The wall was then loaded up to 0.4F and held for 30 seconds before being allowed to decay. At this point the through wall peg at the top of the wall had disconnected (see Figure 28). Differential movement was observed between the panel being loaded and the panel to the right-hand side. There was also cracking noted internally on the face of the panel in the equivalent spot on the outside face where the shear tie had broken<sup>1</sup>.

<sup>1</sup> Upon inspection of photos later, it was found that this cracking was present before testing began.

Figure 28 - Damage to the East Wall at 0.4F Loading showing Broken Bow tie plate (L) and Internal Cracking (R)

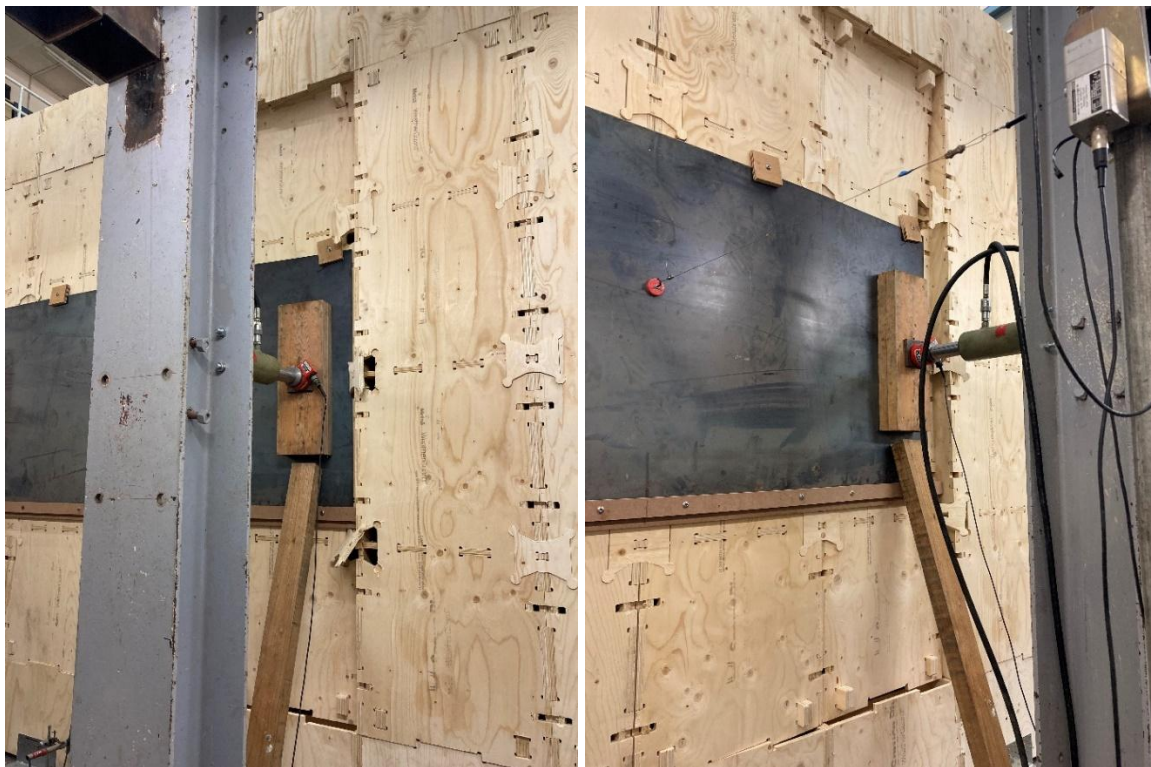
For the third cycle, the module was loaded up to failure. At failure the through wall peg had become disconnected at the bottom on the right-hand side of the plate. In this test, the module was considered to have failed when there was loss of 20% or greater of the load. Photos of the east facing wall at the failure load can be seen in Figure 29 - Figure 31.

Figure 29 - Damage to the East Wall at Failure Loading

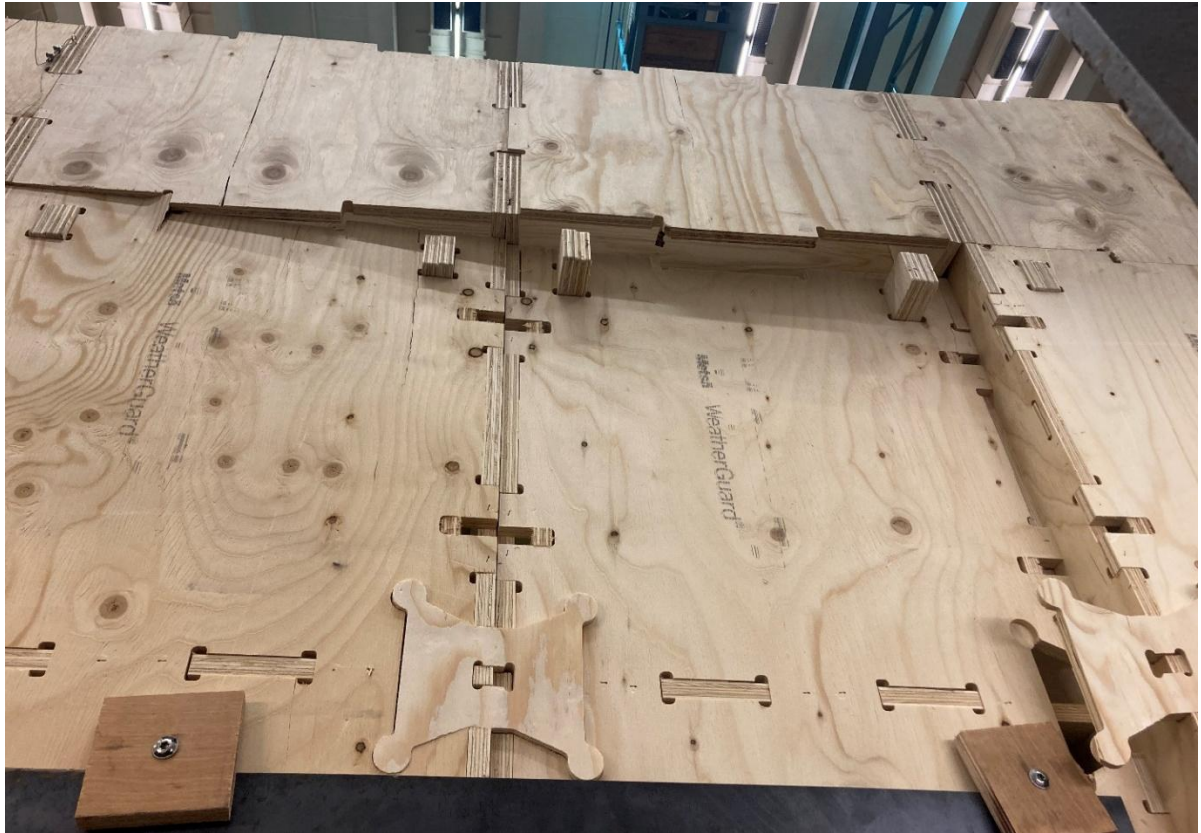
Figure 30 - Top Through wall peg at Failure Load

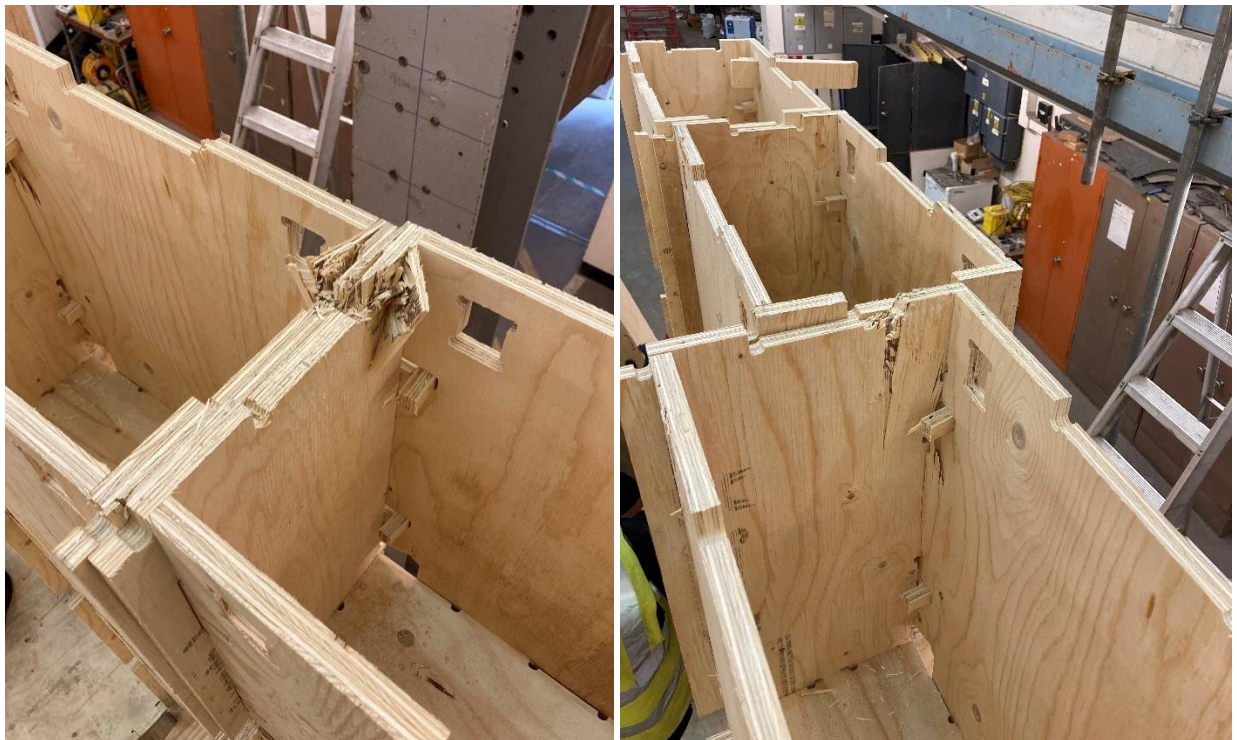
Figure 31 - Internal Elements on East Wall After Testing
