Case history of liner veneer instability

ABSTRACT: Construction conditions experienced during installation of a landfill geocomposite liner system led to two slides on a 3H:1V slope during construction. The landfill was being developed for final disposal of flue gas desulfurization by-product material (FGD). The slides occurred in two different areas of the 3H:1V slope and encompass 10,500 and 20,235 m² in the Fall of 1996 and Summer of 1997, respectively. The slides developed by movement along the PVC geomembrane/compacted clay liner interface during or shortly after placement of the protective FGD cover material over the drainage sand layer. Laboratory direct shear tests revealed that the shear strength of this interface is sensitive to the moisture content of the exposed compacted clay liner. The direct shear tests revealed reductions in the available shear strength of 35% and 37% for the peak and large displacement values as the compacted clay liner moisture content increased by 8 percentage points. In addition, shear stresses induced by surface traffic activities might result in shear displacements along the interface, which in some cases were large enough to lower the availa

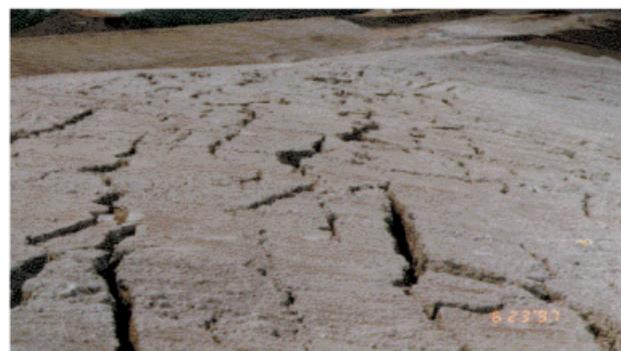
After subgrade preparation for placement of the composite liner system in Phase B, the slope inclinations ranged from 3H:1V to 5H:1V (see Figure 1). In late October 1996, shortly after placement of the drainage sand and protective FGD cover material, a network of cracks in the protective FGD cover and drainage sand was observed over approximately 10,500 m² of the slope. The cracks were located in the 3H:1V portions of the slope. The parallel cracks extended across the slope and were about 15 m down the slope from the crest of Valley B, as shown

in Figure 2a. The width of the cracks ranged from 12 mm to 125 mm but did not show any significant vertical offset. This lack of vertical offset was caused by translational sliding occurring above the stiff CCL. Investigations at the crack locations revealed that the 0.75 mm (0.03 in) thick PVC geomembrane was in significant tension, which resulted in localized tearing of the geomembrane. Figure 2b illustrates the torn PVC geomembrane in the October 1996 slide area. During the investigation, it was observed that a thick, wet moisture film (approximately 10 mm in thickness) was present at the surface of the compacted clay immediately below the PVC geomembrane. Construction records indicate that the compacted clay liner in this area was compacted at a moisture content equal to 21.5%. The Standard Proctor (ASTM D 698) optimum compac-

Figure 2. (a) Slope cracking and (b) tear observed in PVC geomembrane after October 1996 slide

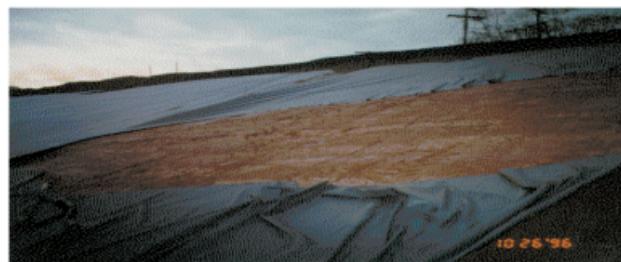
(b)

Based on field observations, the slides occurred as a result of movement at the PVC geomembrane/CCL interface. This caused tension in the PVC geomembrane and allowed the drainage sand layer and protective cover material to translate downslope. In some locations the geomembrane tore, resulting in the slide surface migrating up through the drainage sand and protective FGD cover material. The slides were translational in nature owing to the compacted and stiff nature of the underlying compacted clay liner and existing terrain.

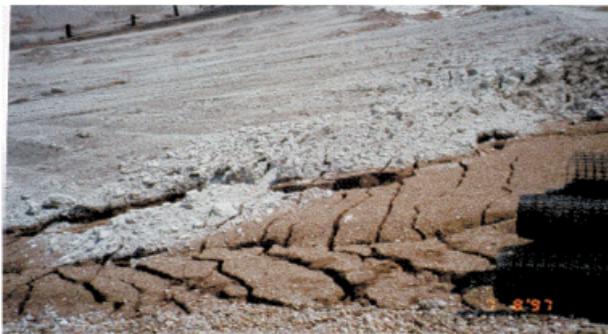
In June 1997, another section of 3H:1V slope in Phase B slid. Figure 3 illustrates the slope cracking and condition of the PVC geomembrane in the June 1997 slide area. Construction records indicate that the CCL in this area had been compacted to an average moisture content of approximately 19.5% or about the optimum moisture content. The PVC geomembrane was placed over the CCL, and the moisture content of the CCL was monitored before the drainage sand was placed. The moisture content was monitored with the PVC geomembrane in place by cutting out a square section of the PVC geomembrane at a few locations and patching it after a sample of the CCL was obtained for moisture content testing. No significant change in the moisture content was measured prior to placement of the drainage sand. The FGD protective cover was placed following placement of the drainage sand. The liner system was completed and stable for a period of two weeks. After two weeks, three temporary haul roads were constructed on the 3H:1V slope. The three haul roads were equally spaced along the 92.7 m long slope, with one road constructed at the toe of the 3H:1V slope and one being constructed within approximately 15.2 m of the slope crest. A few days after the haul roads were put into service, the June 1997 slide occurred. As a result, it is possible that the shear stresses induced by traffic on these roads contributed to the 1997 slide. The observed network of cracking is similar to the network observed for the

October 1996 slide, as shown in Figure 3a. The parallel cracks extended across the slope and were also about 15 m down the slope from the crest of Valley B. The width of the cracks ranged from 12 mm to 125 mm but also did not show any significant vertical offset. This lack of vertical offset again was caused by translational sliding occurring above the stiff CCL.

Figure 3. (a) Slope cracking and (b) tear observed in PVC geomembrane after June 1997 slide
