GeoDenver 2007

ASCE Specialty Conference

SLOPE STABILIZATION USING GEOFOAM

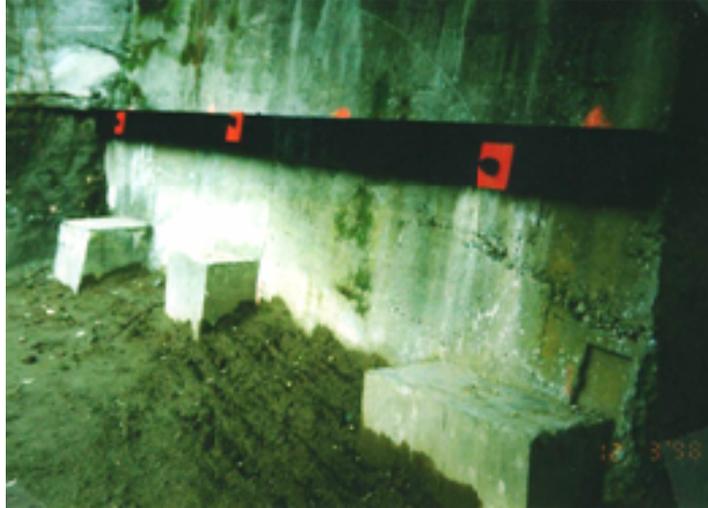
Figure 2: View of the anchors, waler beam, and encapsulated pier heads.

The tie-back anchors extend to a depth of 20 feet on five foot centers at a downwards inclination of about 15 degrees (see Figure 1). The measured anchor resistance of 1.5 ksf was achieved in the firm and competent native silt soils existing beneath the residence. After the anchor grout set up, the anchors were locked off by hand against the rear face of a C6x15 steel channel which acts as a waler beam. Figure 1 shows a schematic of the underpinned and anchored existing concrete wall. Figure 2 shows a photograph of the backyard area and the existing concrete wall, including the installed anchors and waler beam.

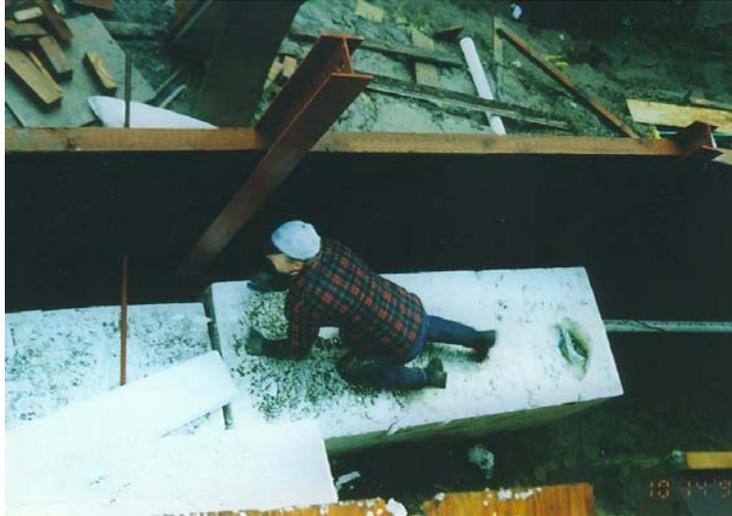
Figure 4. Geofabric block field installation

The compressive strength of the geofoam at less than 2 percent axial strain is 45 psi and the unit weight is 2.2 pcf. The dimensions of the geofoam blocks used on this project are 8 feet long, 4 feet wide and 4 feet thick. The 4-foot thickness proved difficult to handle, particularly in moderate to high wind conditions. To facilitate handling, the contractor cut the blocks in half with a hot wire cutter. This size reduction allowed a single workman to lift, carry, and place the individual blocks with ease (see Figure 4).

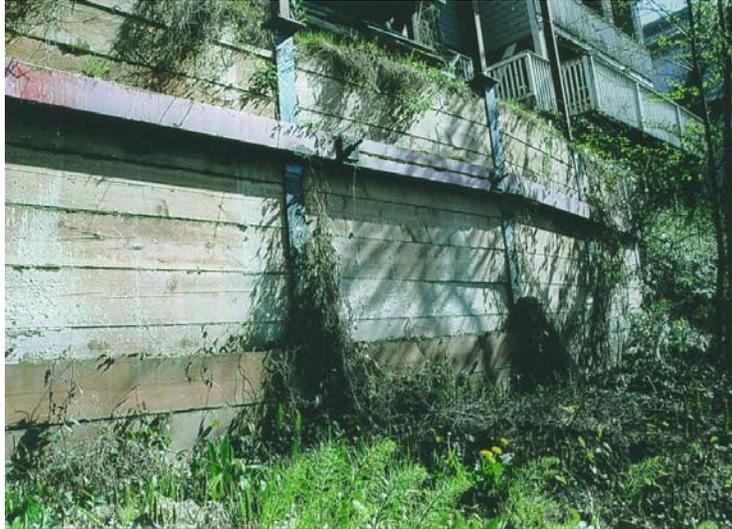
Figure 6: Existing anchored retaining wall system after nearly six years.

Both retaining structures have been in-place for about seven years. The geofram retaining structure is the furthest downslope and has survived a large downslope movement (a regional landslide failure of the downgrade slope) without any detrimental impact. This large downslope movement was apparently induced by the installation of the “heavy” retaining system by adjacent homeowners. There has been some loss of soil from along the face of the wall due to the downslope soil movement associated with the large landslide event. This necessitated the installation of two additional timber lagging planks at the base of the wall to retain the exposed soil. However, there has been no apparent impact to the residence, the wall system, or the geofram backfill from this soil loss. The current condition of the anchored wall is shown in Figure 6.
