Severn Rivers Trust

Fish Passage Options Appraisals – River Stour

JANUARY 2019

Title: Weir surveys and fish passage options appraisals on the River Stour

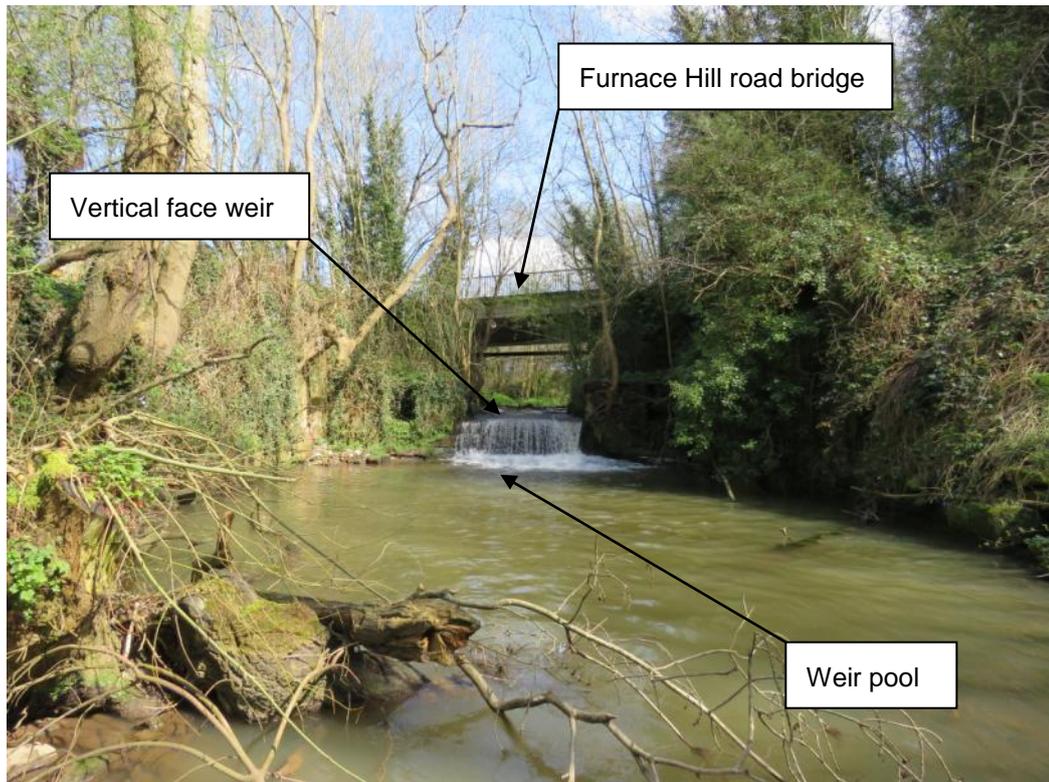
The structure at this location comprises a vertical face weir with a flat crest and at the time of the surveys a head loss of 1.27 m (Figure 2.1).

Figure 2.1: The weir and downstream weir pool underneath Furnace Hill road bridge.

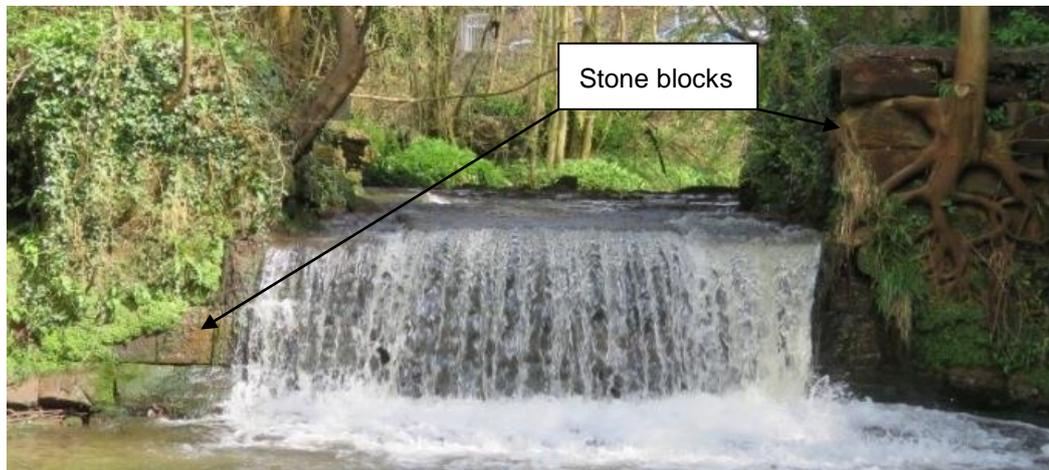
The weir appeared to be constructed primarily from large stone blocks with retaining walls comprised of smaller stone blocks on either side of the weir crest (Figure 2.2).

Figure 2.2: Close up photograph of the weir face with the stone blocks from which it is comprised visible.

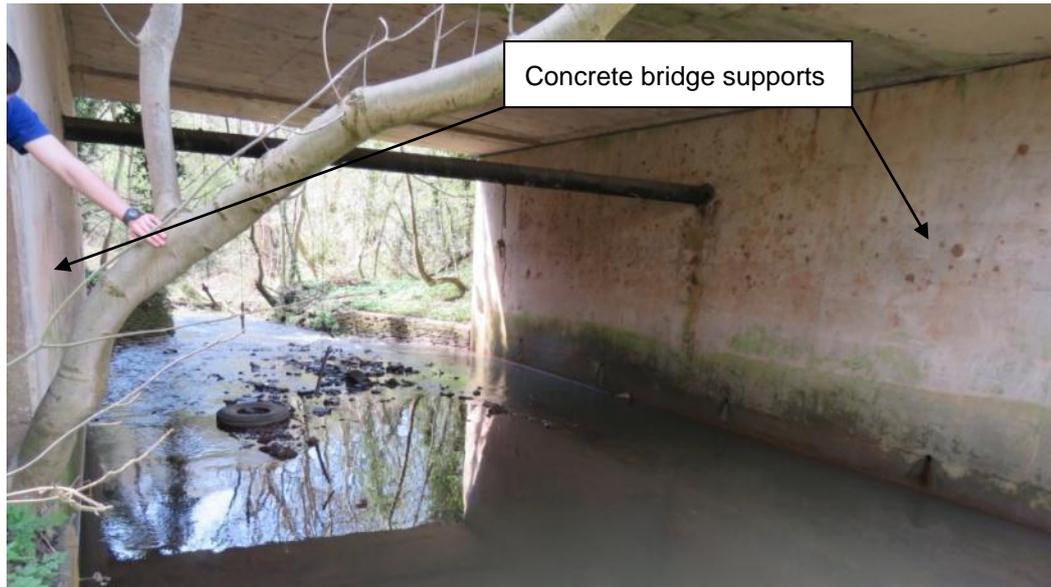
Immediately upstream of the weir the channel widened into a uniform rectangular channel flanked on either side by the concrete bridge support structures.

Figure 2.2: Photograph looking in a downstream direction from the upstream side of the road bridge.

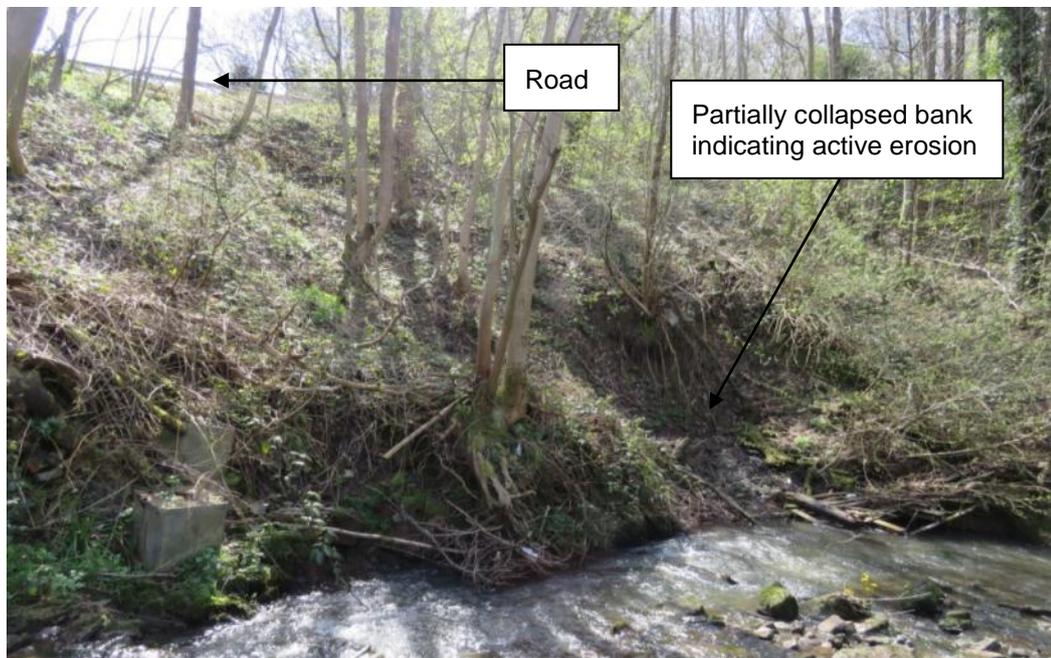
The river bank on the true left of the channel (left hand bank when looking in a downstream direction) was very high and very steep. The bank was heavily vegetated with a mixture of scrub and trees and a road ran along the top of the bank (Figure 2.3). There was some evidence of active erosion of the lower part of the bank at the point where the river bends sharply round to the right approximately 20 m downstream of the weir.

Figure 2.3: Photograph showing the steep, vegetated bank on the true left of the river channel approximately 20 m downstream of the weir.

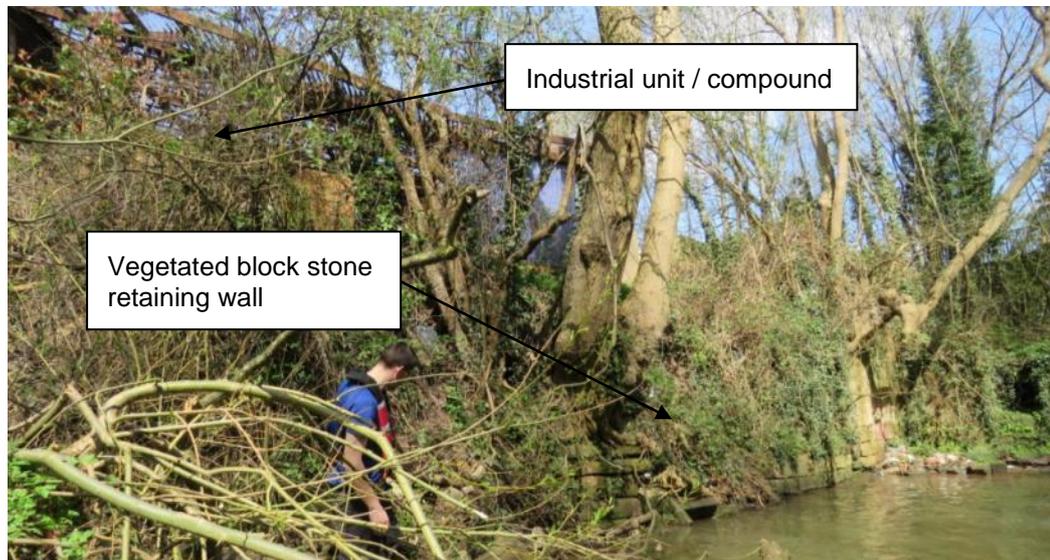
The true right hand bank of the river immediately downstream of the weir comprised block stone retaining walls with multiple trees and other vegetation growing out of gaps between stones or on the stone faces (Figure 2.4).

Figure 2.4: Photograph showing the block stone retaining wall on the right hand bank immediately downstream of the weir.

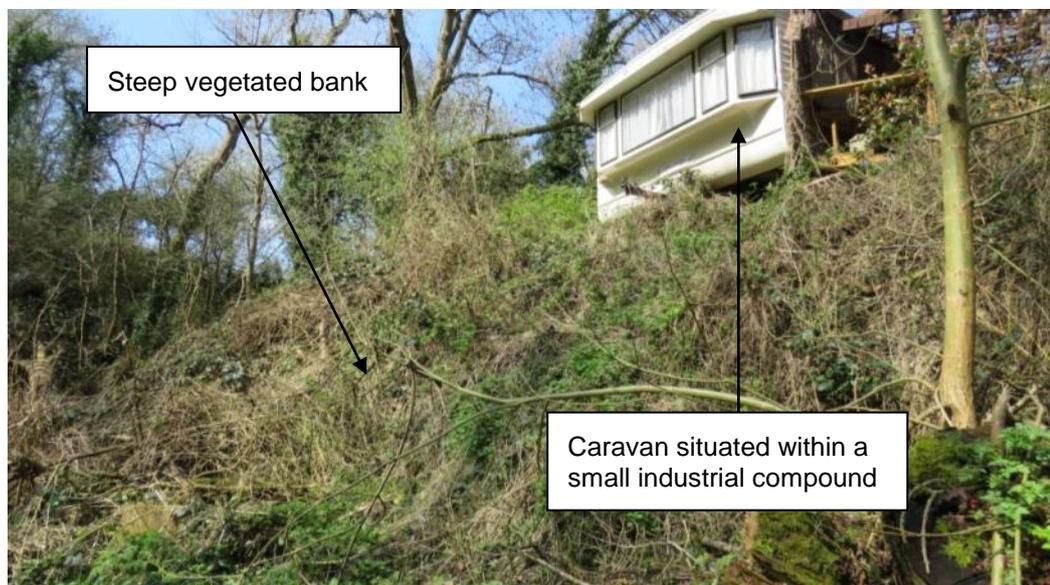
Approximately 20 m downstream of the weir the block stone walls gave way to steep, vegetated banks. A small industrial unit, yard and static caravan were situated on top of the right hand bank (Figure 2.5).

Figure 2.5: Photograph showing the steep, vegetated bank and static caravan within an industrial compound on the true right of the river channel approximately 20 m downstream of the weir.

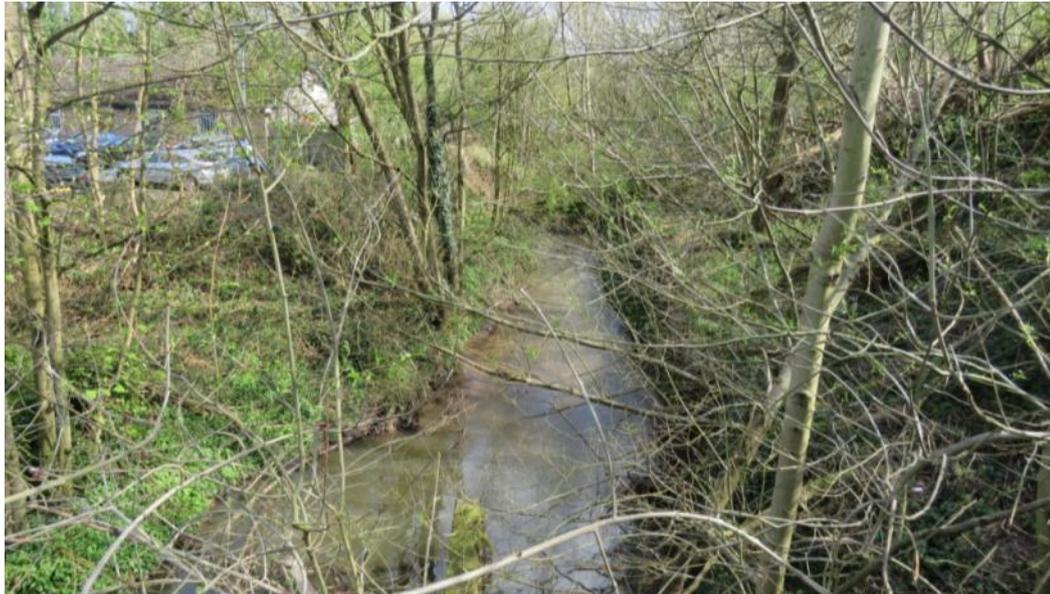
Upstream of the weir the channel was a relatively uniform, trapezoidal shape with steep vegetated banks and a flow type comprised mainly of shallow glide (Figure 2.6). The substrate was predominantly silt.

Figure 2.6: Photograph showing the river channel immediately upstream of the weir.

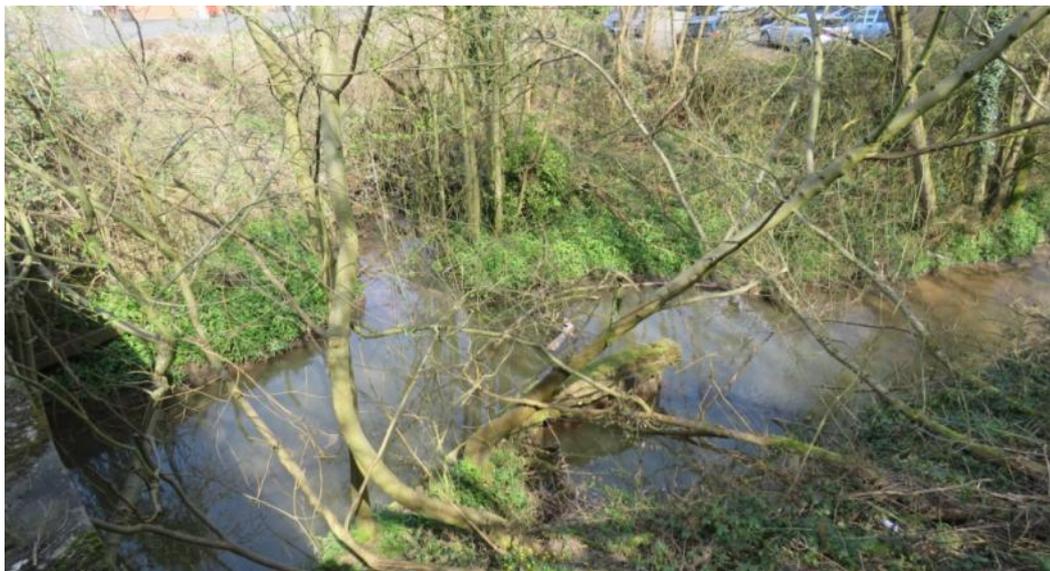
A small tributary entered the main channel approximately 5 m upstream of the road bridge (Figure 2.7).

Figure 2.7: Photograph showing the small tributary entering the main channel.

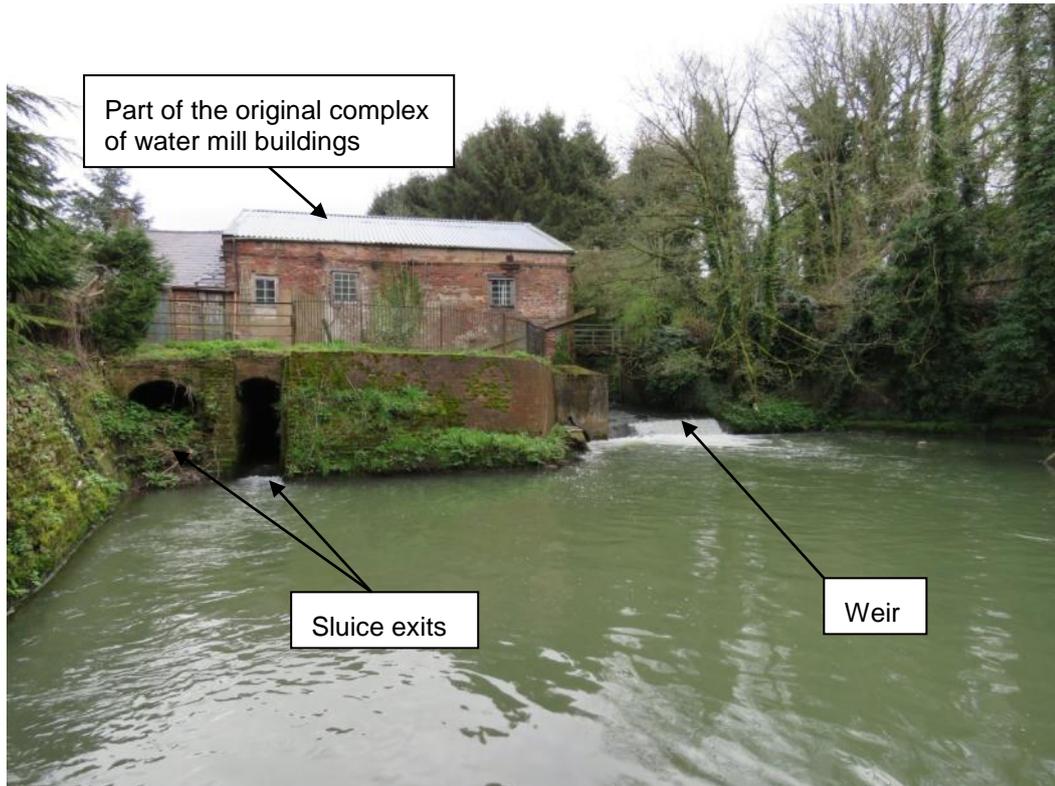
This site comprises a complex of structures which form part of the original water mill. The structures of interest include a vertical face weir with an elongated, sloping crest and two sluice structures (Figure 2.8).

Figure 2.8: Photograph illustrating the main features of interest at Bells Mill with respect to fish passage issues.

The weir appeared to be constructed from small stone blocks or bricks and concrete. The weir crest was approximately 5 m long and just under 3 m wide with a gentle slope running in an upstream to downstream direction. The weir crest terminated with a vertical drop, and non-adherent nappe, into the weir pool (Figure 2.9). Water depths over the weir face were estimated at less than 10 cm with the true right hand side of the weir having no flow over it at the time of the survey. The head loss at the weir face was approximately 0.5 m with an additional head loss between the upstream end of the weir crest and the downstream end of the weir crest of approximately 0.2 m. This equates a total head loss across the weir structure of ca 0.7 m.

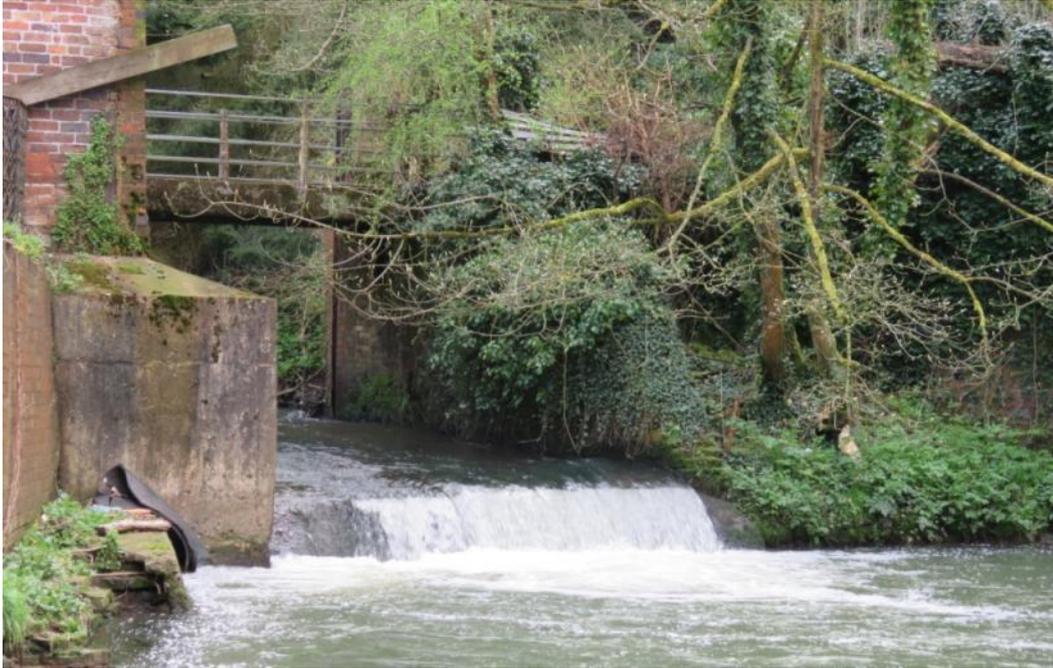
Water depths within the weir pool were varied due to variations in the bed level likely resulting from years of scouring. Adjacent to the toe of the weir depths were estimated by the current structure owner (based on previous measurements undertaken with large poles) at 1.2 m with depths increasing to more than 2.5 m at ca 8 m downstream from the weir.

Figure 2.9: Photograph illustrating the main features of interest at Bells Mill with respect to fish passage issues.

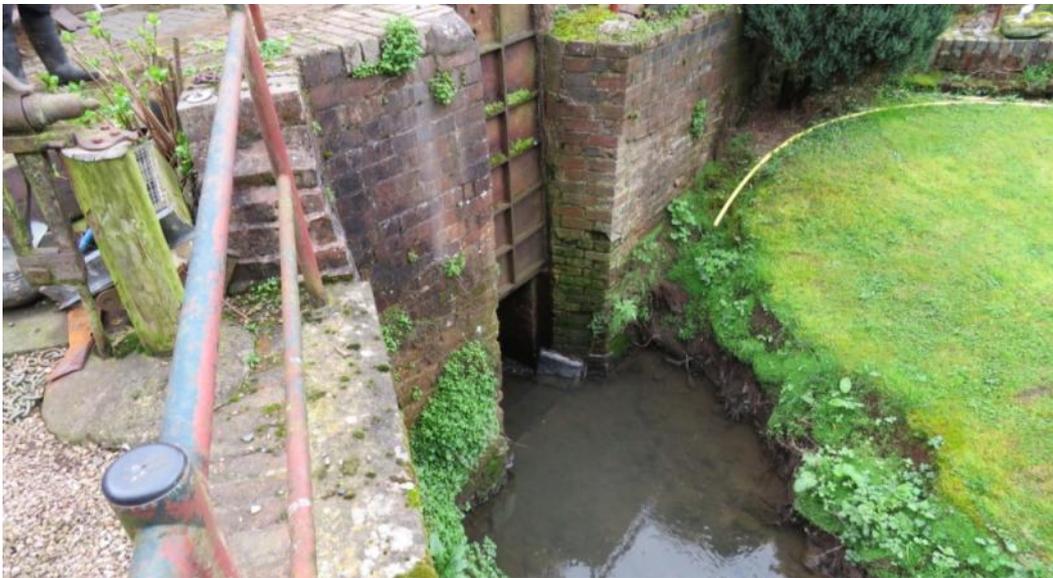
The upstream inlet to the sluice is located on the true right hand side, and upstream side of the weir (Figure 2.10). It can be manually closed using a winding sluice gate although the landowner advised that is never used.

Figure 2.10: Photograph of the upstream sluice inlet.

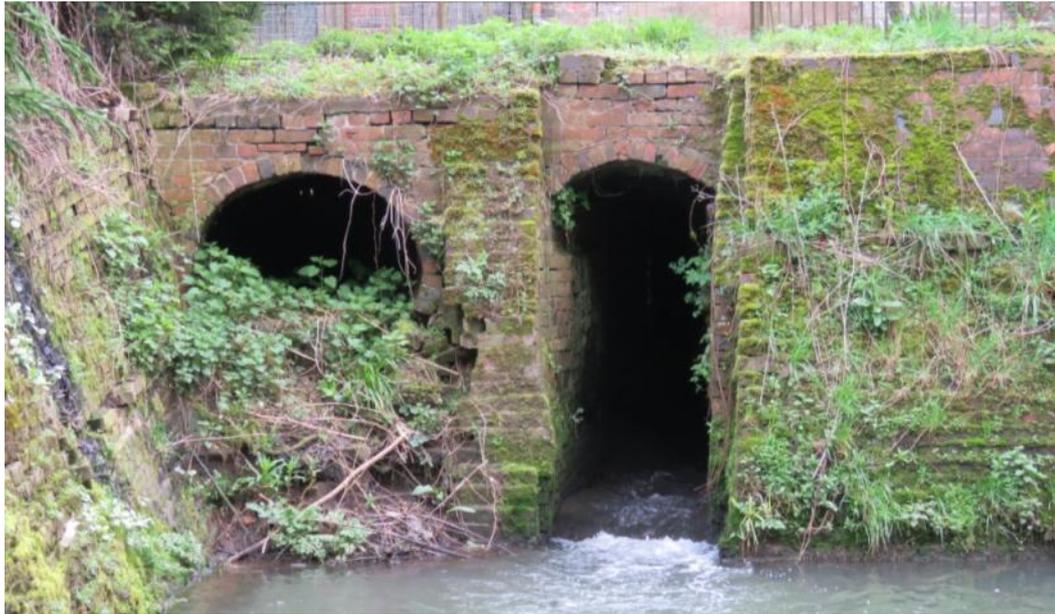
The downstream exit from the sluice, which bypasses the weir, is located on the true right hand side of the weir (Figure 2.11). There is a small head loss between the exit location and the weir pool water level of ca 0.15 m. The total head difference between the upstream sluice inlet bed level and the downstream weir pool water level was approximately 0.8 m.

Figure 2.11: Photograph illustrating the main features of interest at Bells Mill with respect to fish passage issues.

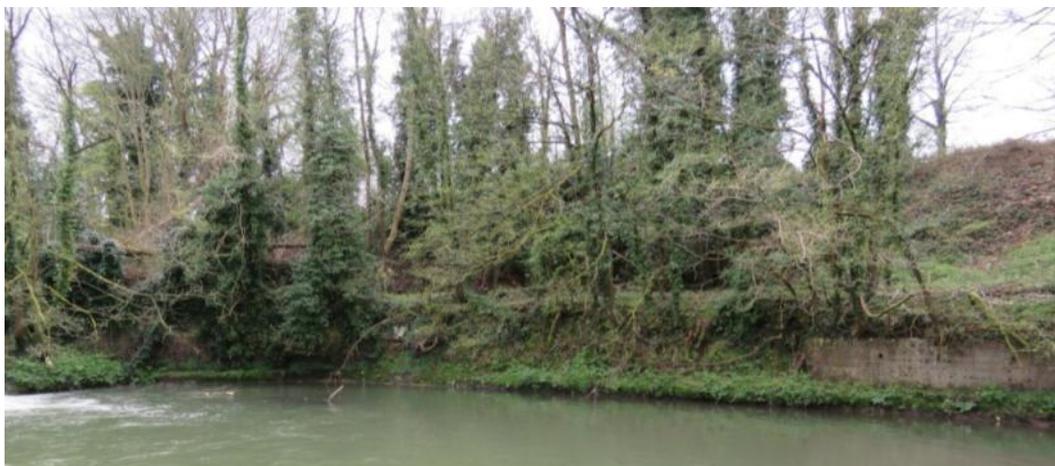
The true left hand bank comprised brick and block stone retaining walls at the base of very steep and high, wooded banks (Figure 2.12). The Stourbridge canal runs roughly parallel to the river at the top of the aforementioned banks.

Figure 2.12: Photograph of the true left hand bank immediately downstream of Bells Mill weir.

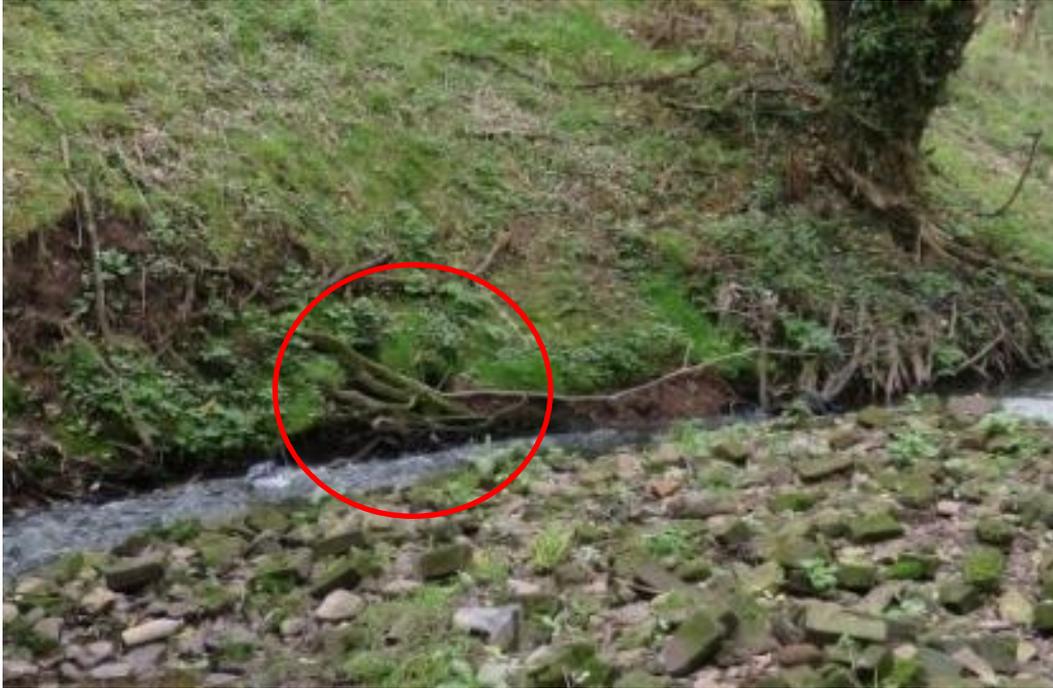
Approximately 20 m downstream of the weir a small undercut section of bank with exposed roots was observed (Figure 2.13). Upon closer inspection there was a ‘tunnel’ running further into the bank. While the location of the hole / potential burrow so close to the water level probably precludes it from being used as a permanent holt by otters it had potential to serve as a temporary resting place or ‘couch’ and any proposed activities at this location should take this into consideration.

Figure 2.13: Photograph showing the location of a potential otter resting place.

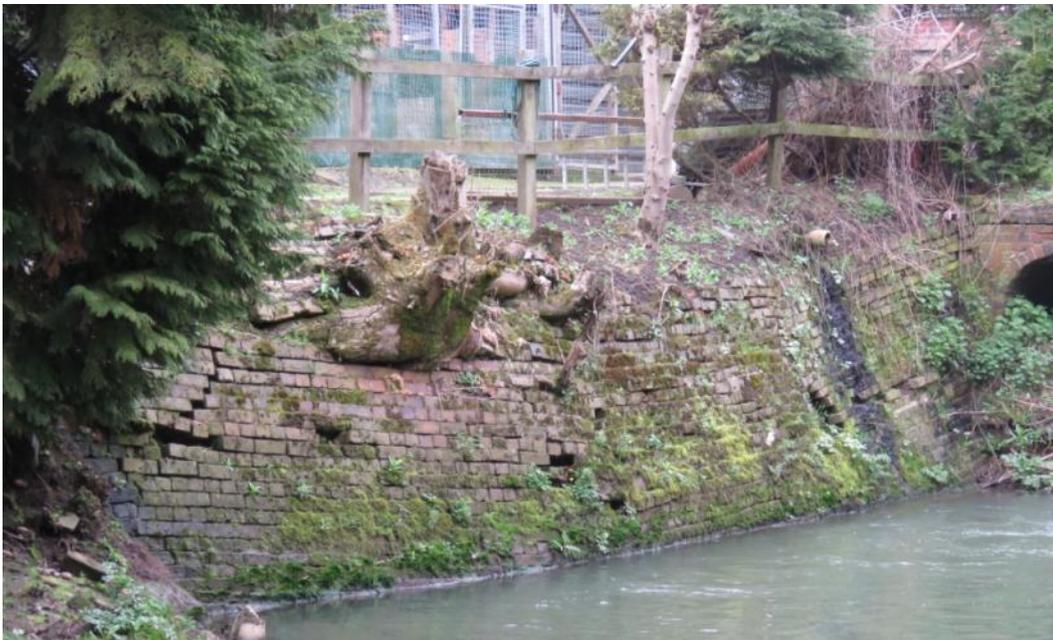
The true right hand bank comprised an unstable brick retaining wall with multiple dog kennels and the mill gardens situated immediately beyond this (Figure 2.14 and Figure 2.15).

Figure 2.14: Photograph showing the unstable brick retaining wall immediately downstream of the sluice exits on the right hand bank. Kennels can be seen in the top of the photograph.

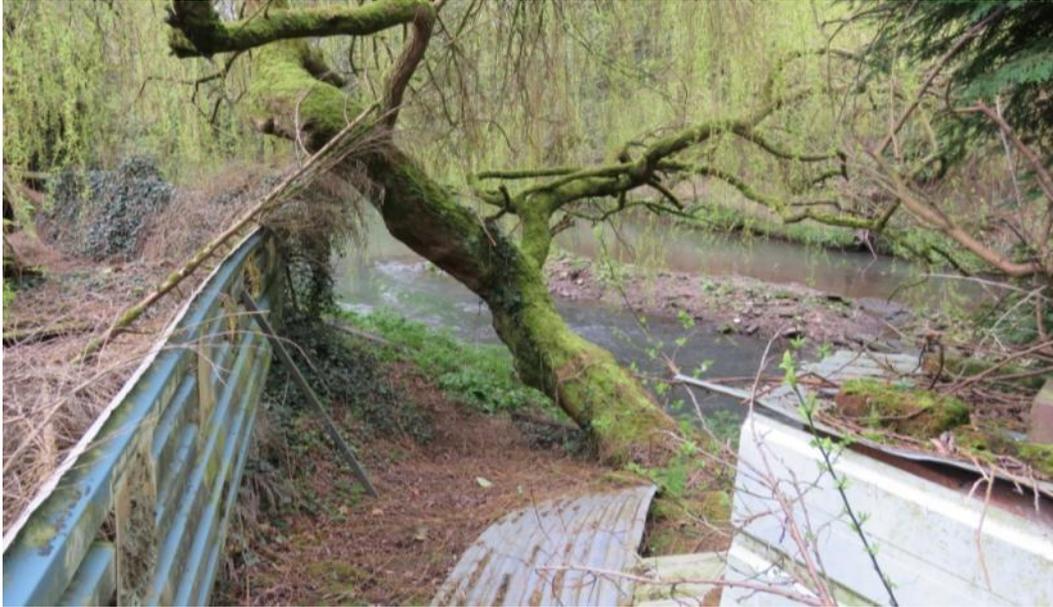
Figure 2.15 : Photograph showing the right hand bank at the downstream end of the weir pool approximately 20 m downstream from the weir and sluice structures.

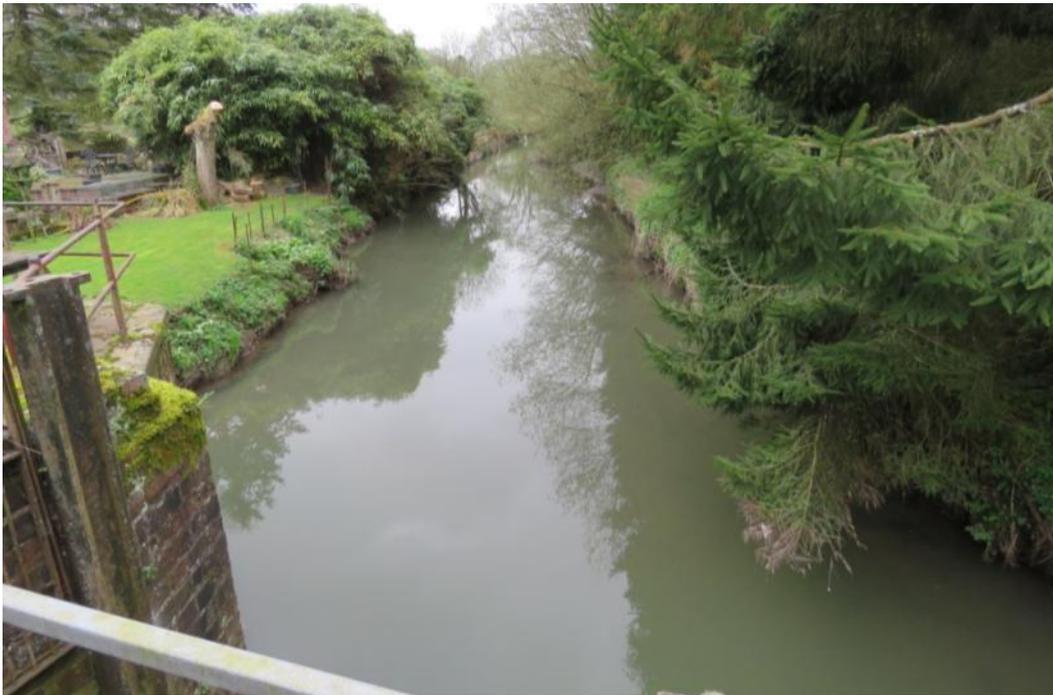
The upstream channel was impounded with predominantly glide flow type and a silt covered substrate. The banks were straight and predominantly vegetated with a dominance of trees (Figure 2.16).

Figure 2.16: Photograph looking upstream from a small footbridge above the weir at Bells Mill.

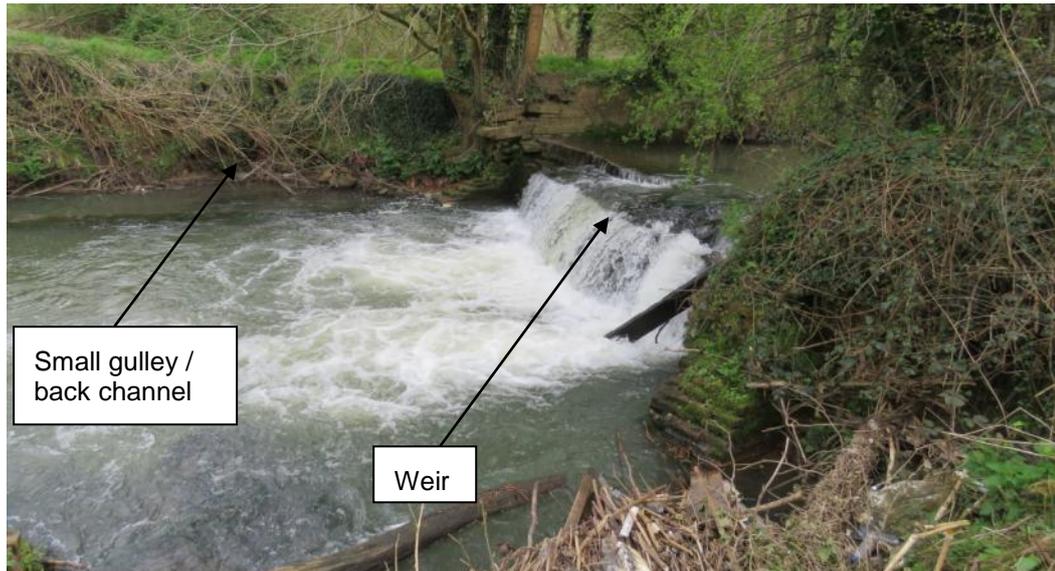
This site comprises a single weir structure made from block stone / masonry blocks with brick wing walls (Figure 2.17). The weir has a broad, block stone crest with water depths of approximately 0.1 m at the time of the survey and a vertical weir face with plunging flows into a weir pool and a non-adherent nappe (Figure 2.17). The head loss was estimated at ca 1 m on the day of the survey.

Figure 2.17: Photograph illustrating the main features of interest at Bells Mill with respect to fish passage issues.

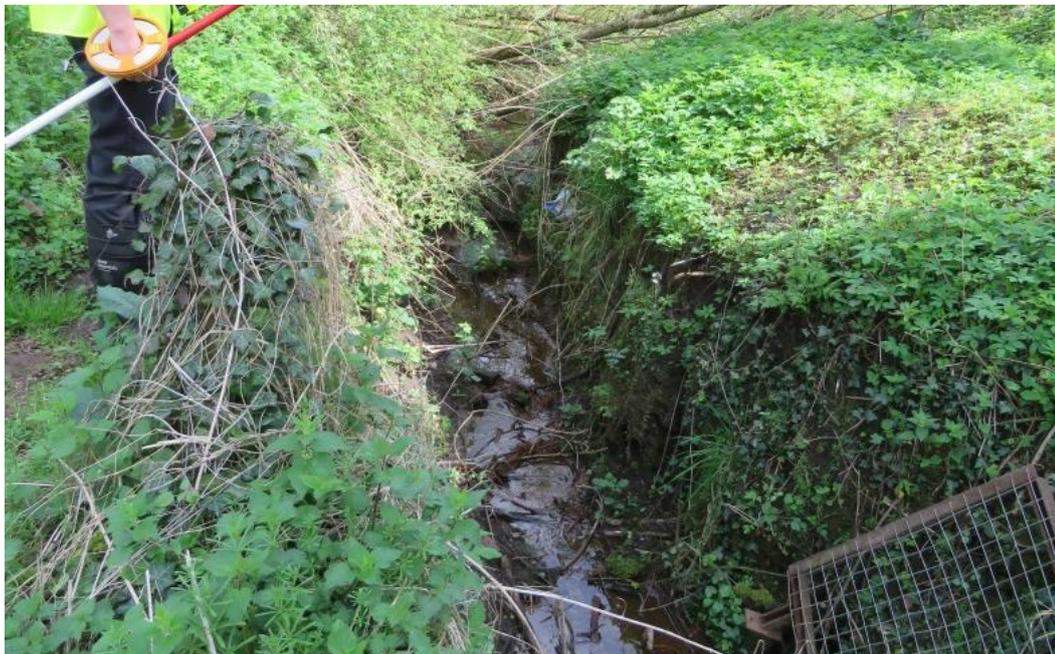
A small gully / back channel with flowing water in it was located on the true right hand bank approximately 4 m downstream from the weir in the main channel (Figure 2.17 and Figure 2.18). This gully originated from an overgrown and fully sedimented channel passing through some wetted woodland habitat (Figure 2.19) and pastureland on the right hand bank. The gully was traced back as far as the pasture in front of the Bells Mill house.

Figure 2.18: Photograph of the downstream end of the small gully / back channel.

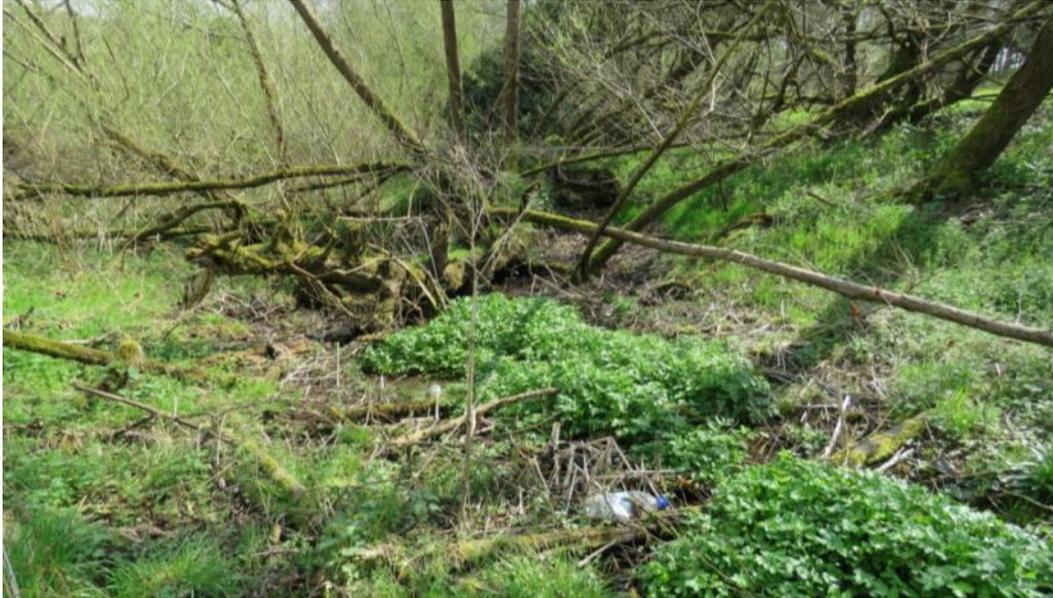
Figure 2.19: Photograph of the middle section of the gulley / back channel showing how sedimented and overgrown the channel has become.

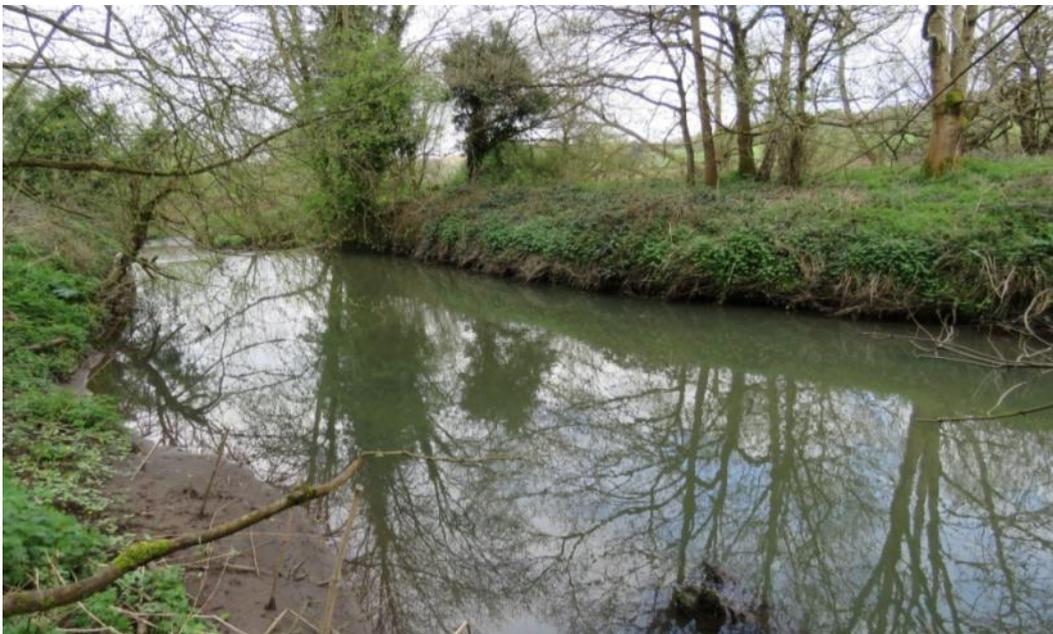
The habitat upstream of the weir was predominantly impounded with glide flow type and a predominantly silt covered substrate (Figure 2.20). The channel was straight with a very high and steep, partially wooded left hand bank and a lower left hand bank with mainly woodland and scrub.

Figure 2.20: Photograph showing the upstream habitat looking downstream towards the weir from a viewing point ca 50 m upstream of the weir.

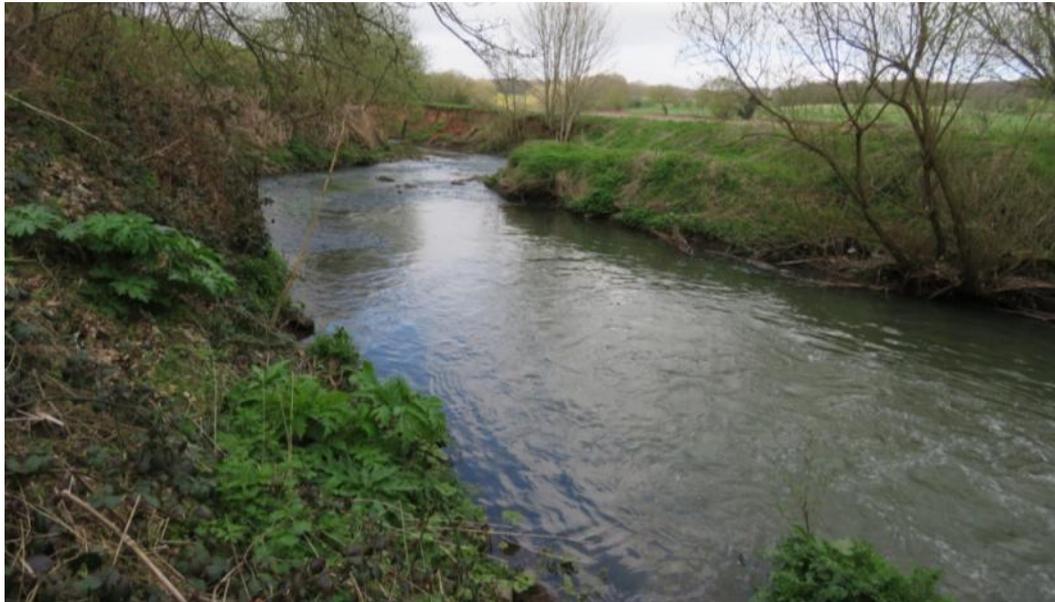
Immediately downstream of the weir was a weir pool followed by a mixture of run, riffle and glide habitats (Figure 2.21). The substrate was a mix of cobble, pebble and gravel interspersed with some finer sand or silt patches. Both banks were steep with the left hand bank being a lightly wooded slope and the right bank being near vertical with

arable fields at the top of the bank. The banks had become unstable and collapsed in several places.

Figure 2.21: Photograph looking downstream from the tail end of the weir pool.

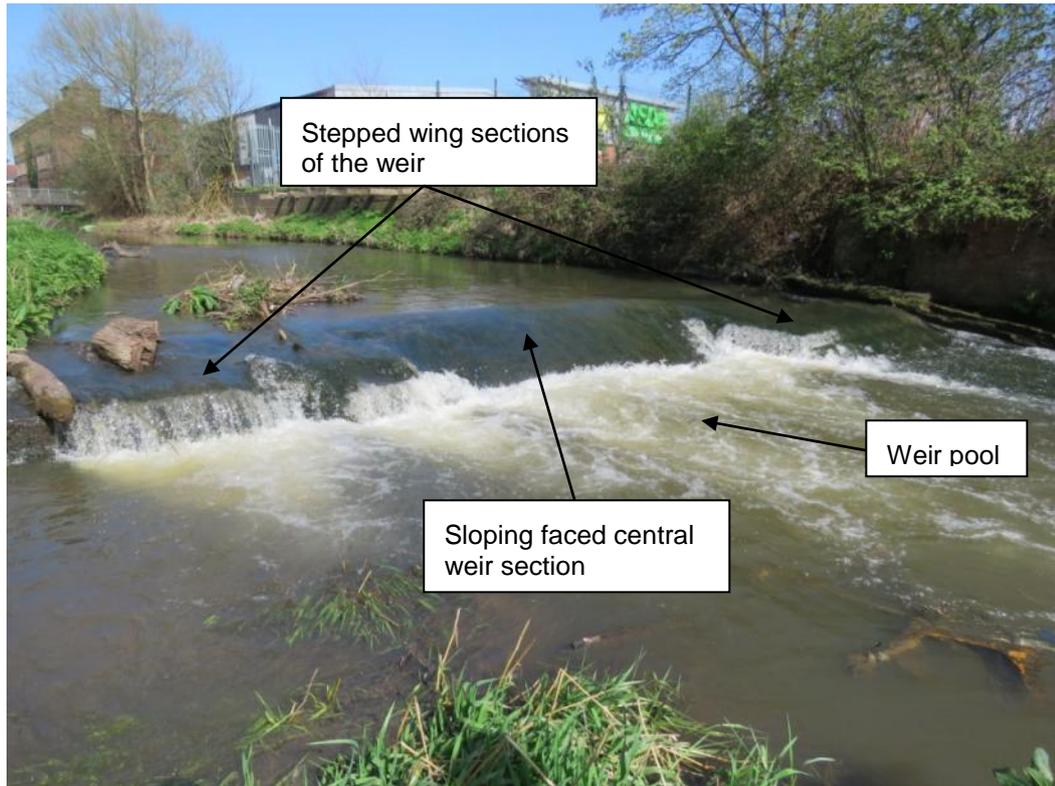
This site comprises a compound weir structure including a sloping central section and two stepped wings (Figure 2.21). The head loss across the structure was approximately 0.45 m on the day of the survey.

Figure 2.21: Photograph illustrating the main features of interest at Kidderminster Furniture Warehouse weir.

There was streaming flow over the central, sloping-faced section of the weir with a small standing wave and turbulent conditions at its base. Water depth over the weir face was approximately 0.15 m. Flow over the wing sections was predominantly plunging with the exception of the farthest true left section of the weir where the nappe appeared to be adherent.

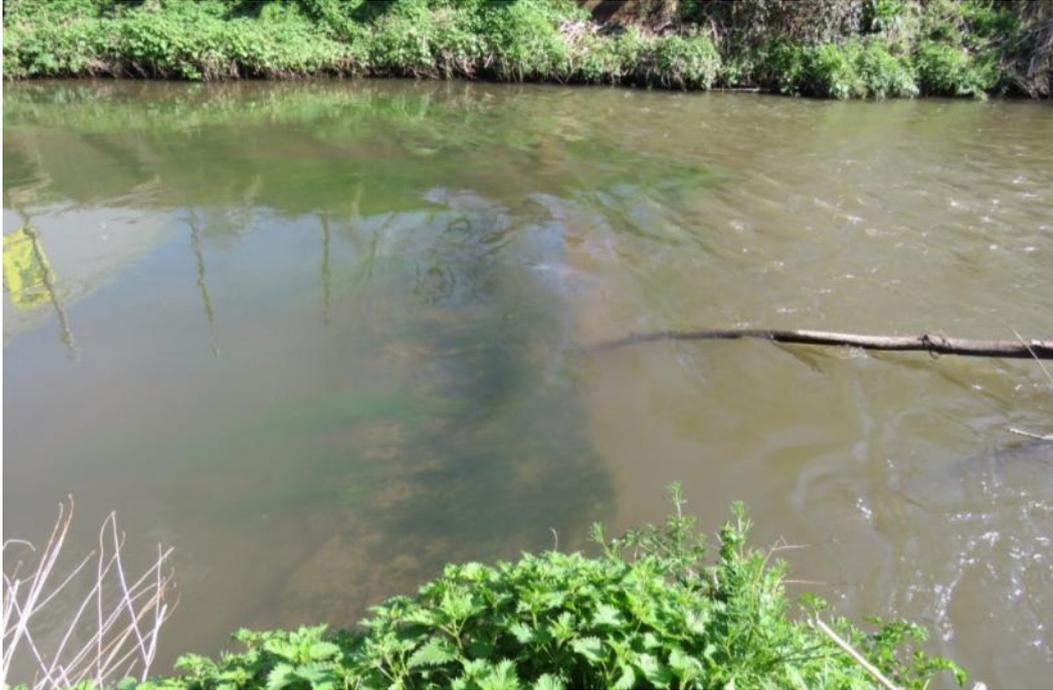
An additional concrete structure was also observed approximately 10 m upstream of the main weir structure (Figure 2.22). According to the Environment Agency it is likely that this is concrete protection above a buried sewage transfer pipe. Further investigation into the purpose of this structure should be undertaken as a priority for any subsequent feasibility studies due to the potential for any changes in downstream bed or water levels associated with fish passage improvements to impact upon this structure (e.g. due to increased scour). Furthermore, if the water levels were to drop significantly (e.g. due to very low river flow levels during prolonged periods of no rainfall or due to downstream alterations to the weir structure) this could result in this structure becoming an obstacle to fish.

Figure 2.22: Photograph illustrating the structure upstream of the main weir believed to be a buried sewage transfer pipe.

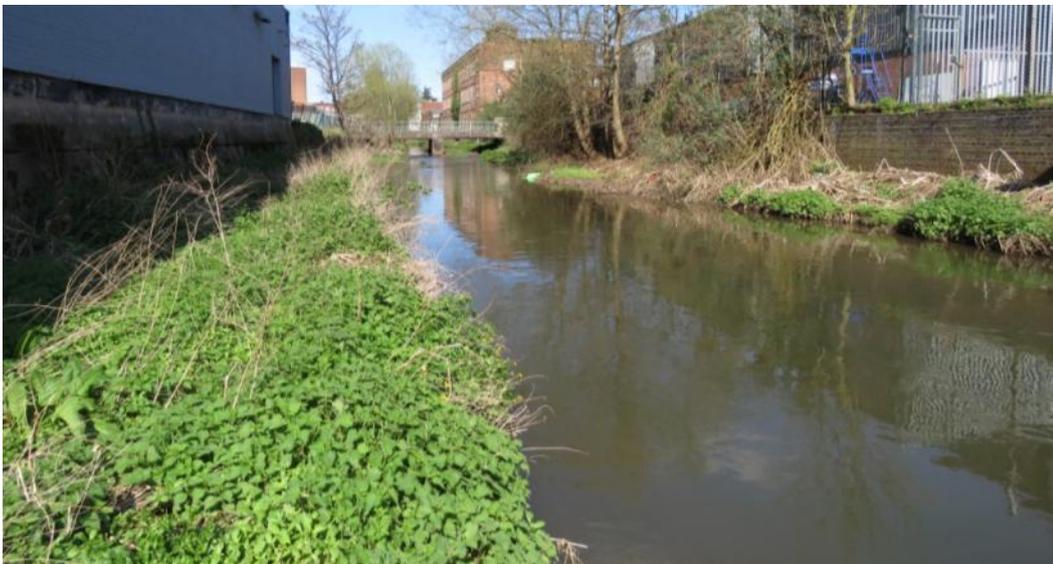
The habitat upstream of the weir was predominantly uniform with glide flow types and a substrate that appeared to be predominantly gravel interspersed with sand and occasional boulders. There were multiple patches of submerged linear macrophyte also visible.

Figure 2.23: Photograph of the river channel upstream of the weir structures.

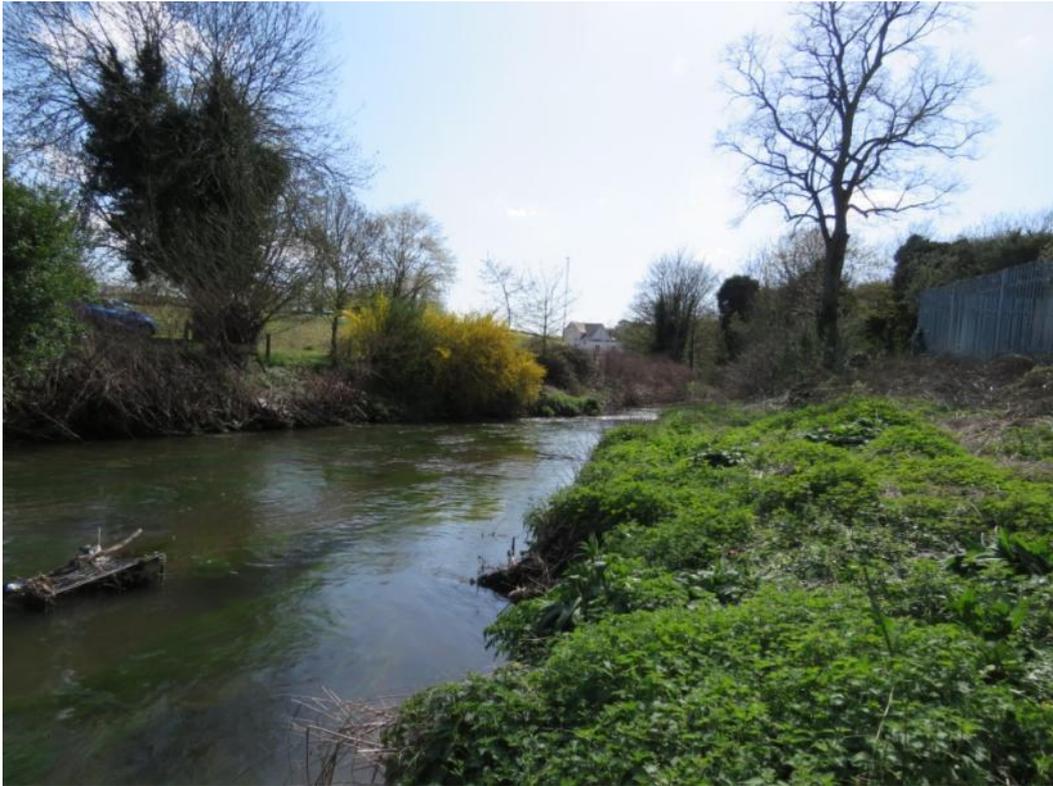
Figure 2.24: Photograph showing the river channel downstream of the weir.

The river channel downstream of the weir was straight but with more variable flow patterns compared with the upstream channel. Glide, run and riffle areas were all observed with some marginal slack water areas. The substrate was similar to that upstream but with some coarser substrate types present in patches.
