RUSSIAN ROULETTE:

COATING PERFORMANCE WITH OR WITHOUT A SULFIDE REMOVAL TREATMENT

BY DR. YASIR IDLIBI, MICHAL CONSULTING;
JASON HARTT, ADANAC GLOBAL TESTING &
INSPECTION; DR. MIKE O'DONOGHUE AND
VIJAY DATTA, MS, INTERNATIONAL PAINT LLC;
AND BILL JOHNSON, ASCT, ACUREN GROUP INC.

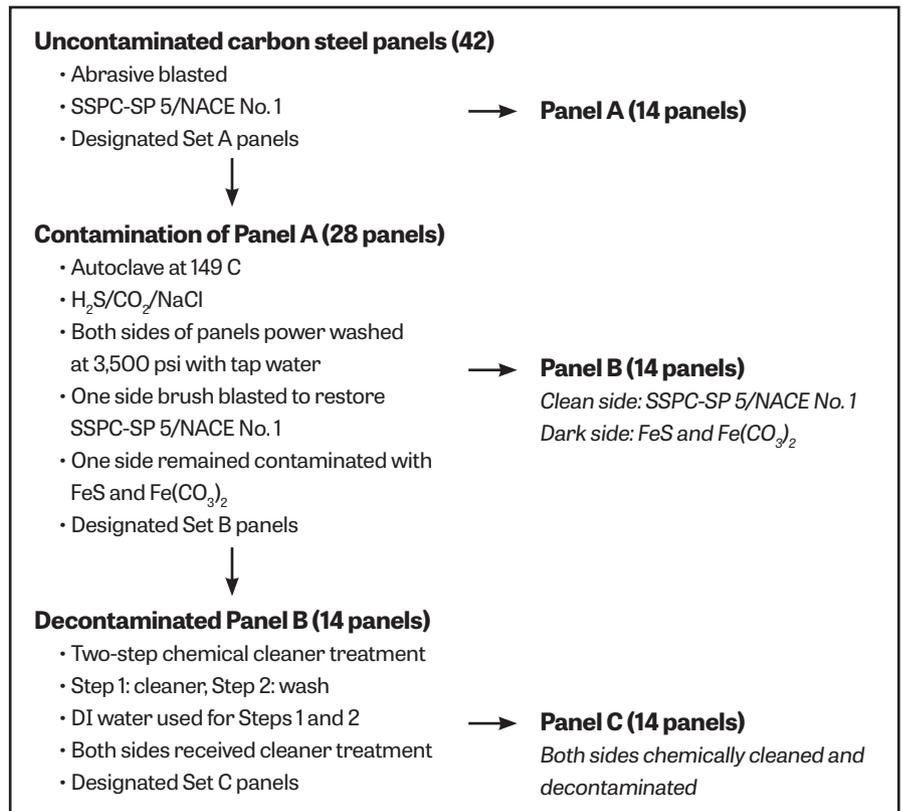
Figure 1 is a schematic outline of the preparation of carbon steel panels designated as A, B and C.

Fig. 1: Preparation and treatment of 42 panels prior to coating application. All figures courtesy of the authors unless otherwise noted.

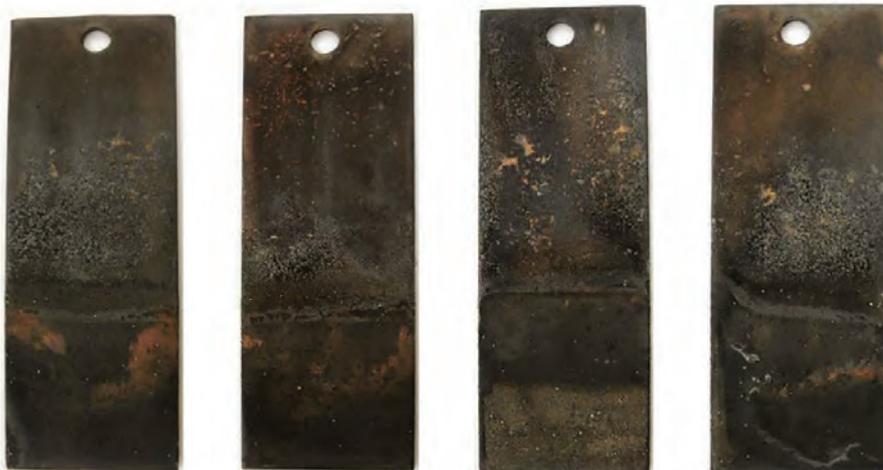
Fig. 2: Examples of deliberately contaminated panels.

The remaining 28 bare panels were deliberately contaminated by exposing them to a gaseous phase of 10-percent H_2S , 10-percent CO_2 , 80-percent CH_4 , and an aqueous phase of 5 percent NaCl, in an autoclave for four days at 149 C and 250 psig. Figure 2 shows the rusted panels after their removal from this exposure. This contamination procedure was undertaken to ensure that a significant amount of black iron sulfide was formed on the steel panels and that the steel was also contaminated with iron carbonate and chlorides.

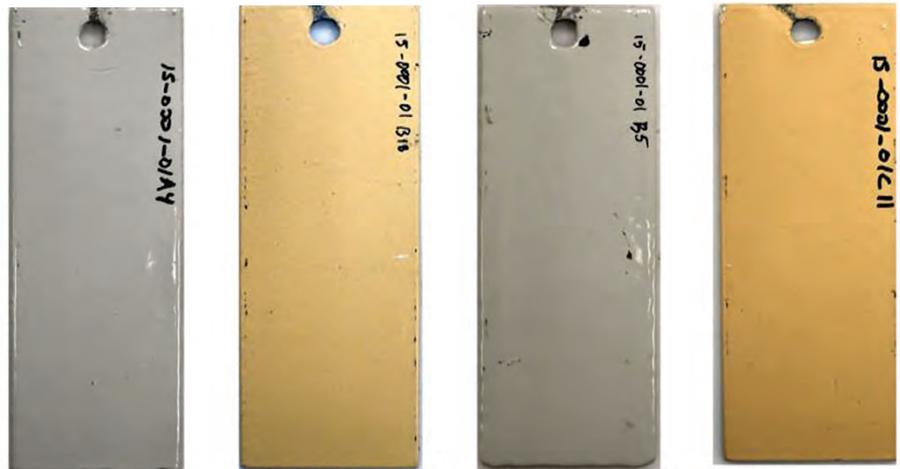
Fig. 3: Examples of pre-test panels. (Left to right): Coating 2-Panel A, Coating 1-Panel B, Coating 2-Panel B and Coating 1-Panel C.

Coating 1 was applied in three coats while Coating 2 was applied in a single coat. Both Coating 1 and Coating 2 were applied in accordance with the lining manufacturer's instructions to the three sets of panels; Set A, Set B and Set C. Figure 3 shows examples of the coated panels. The same

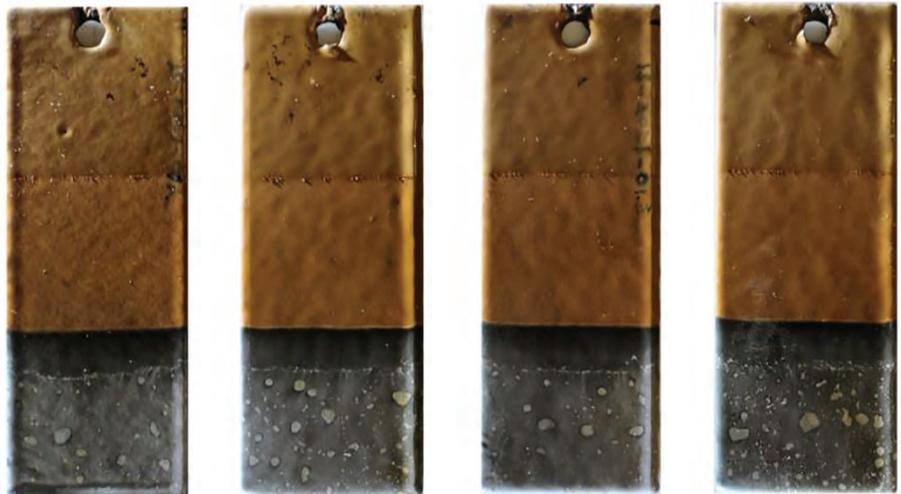
Fig. 4: Coating 1 panels, post autoclave test. (Left to right): 2A, 1B, 2B and 1C.

Post-autoclave test panels are shown in Figures 4 and 5. Figure 6 provides a comparison of pre- and post-test impedance values.

The solvent-borne Coating 1 showed no blistering in all phases regardless of panel type, with the exception for panel 2B which showed F#2-sized blisters in the water phase. Coating 1 maintained or in many cases improved its adhesion rating compared to its pre-test condition. The coating showed excellent pre-test impedance and maintained high log Z of greater than 10 values post-test in the gas and hydrocarbon phases. However, these values decreased in the water phase to log Z of 7-to-8 indicative of the more aggressive water phase.

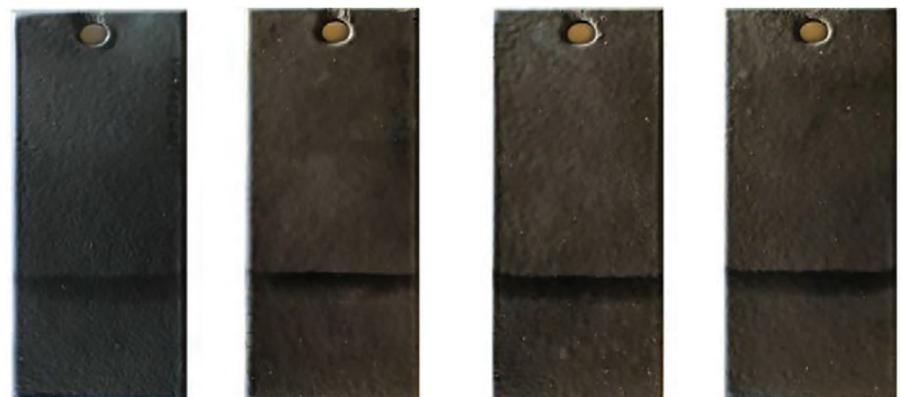
Fig. 5: Coating 2 panels, post autoclave test. (Left to right): 2A, 1B, 2B and 1C.

The solvent-free Coating 2 had as high pre-test impedance values as did Coating 1 and showed similar post-test impedance behavior. With Coating 2 on white metal Set A panel surfaces there was an inconsistency of EIS values not seen on the chemically cleaned Set C panels. Adhesion of Coating 2 on Set B panels decreased significantly in all phases when compared to panels from sets A and C which maintained, or slightly changed, vis-à-vis adhesion rating. Overall, the adhesion ratings of Coating 2 were lower than Coating 1 indicating superior wetting out of the solvent-borne Coating 1. Interestingly, the adhesion ratings for Coating 2 improved significantly in the gas phase on the chemically prepared Set C panel surfaces.

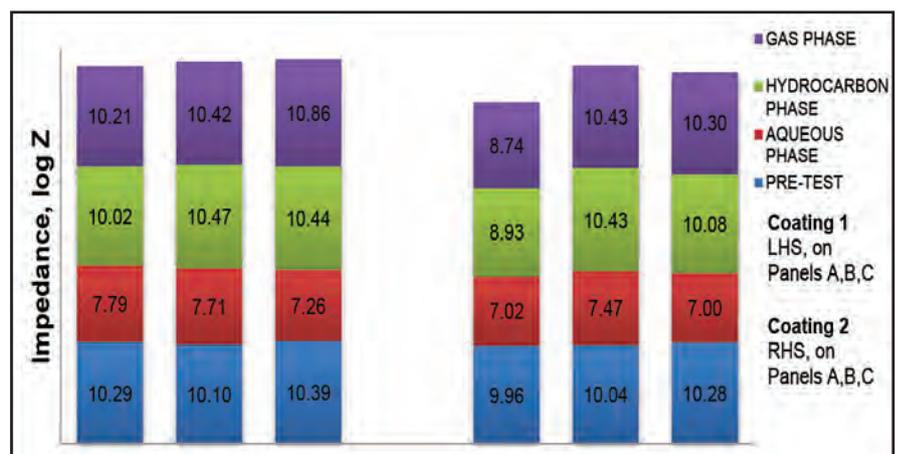
Fig. 6: Impedance, pre- and post-autoclave exposure.

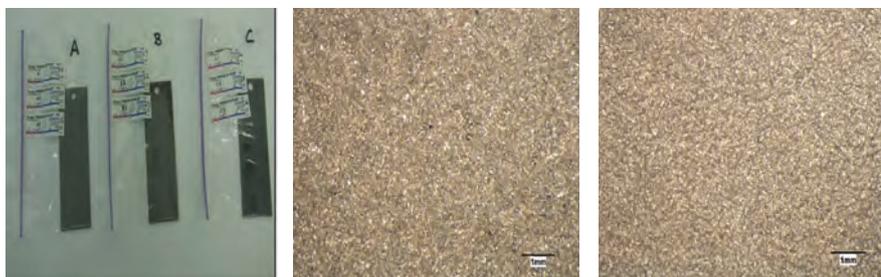
Fig. 7: (Left) Panel A, Panel B (washed, brush blasted one side; contaminated on other side) and Panel C. (Center) Panel A, SSPC-SP 5/NACE No. 1 and (Right) Panel C, SSPC-SP 5/NACE No. 1 and chemically cleaned.

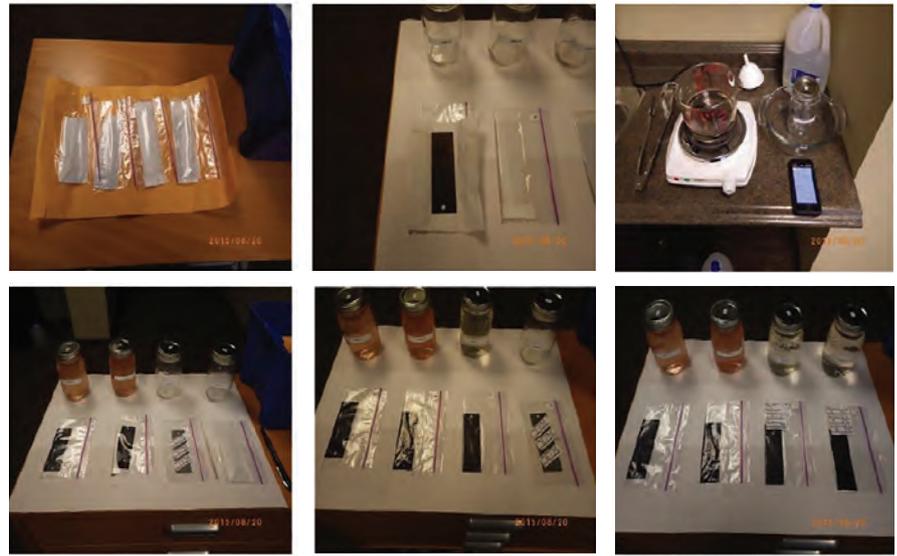
Fig. 8: (Top row, Left) Test panels as received, (Center) unpacking of Test Panel B washed, uniform rusting throughout; Test Panel B unwashed similar and (Right) Test Panel B, boiling extraction method, all others similar. (Bottom row, Left): Test Panel A, surface profile measurements (ASTM D4417) prior to boil extraction, (Center) Test Panel C, surface profile measurements (ASTM D4417) prior to boil extraction and (Right) Liquid reagent sample cooling and test panels repackaged after boil extraction. Photos courtesy of Norske Corrosion and Inspection Services Ltd.

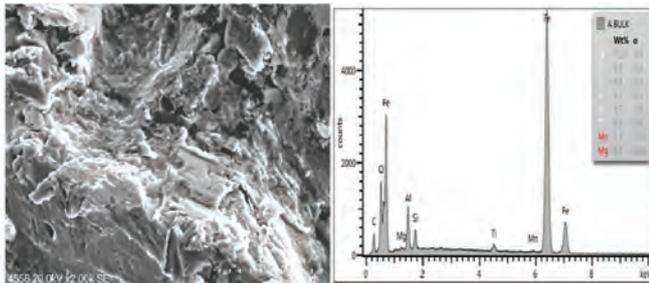
Fig. 9: SEM image of Panel A (2,000 times as taken) showing surface and bulk energy-dispersive X-ray analysis (EDXA) elemental analysis showing iron, oxygen and other elements.

Residual oxides, sulfides and embedment of abrasive media were clearly seen on the SSPC-SP 5/NACE No. 1 blast-cleaned surface of Set A panels (Fig. 9).

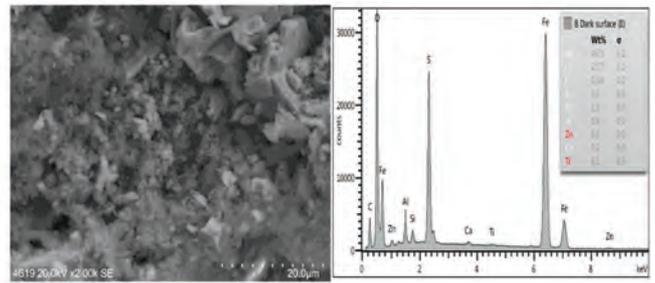
Fig. 11: SEM image of Panel B dark surface (2,000 times as taken) showing surface and bulk EDXA elemental analysis showing iron sulfide and iron carbonate (as per XRD analysis).

Residual oxides and sulfides were present on a panel from Set B, especially the back surface which also exhibited a dark surface with a visible cross-hatch pattern (panels were placed on a grid). The amount of surface oxide and

sulfide constituents was greatest on this sample (Figs. 10 and 11).

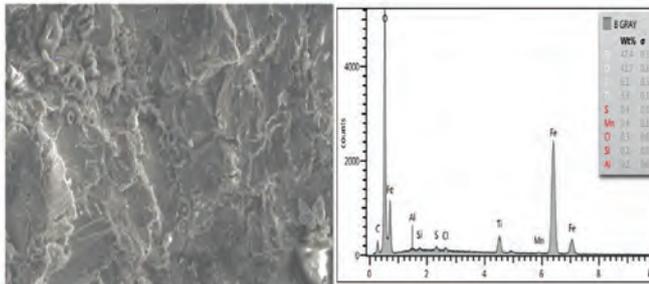
Fig. 10: SEM image of Panel B clean surface (2,000 times as taken) showing surface and bulk EDXA elemental analysis showing iron oxide and other elements.

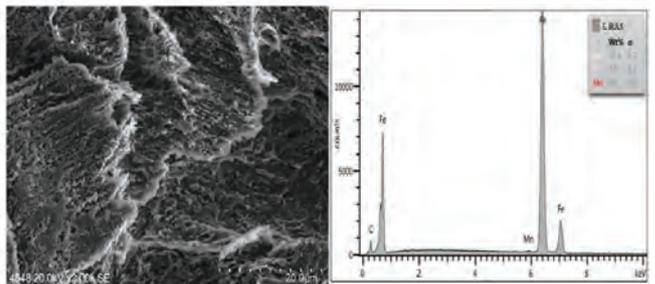
Fig. 12: SEM image of Panel C (2,000 times as taken) showing etched surface from exposure to corrosive environment subsequently treated with cleaner. Surface is clean as shown by the predominantly iron peak shown in the EDX analysis.

chemically treated surface of a panel from Set C was extremely clean and as shown in Figures 12 and 13 evidenced a uniformly etched surface with greater

angularity and profile depth compared to the blasted and water-washed surface of panels from Set B. These features accord well with a) the greater profile depth of panels from Set C versus panels from Set B when measured with coarse replica tape, b) a difficulty observed in removing the replica tape on panels from Set C, and c) the snagging of a rubber glove when moved across a panel from Set C but not when moved across panels from Sets A or B. This profile difference is a direct result of the corrosion of the abrasive-blasted steel in autoclave conditions and not due to the cleaner treatment itself.

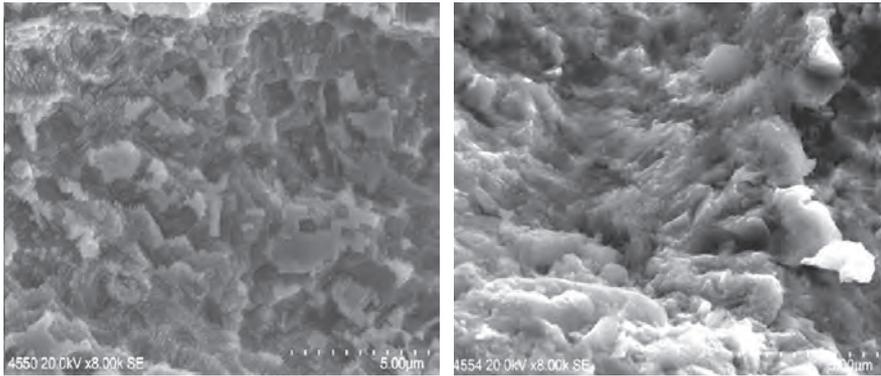
Fig. 13: (Left) At 8,000 times magnification, the surface of Panel A as blasted and (Right) Panel C after chemical treatment. Panel C shows etching effect from exposure to corrosive environment. By removing all the contaminants the chemical cleaner system has revealed the surface topography.
