# PRE-PURCHASE BUILDING INSPECTION REPORT

100 Smith Street  
Kelson, Lower Hutt  
5010, New Zealand

Inspection Date: 09 Mar 2017

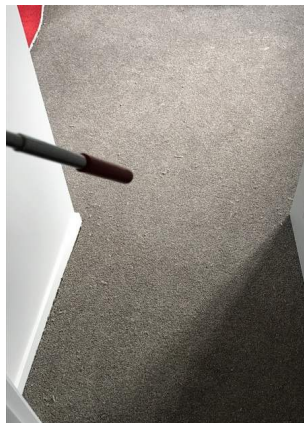
Location : Northern bedroom in front of the door  
Rating: Minor Maintenance

Floors (Timber); Are floors free of movement such as spring and bounce, and cracking, and are they free of dampness/staining and other damage?

Further investigation is required into the floor movement in this area, repair and improvement can be made.

**- Floor Movement -** A small amount of movement was detected in the northern bedroom on the 2nd storey, I recommend asking the contractor if they can rectify this issue.

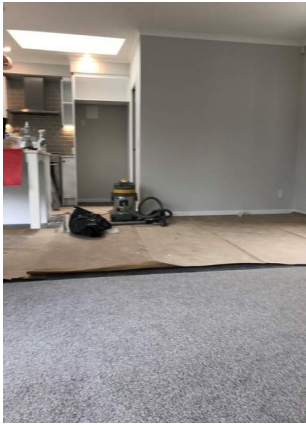
The vinyl floors were not inspected as these were still covered and cleaning was underway. These should be checked for defects, imperfections and to check if the perimeter has been sealed prior to settlement.

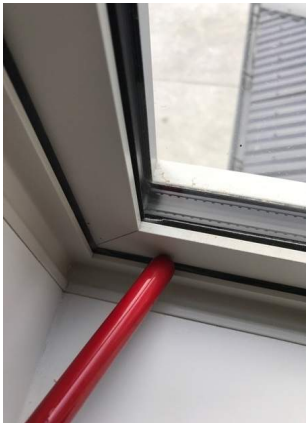
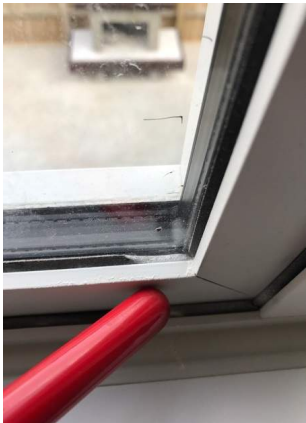
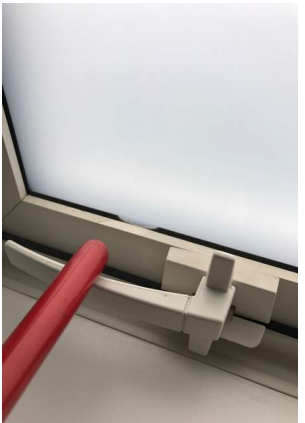
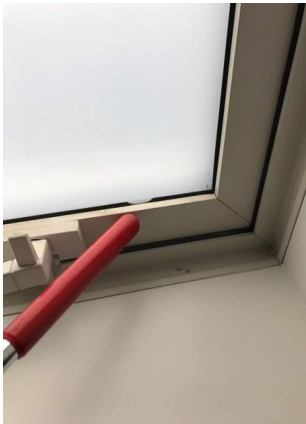
Windows (Metal framed); Are all windows free of broken/cracked glass, damage to glazing seals, staining/ corrosion, or do they operate freely?

Some of the rubber seals on the inside of the new windows are pushed down maintenance is recommended.

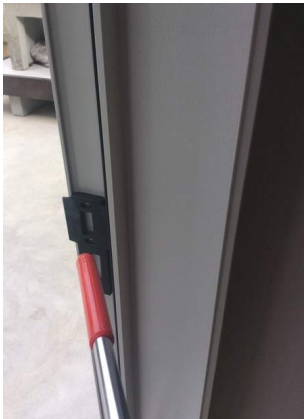
SUPPLEMENTARY INFORMATION	Maintenance is required by the installer.
EXPLANATIONS	<p>Location : Kitchen bifold door</p> <p>Details : The bifold door was binding against the striker place, I recommend adjustment takes place.</p> <p>Rating: Minor Maintenance</p>
IMAGES

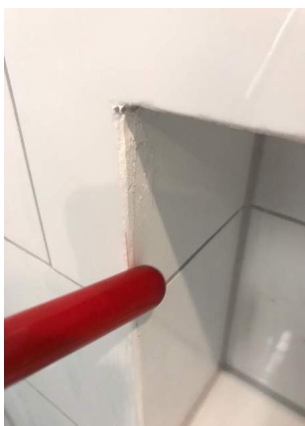
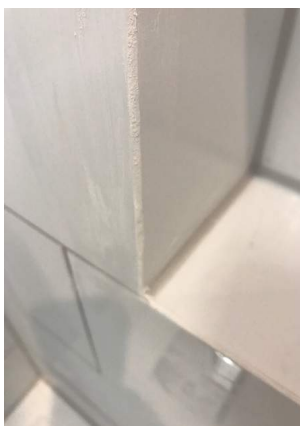
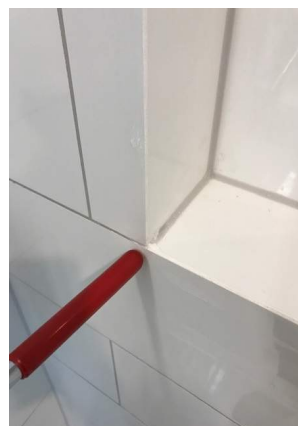
Bathrooms/WC; Are the shower tiles free of cracking, drumminess, or loose/missing grout/sealant?

Improvement can be made on the finishing around the recesses in both bathrooms, i recommend these are finished and well sealed.

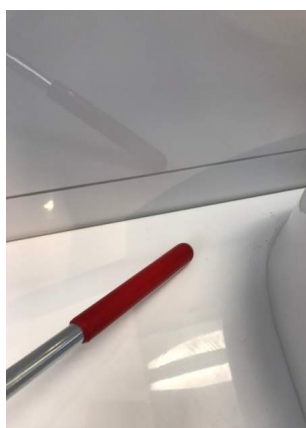
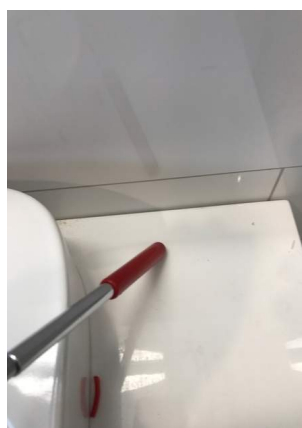
✗ No - Vanity sealing required

SUPPLEMENTARY INFORMATION	The vanity requires sealing to the wall to prevent deterioration of the cabinetry.	
EXPLANATIONS	Location :	Top level bathroom
	Details :	The vanity on the 2nd storey is missing a tile splash back when the en suite vanity has one in place. Check if this has been missed.
	Rating:	Minor Maintenance

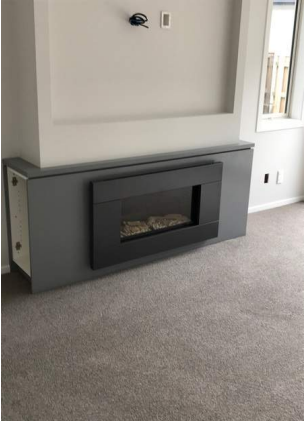
☐ Other - The gas fire place requires testing

SUPPLEMENTARY INFORMATION	I recommend testing the gas fire prior to settlement as there was no gas on at the property at time of inspection, regular servicing of all gas appliances by a certified gas fitter in accordance with manufacturers specifications is recommended.	
EXPLANATIONS	Rating:	Recommendation
IMAGES

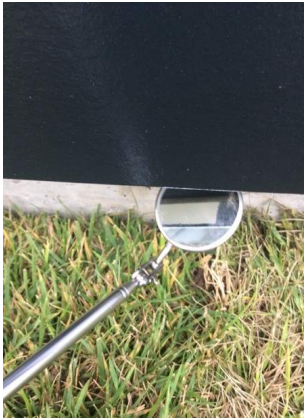
✗ No - Paint defects were detected

SUPPLEMENTARY INFORMATION	Repairs and maintenance is required now by a tradesman painter to protect the cladding.	
EXPLANATIONS	Location : Details :  Rating:	West exterior kitchen wall Most of the weatherboards are painted on the bottom edge where they meet the slab, however one section has been missed I recommend painting takes place. Minor Maintenance
IMAGES

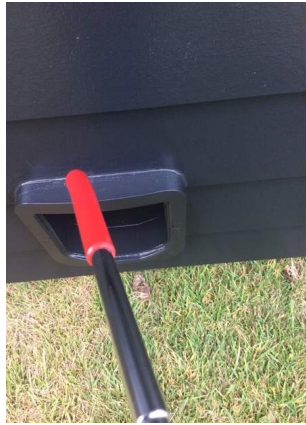
✗ No - Vent flashing install

SUPPLEMENTARY INFORMATION	As a precautionary measure i recommend installing a head flashing over the cat door.	
EXPLANATIONS	Location : Rating:	West facing kitchen wall Recommendation

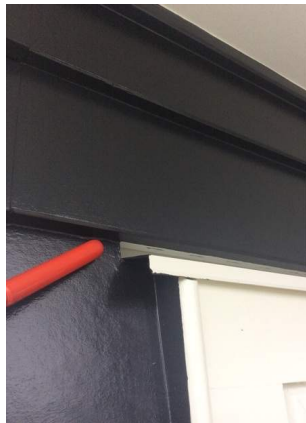
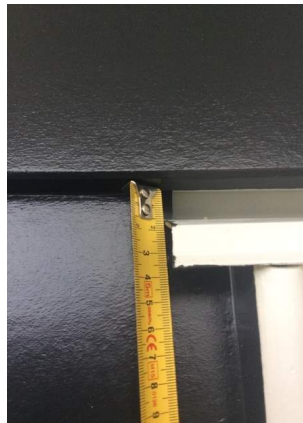
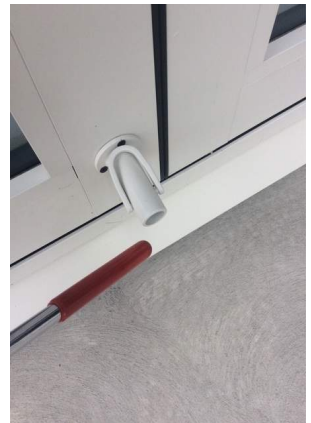
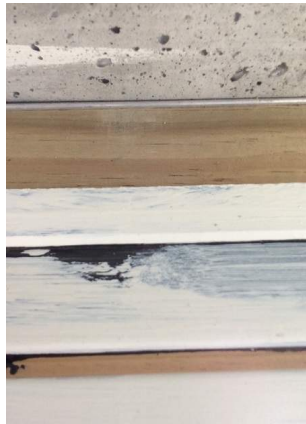
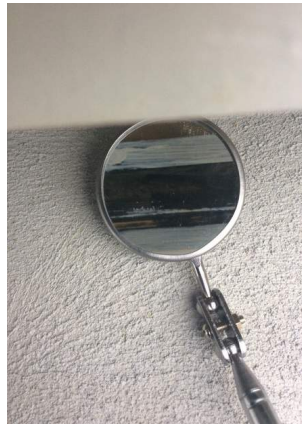
Finishing work is recommended on the bifold door unit.

- The head flashing for the bi fold doors from the kitchen the gap is large, I recommend checking the maximum gap with the product spec. In my opinion the gap should not be larger than 10mm and in this case its 18mm where measured.
- The door stop rubber is missing. Install is required.
- The door sill is un painted underneath the bi fold unit. Improvement can be made.

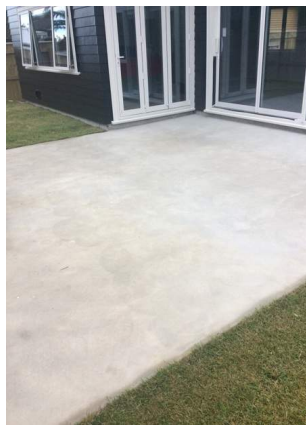
Balconies/verandahs/patios/decks/suspended floors/balustrades; do they appear structurally sound and free of defects?

Further investigation

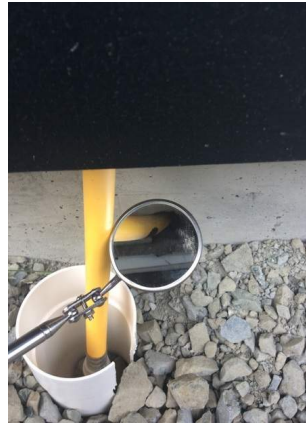
The gas penetration is not sealed completely allowing vermin to enter, I recommend sealing around the gas pipe.

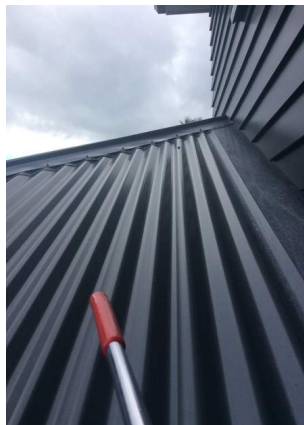
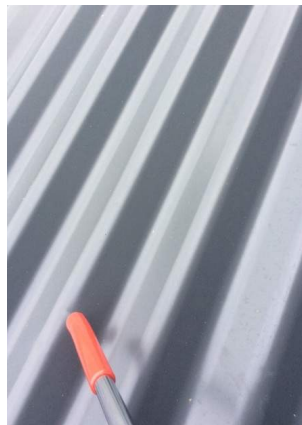
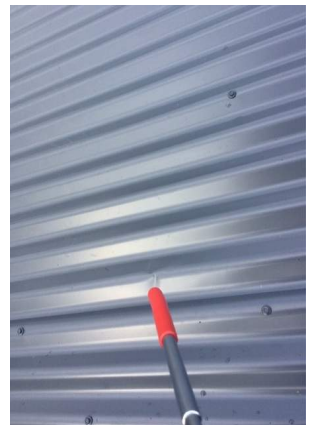
**Location :** Garage roof, west lower roof over kitchen,  
**Details :** - A section of roof could have more screws installed, improvement can be made.  
- Some installation dents were detected, this is common with install and not a defect just a cosmetic issue.  
**Rating:** Minor Maintenance

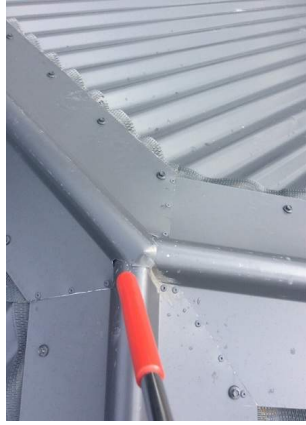
**Location :** Garage roof  
**Rating:** Recommendation

Flashings; Is the flashing free of uplift, corrosion or other defect/damage?

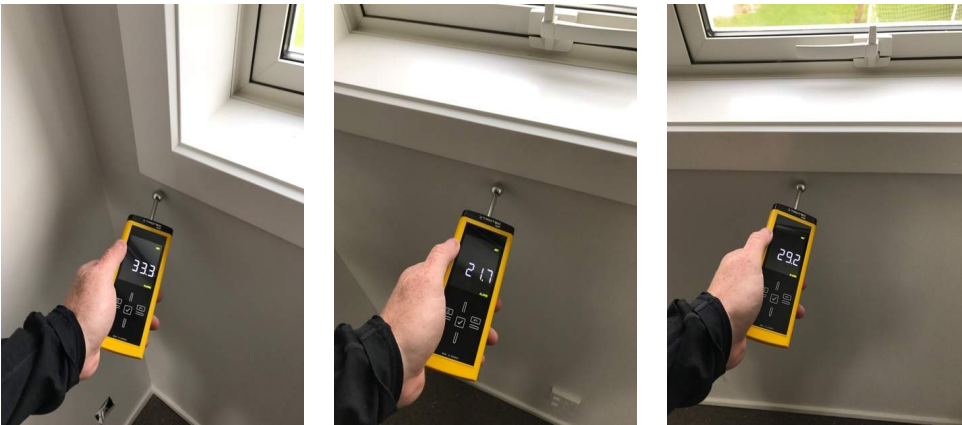
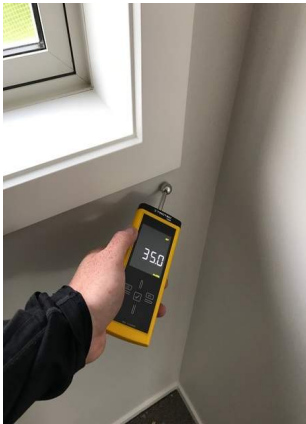
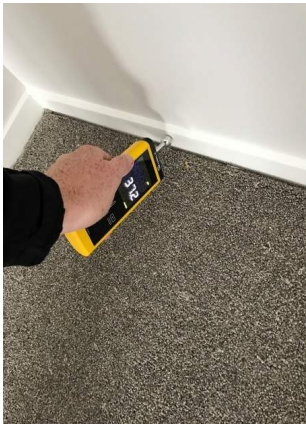
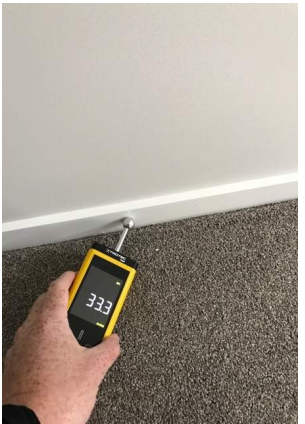
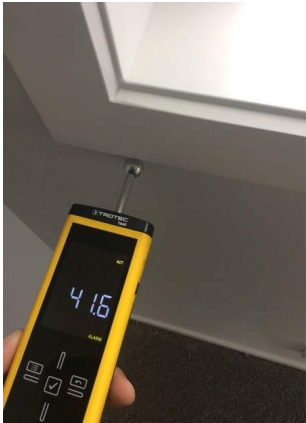
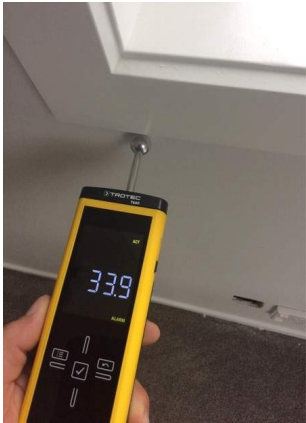
This was a non invasive moisture test to random areas of possible concern (like around the windows and doors on the exterior walls and wet areas; or areas with pipe work running through them). Accessible areas have been checked on the interior to check for moisture within the wall cavity. The moisture measurement is up to approximately 40mm deep. Levels will vary from house to house and any elevated reading will be recorded and further investigation will be required. The conditions and treatment type of internal framing is not known. An invasive instrument will never be used to prevent damage.

Rating: No Defect Observed

To avoid high moisture readings keep the exterior sealed and watertight, keep all vegetation clear from the perimeter of the dwelling and all surface water directed away from the house. Ensure the spouting is flowing and is watertight, sufficient ventilation is always recommended. Bathrooms and laundries should have vented fans in place, the windows of the dwelling should be vented often and use of a dehumidifier or moisture system is recommended.

Recommendations: To keep readings down, keep exterior watertight and weather tight, ensure there is a sufficient amount of paint on the building, ensure the flashings meet the building code NZS 3604, and the roof is water tight.

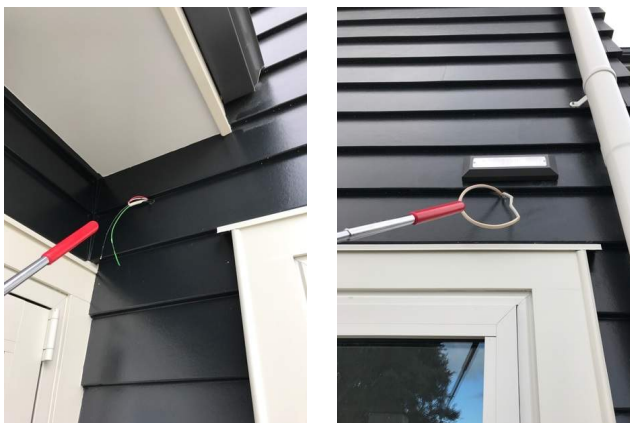
**Comments - Optional:** The outdoor speakers is still to be completed on the exterior.  
**Rating:** No Defect Observed

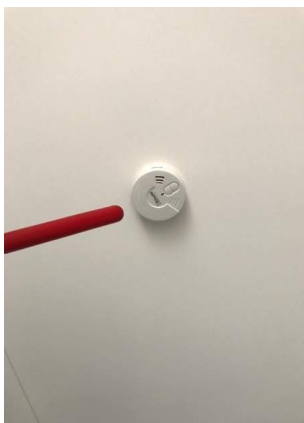
**Replacement Recommended:** No  
**Type:** Battery Smoke Alarms

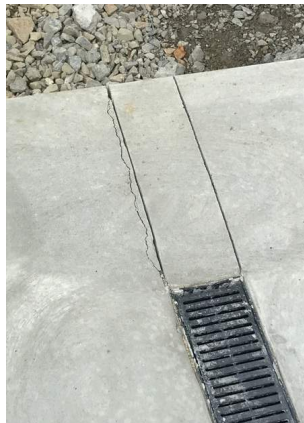
A small crack was sighted this can be repaired when the drain is installed.

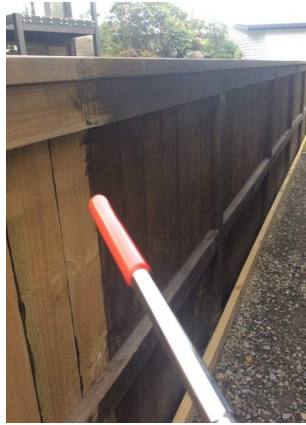
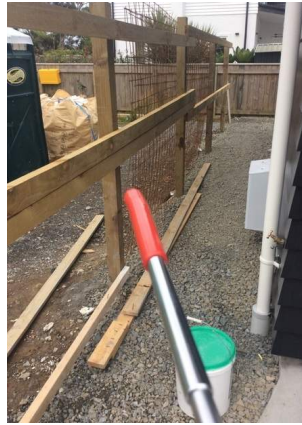
✗ No - Fencing work still to be completed.

- Some fence work is still to be completed.
- Unfinished staining was sighted, I recommend finishing the staining to match and protect the rest of the fence.
