Seismicity Monitoring of Proppant Squeeze Operation at the Wressle W-1 Well

Report Commissioned by Egdon Resources U.K. Limited

Report Internal ID: OLG.EG-W2-SM

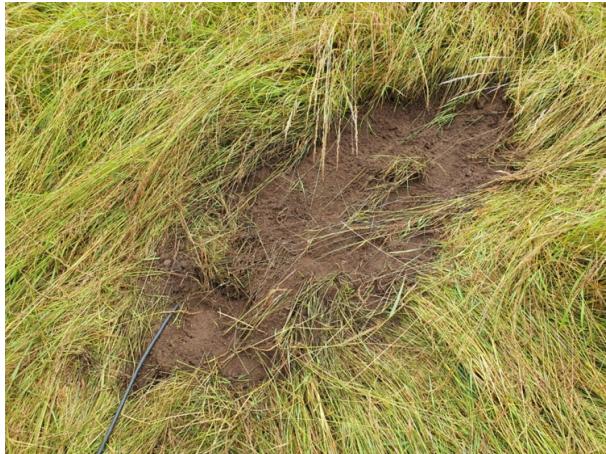
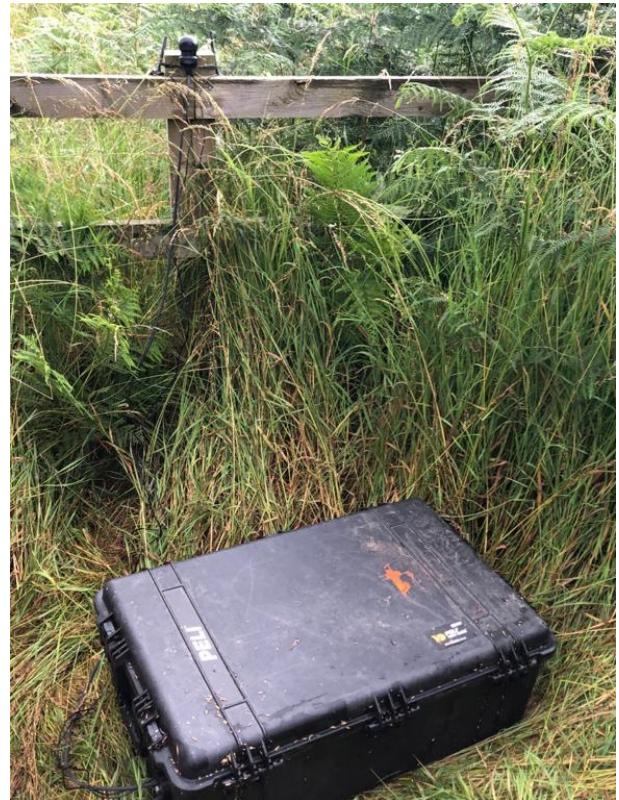
Figure 2-2: Deployment of Station WRE1. In (a) we show the buried seismometer, and in (b) we show the Pelicase containing batteries and digitizer. The GPS aerial and mobile modem were attached to an adjacent fence post.

The seismicity monitoring array consisted of five independent monitoring stations. Each station consisted of a Gürulp 3T seismometer (Gürulp, 2019) with a Minimus digitizer (Gürulp, 2021). The seismometers were buried by hand to a depth of approximately 50 cm, to ensure good coupling with the ground and to reduce surface noise. The digitizers were sited, along with batteries that provided the power source, in Pelicases™ placed at the surface. At some sites we elected to bury the Pelicases to minimise the visibility of the station. This decision was taken at site based on the expected accessibility of each site to passers-by.

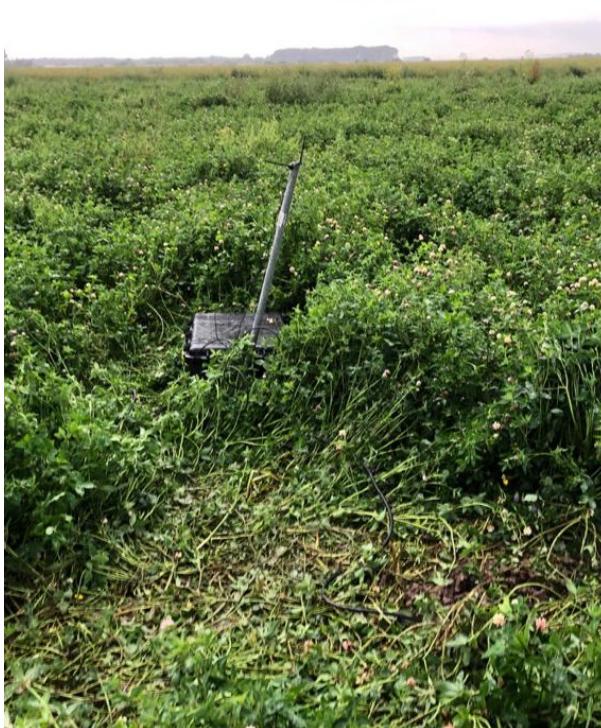
Figure 2-3: Deployment of Station WRE2. The position of the buried seismometer is visible in the foreground, with the Pelicase containing batteries and digitizer behind. The GPS aerial and mobile modem were attached to a short length of scaffold pole.

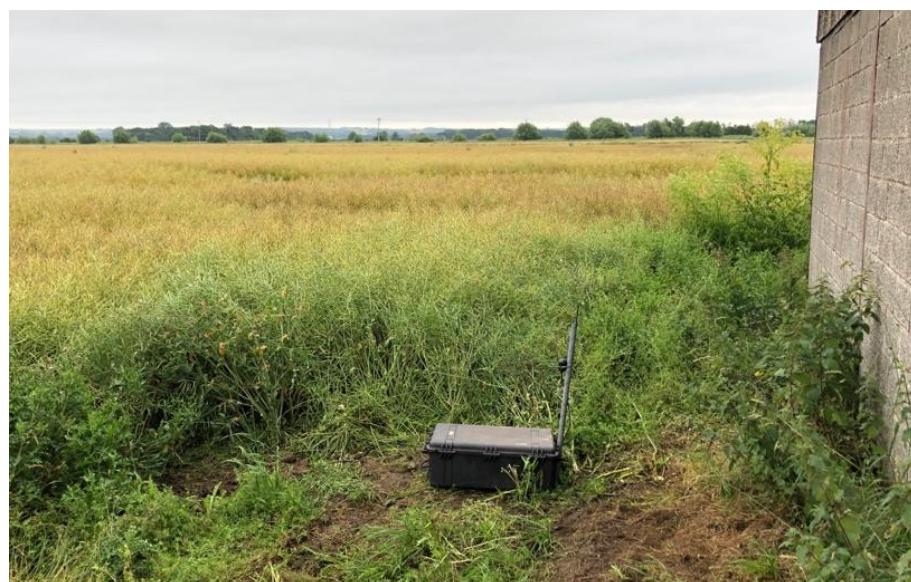
Figure 2-4: Deployment of Station WRE3. The position of the buried seismometer is visible to the left, adjacent to the vegetation, with the Pelicase containing batteries and digitizer in the centre. The GPS aerial and mobile modem were attached to a short length of scaffold pole.

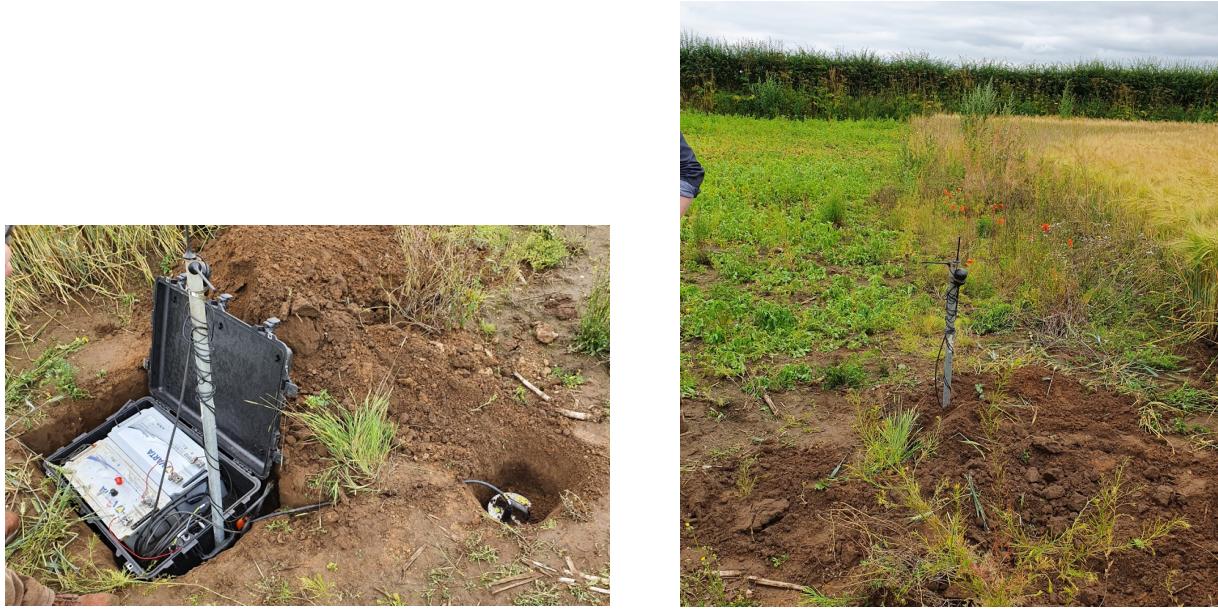
Figure 2-5: Deployment of Station WRE4. In (a) we show the seismometer in place before being covered (right), and the batteries and digitizer are visible in the open Pelicase. In (b) we show the completed station – at this site the Pelicase was also covered with earth: the GPS aerial and mobile modem attached to a short length of scaffold pole were the only objects visible at the surface.
