Highway Embankment Contract Specifications

Abstract: This four-year project was extremely successful and well executed, even though a number of changed conditions developed during the project. Of these changed conditions, only one resulted in a claim that is discussed herein. This claim involved responsibility for repairing a failed 7-m-high embankment that was widened as part of the contract. This paper discusses the slope movement mechanism, presents the relevant contract provisions and State of Ohio Construction and Material Specifications (C&MS), summarizes the various contract interpretations that developed, and the recommendation of the Dispute Resolution Board (DRB) to resolve this claim. Based on the case study, recommendations for clarifying project plans and specifications for future embankment construction are also presented. DOI: [10.1061/\(ASCE\)LA.1943-4170.0000136](https://doi.org/10.1061/(ASCE)LA.1943-4170.0000136). © 2013 American Society of Civil Engineers.

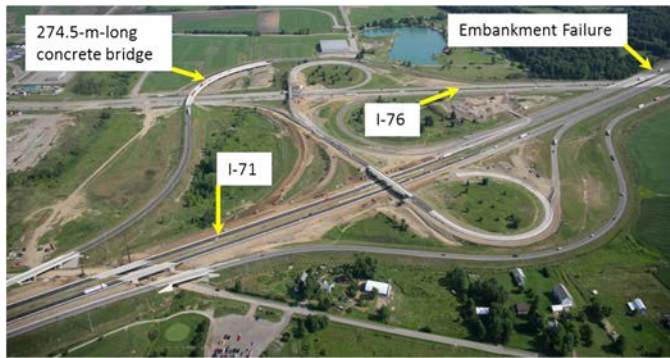
Fig. 1. Aerial view of project during the last year of construction showing a 274.5-m-long concrete off-ramp bridge from I-76 Westbound to I-71 Southbound and I-71 Southbound embankment failure location (photograph used with permission from ODOT)

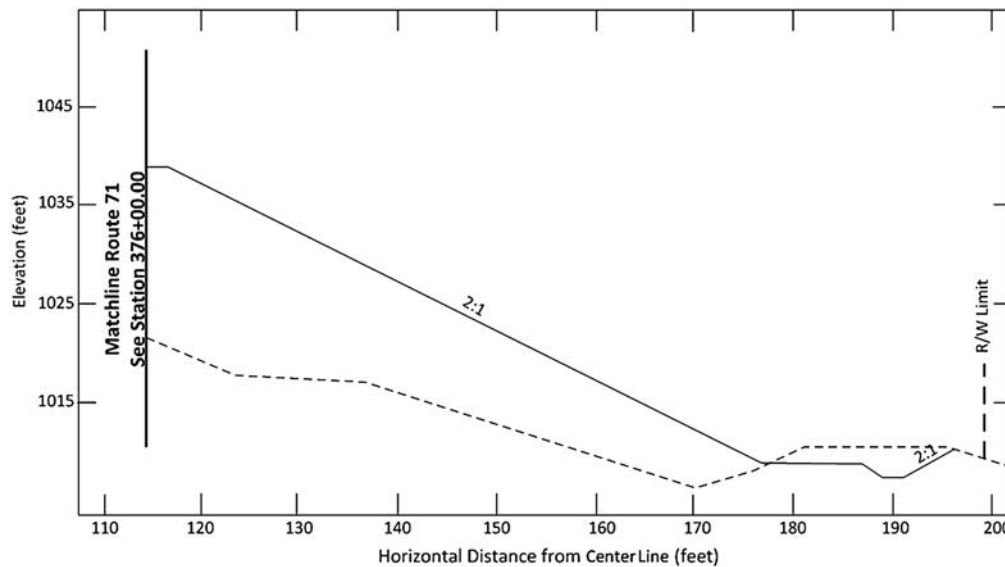
Fig. 8. Benching details from ODOT Construction Plan Sheet 227 of 1120 for Station 376 + 00 to Station 377 + 00 I-71 (adapted from State of Ohio 2004)
