# BRE Test Report

## WikiHouse Structural Testing

Prepared for: Clayton Prest  
Date: 12 July 2021  
Report Number: P120099-1000 Issue: 1

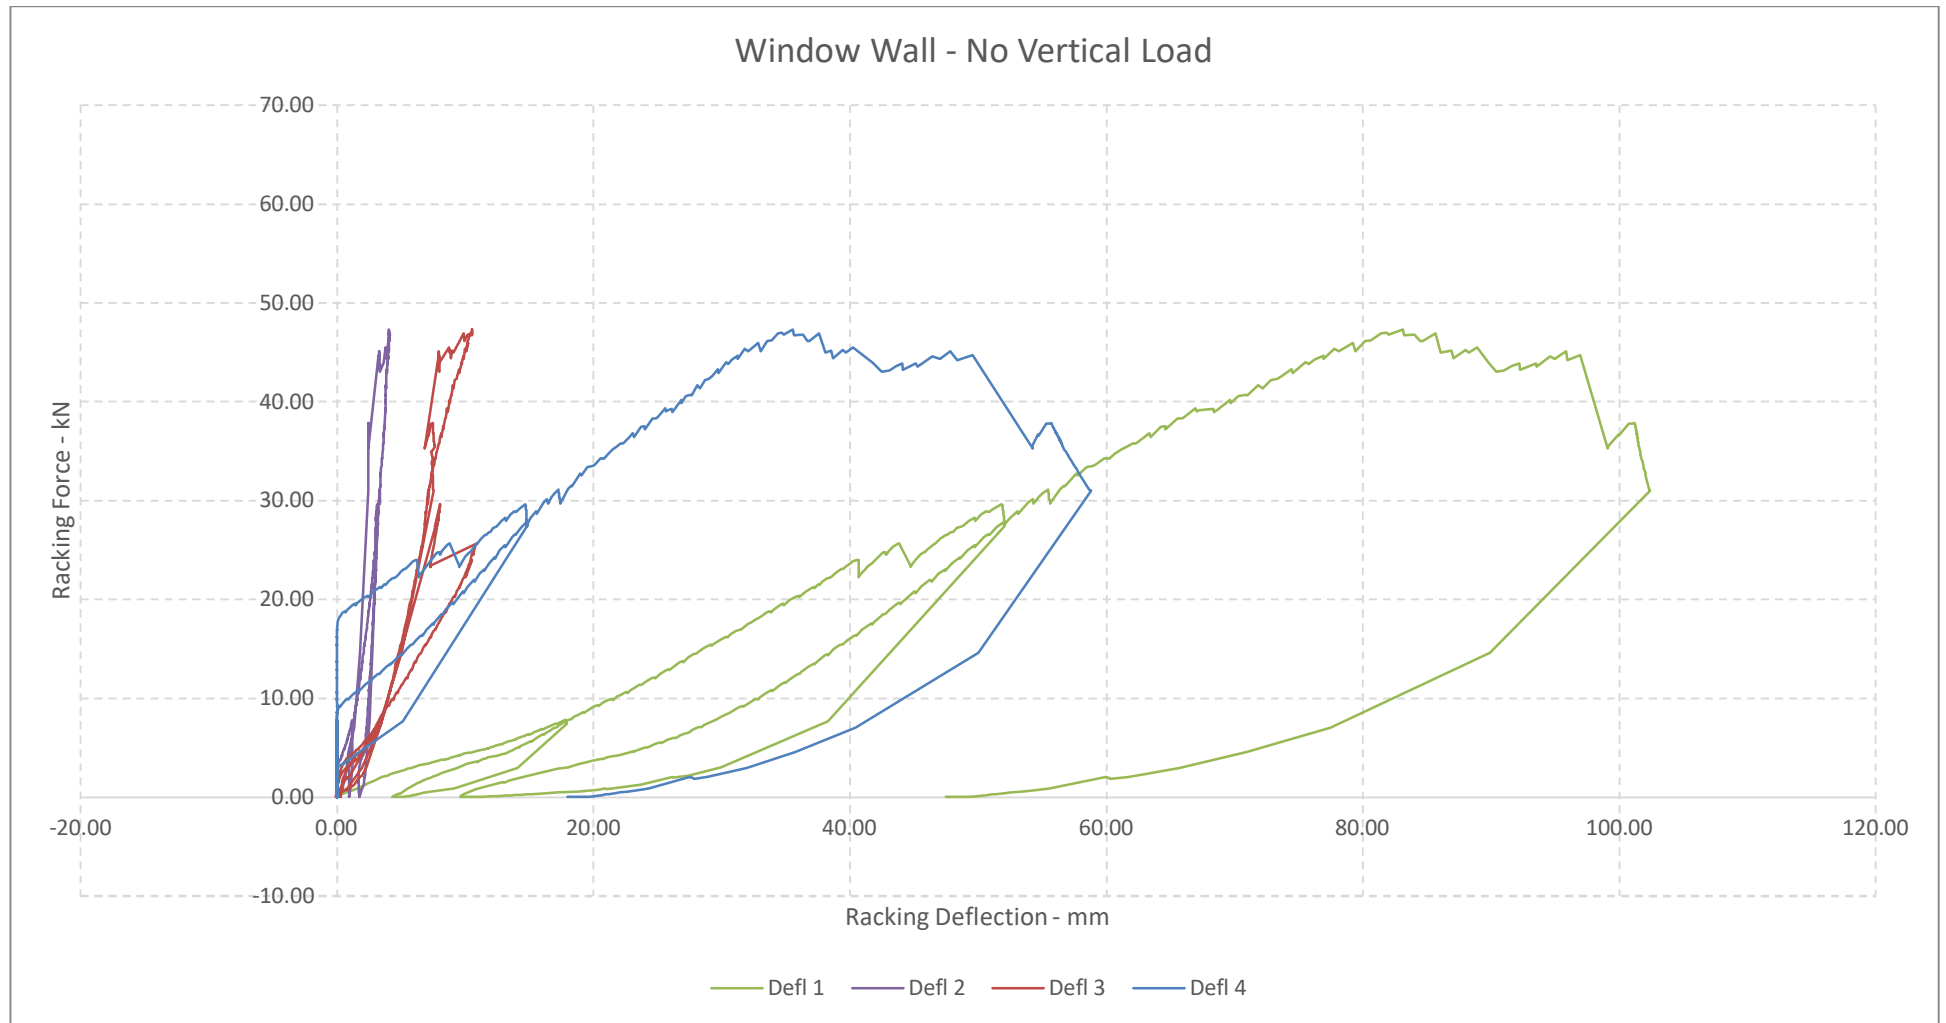
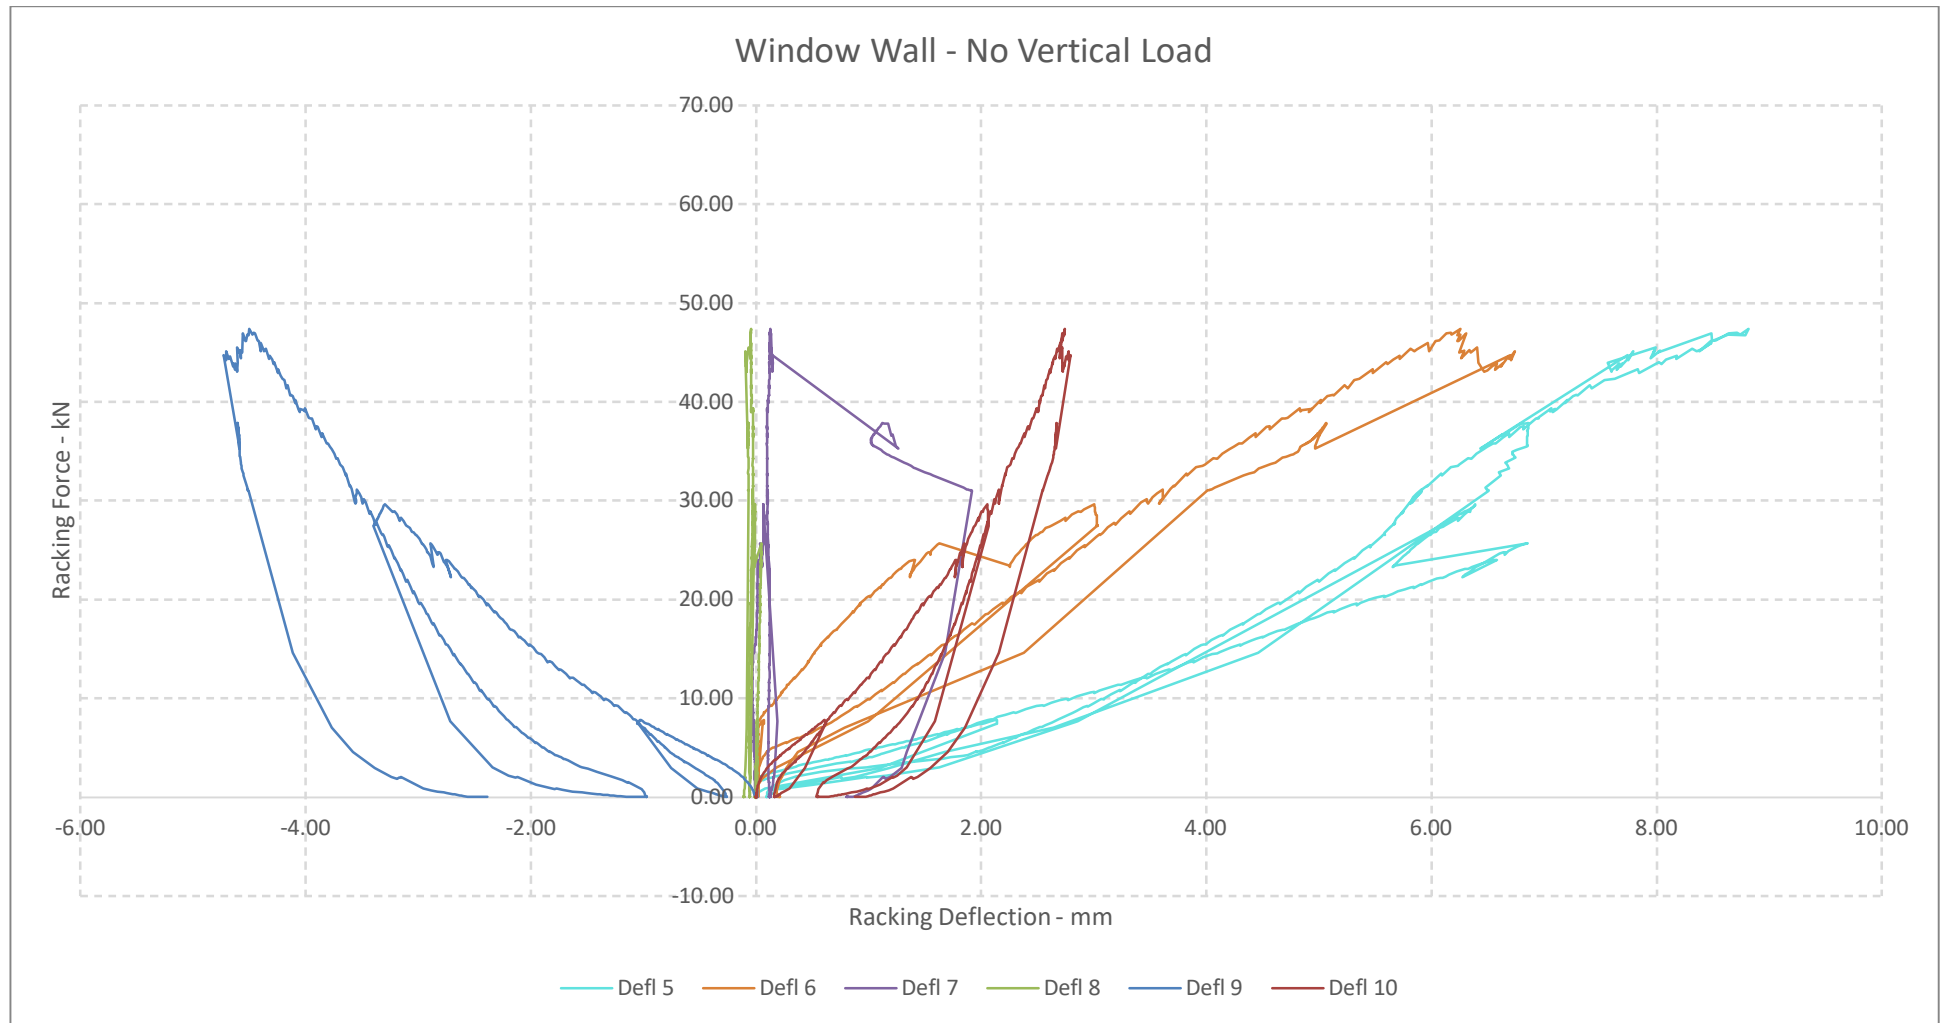
The third cycle was to 0.4F then failure, the load was raised to 32kN as for previous cycle and held for at least 30 seconds then increased until failure. There was eventual failure of the bow tie plates between the wall elements at bottom right corner of window 1 and between the two full height units between windows. At approximately 47 kN there appeared to be a drop in the load sustained by the specimen. Loading continued, however a significant increase in the magnitude of the applied load was not achieved and so the load was removed. The through wall peg between the wall units and foundation beam almost disengaged at the loaded end of wall due to uplift induced movement between units. This failure can be seen in Figure 9 - Figure 12.

Graph 1 – Window Wall without Vertical Loading: Deflections 1-4

Graph 2 – Window Wall without Vertical Loading: Deflections 5-10

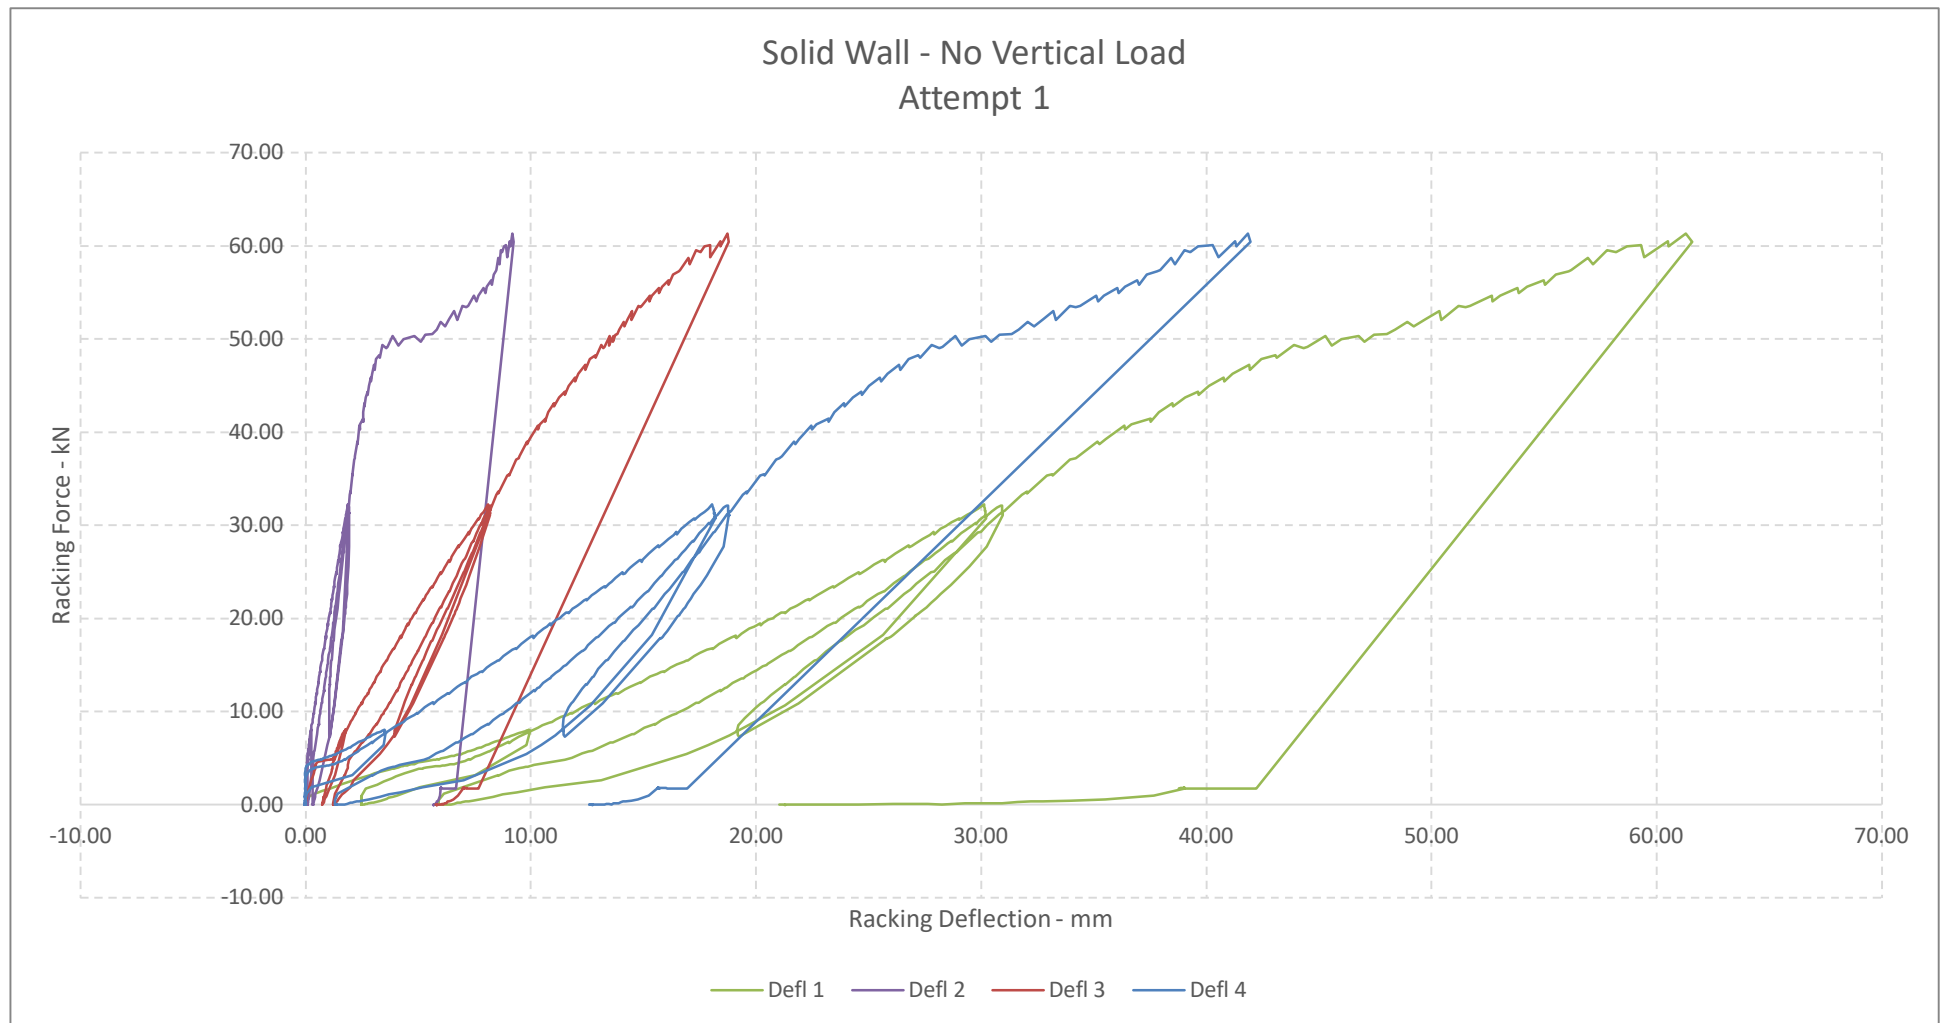
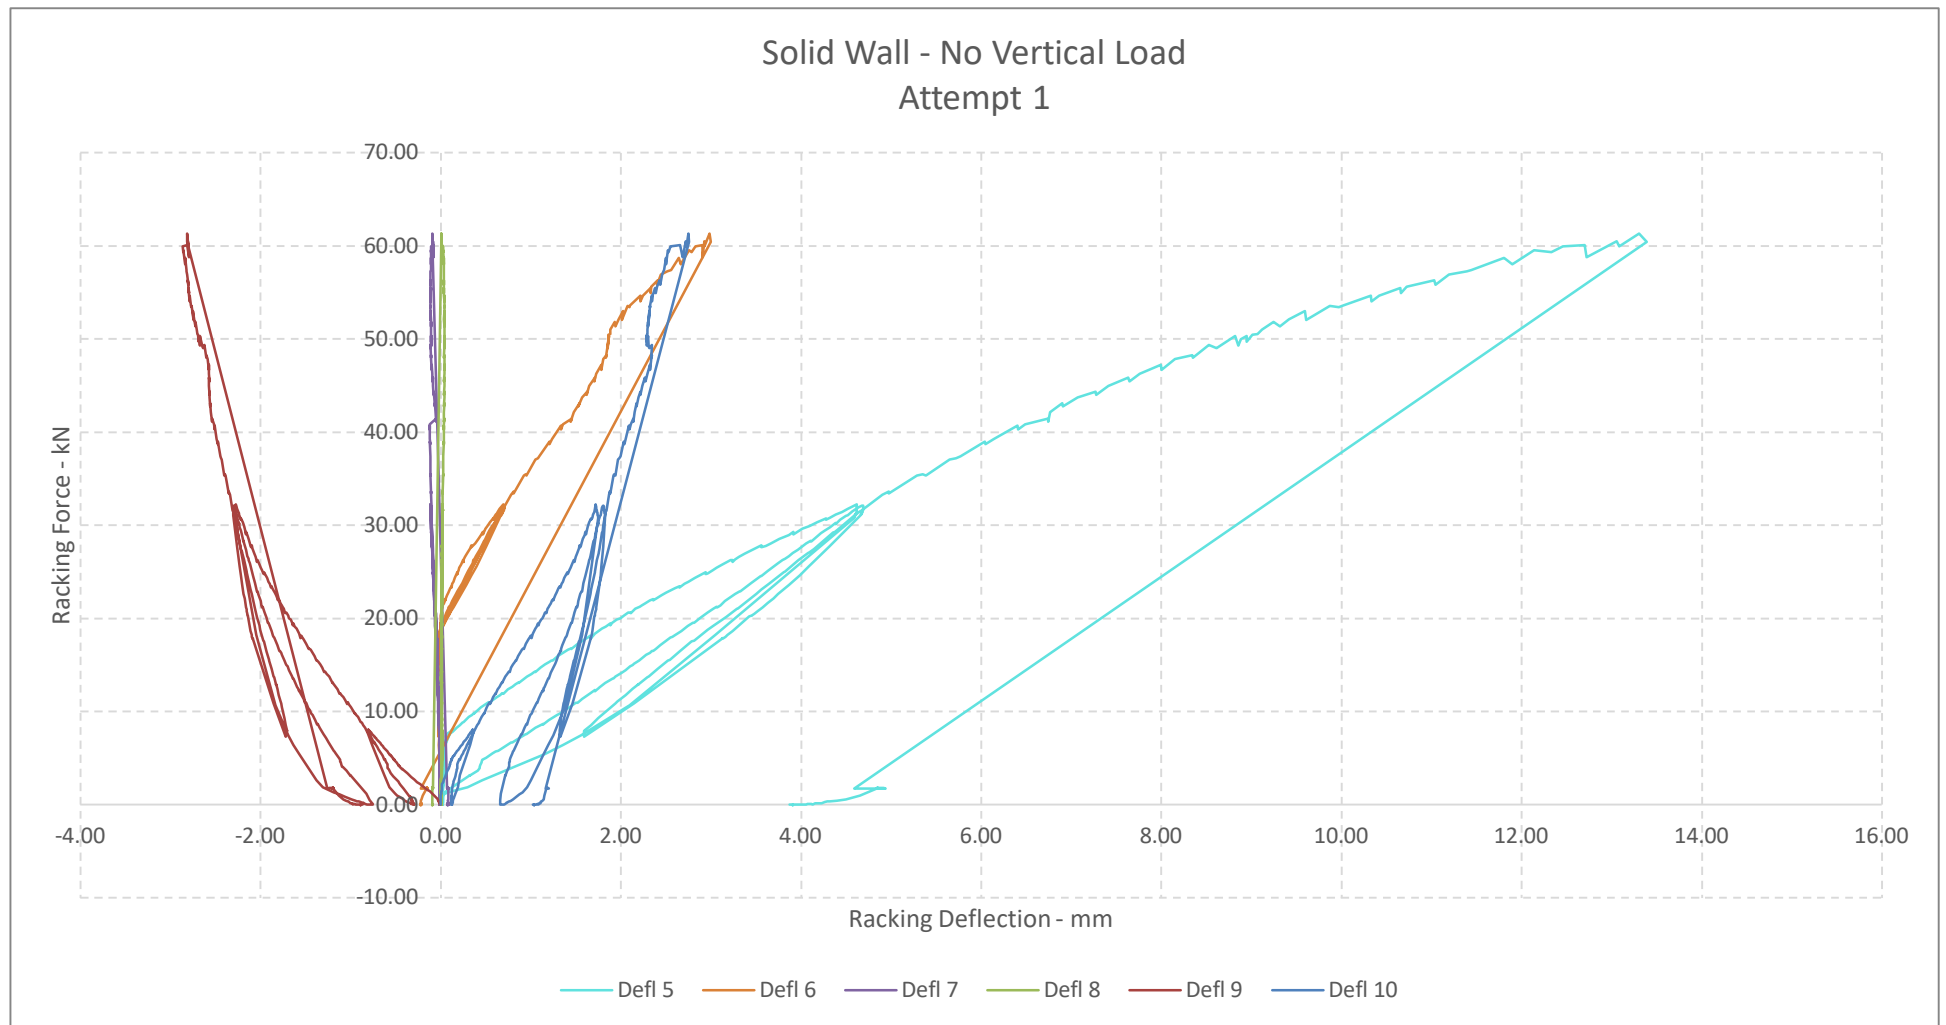
The third cycle was to 0.4F then failure, the load was raised to 32kN as for previous cycle and held for at least 30 seconds then load reduced to 0.1F before increase until failure. This final cycle led to localised compressive failure of the wall under the racking load. This failure can be seen in Figure 14 and Figure 15.

Graph 3 – Solid Wall without Vertical Loading Attempt 1: Deflections 1-4

Graph 4 – Solid Wall without Vertical Loading Attempt 1: Deflections 5-10

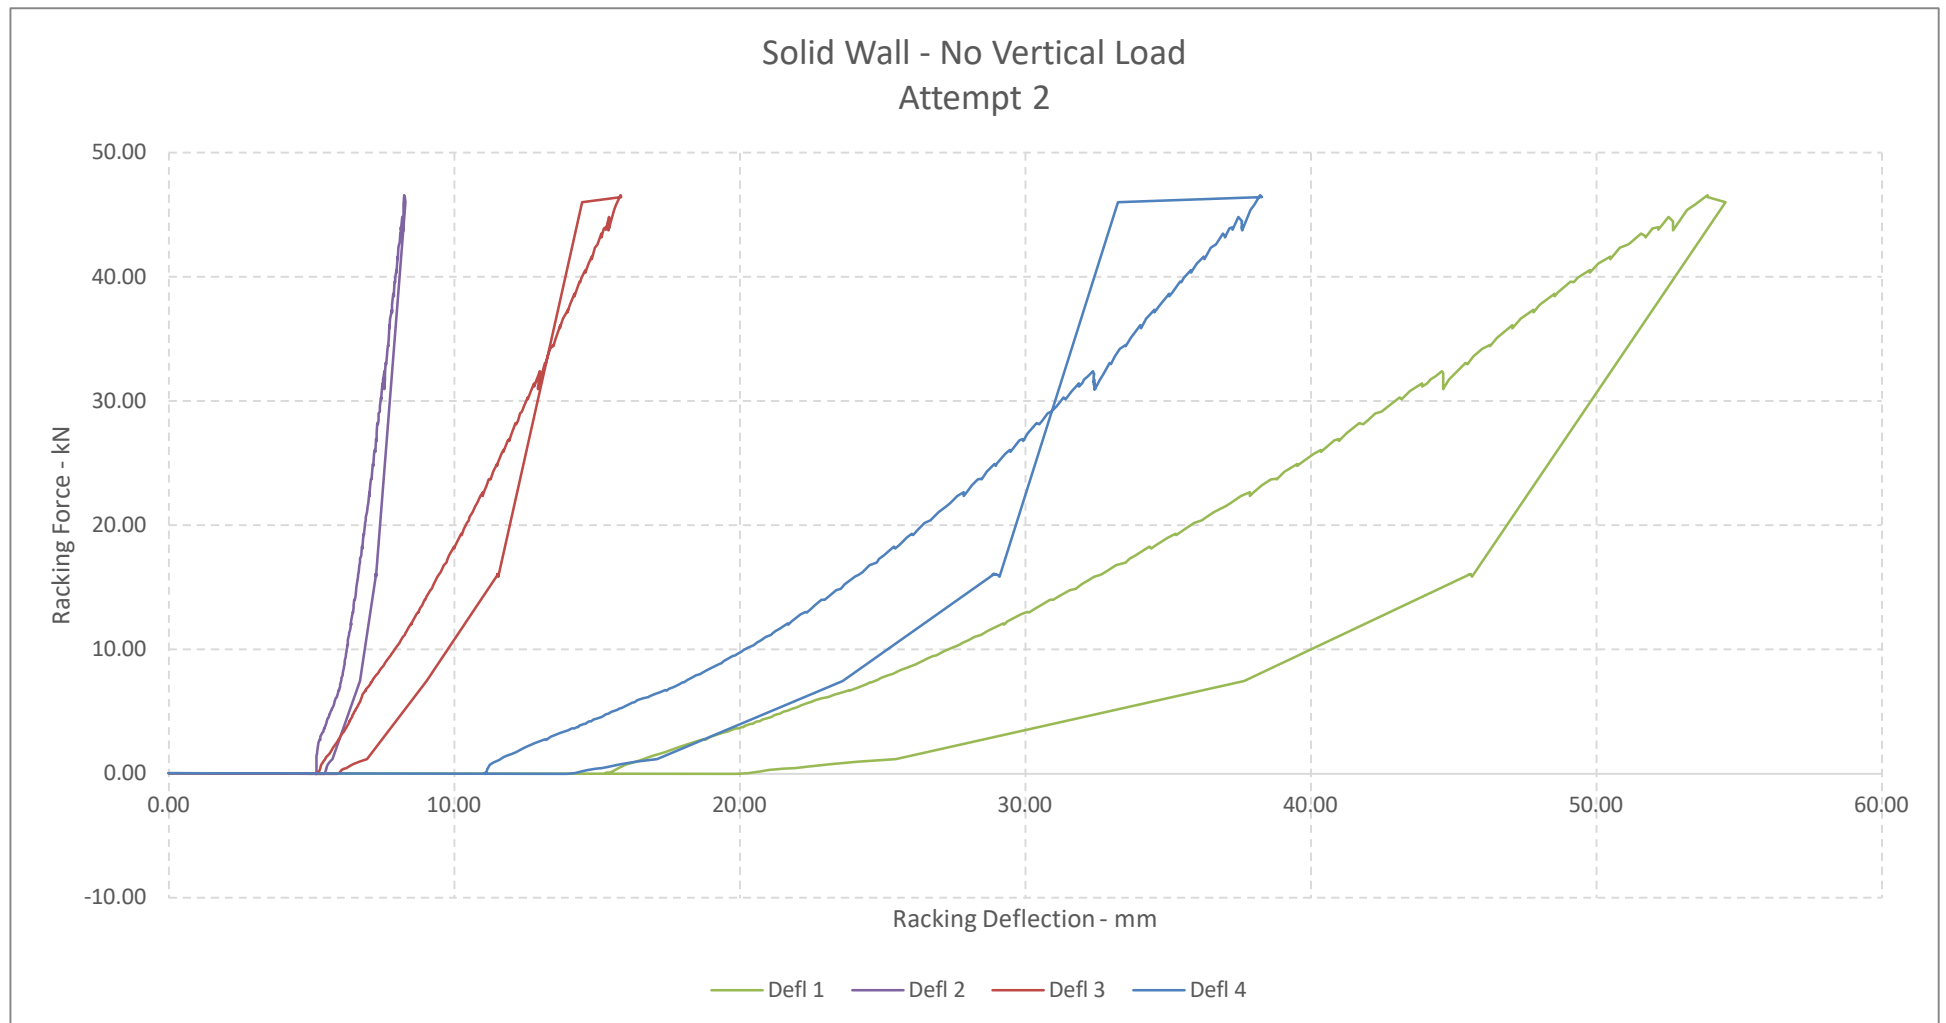
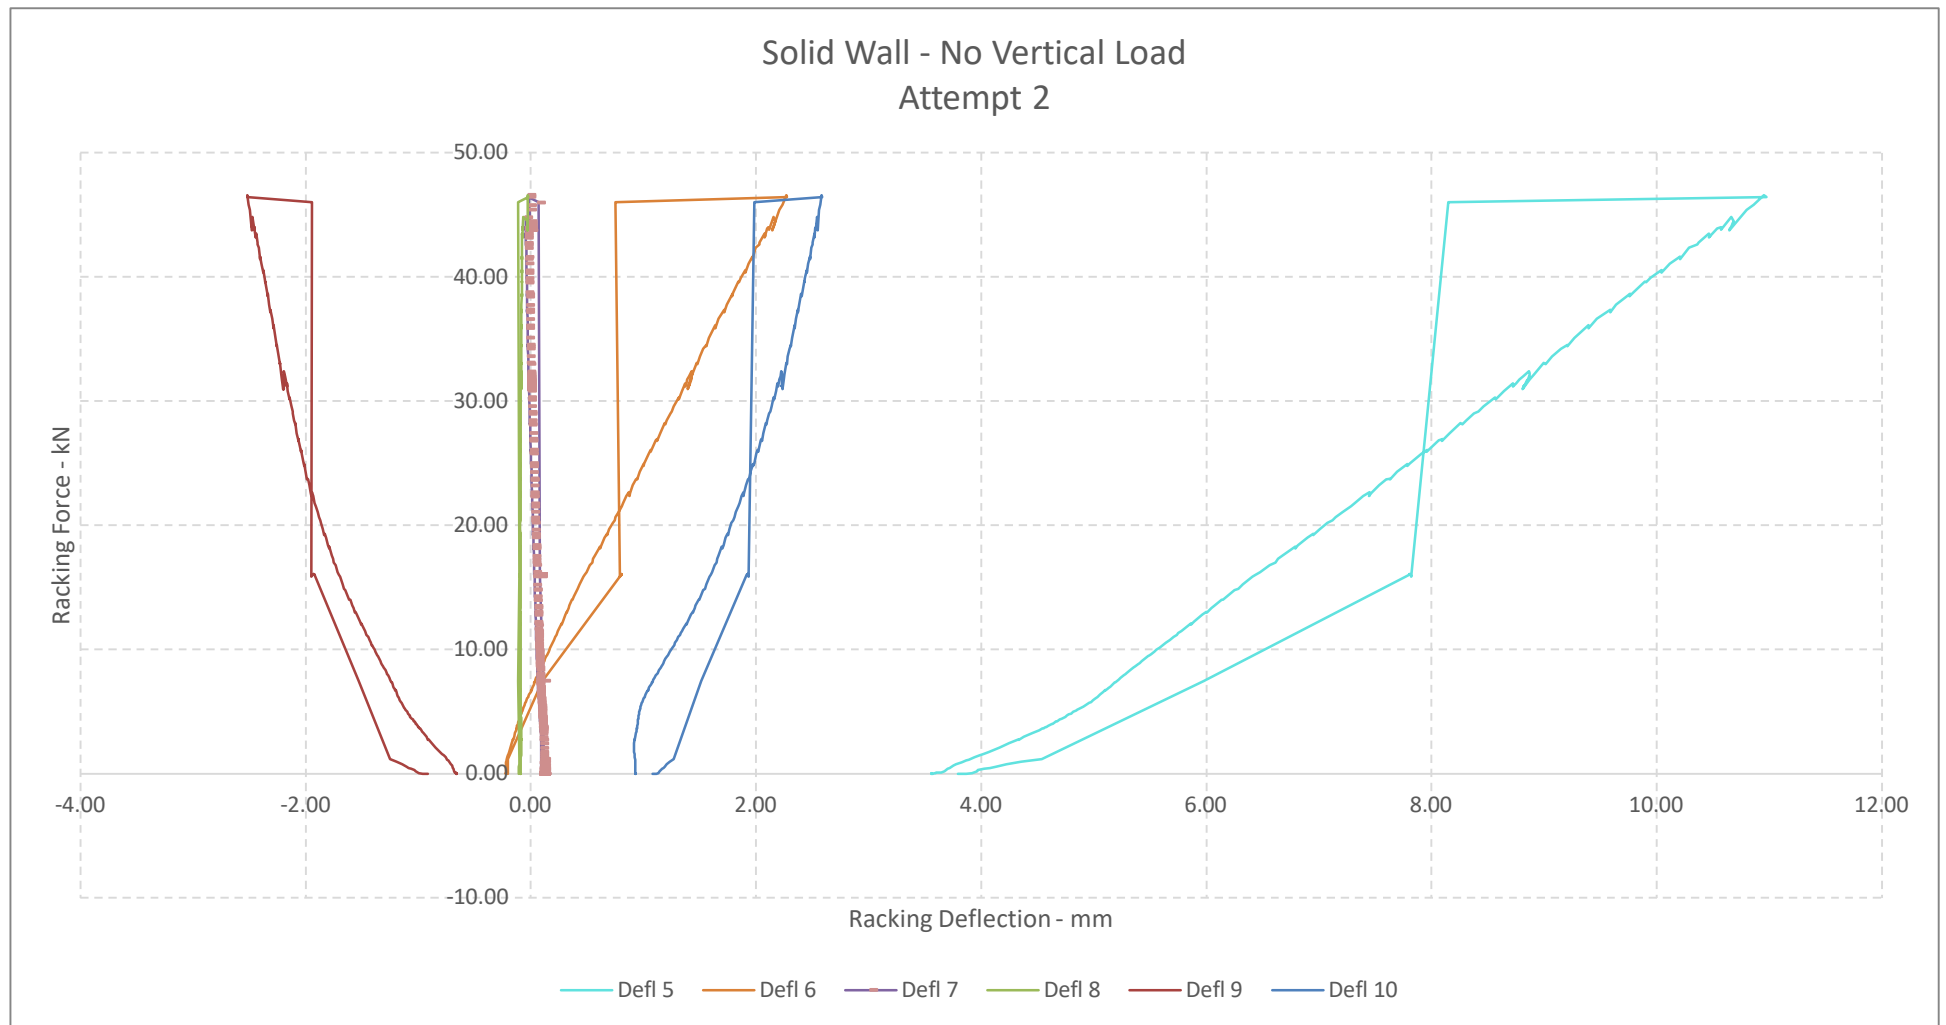
After the first three cycles, the wall was repaired at the loading point and then loaded direct to failure without the intermediate steps outlined above. There was no reset of datums after the first failure attempt. This loading led to localised collapse of the sample at the loading point again.

Graph 5 – Solid Wall without Vertical Loading Attempt 2: Deflections 1-4

Graph 6 – Solid Wall without Vertical Loading Attempt 2: Deflections 5-10

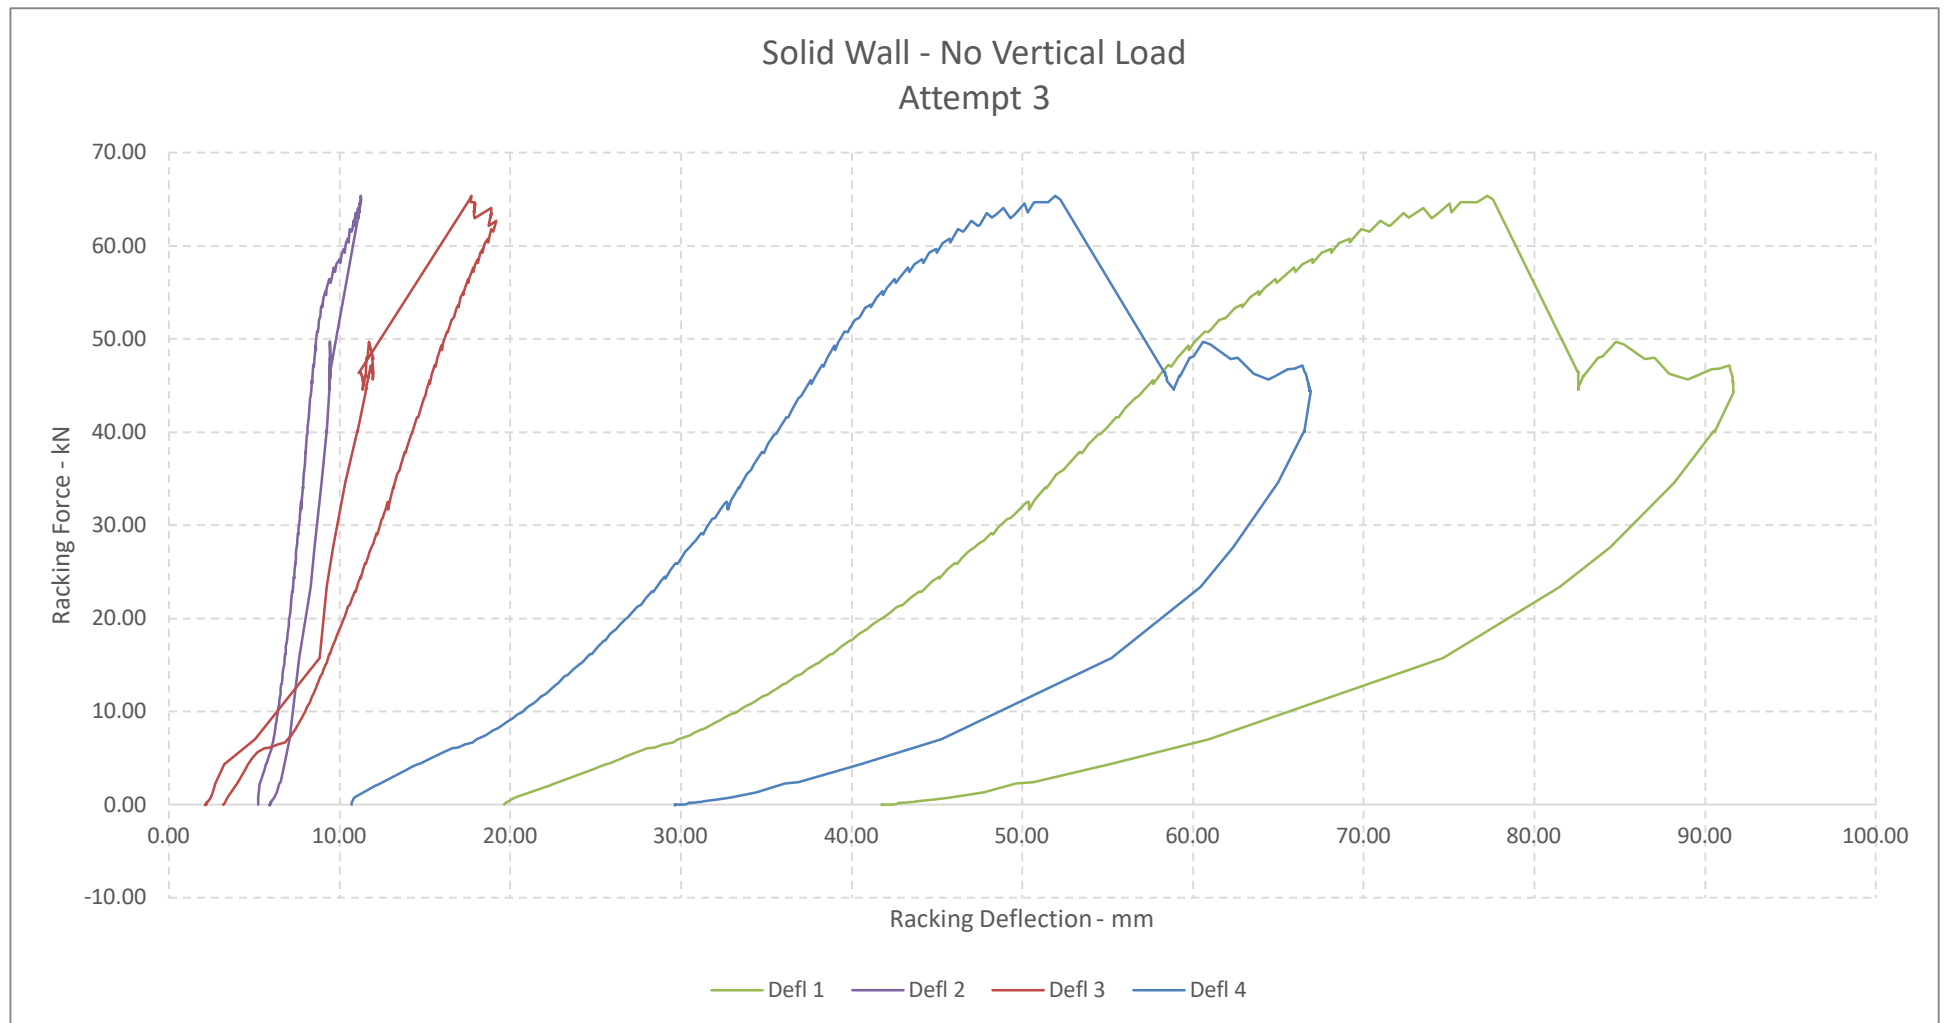
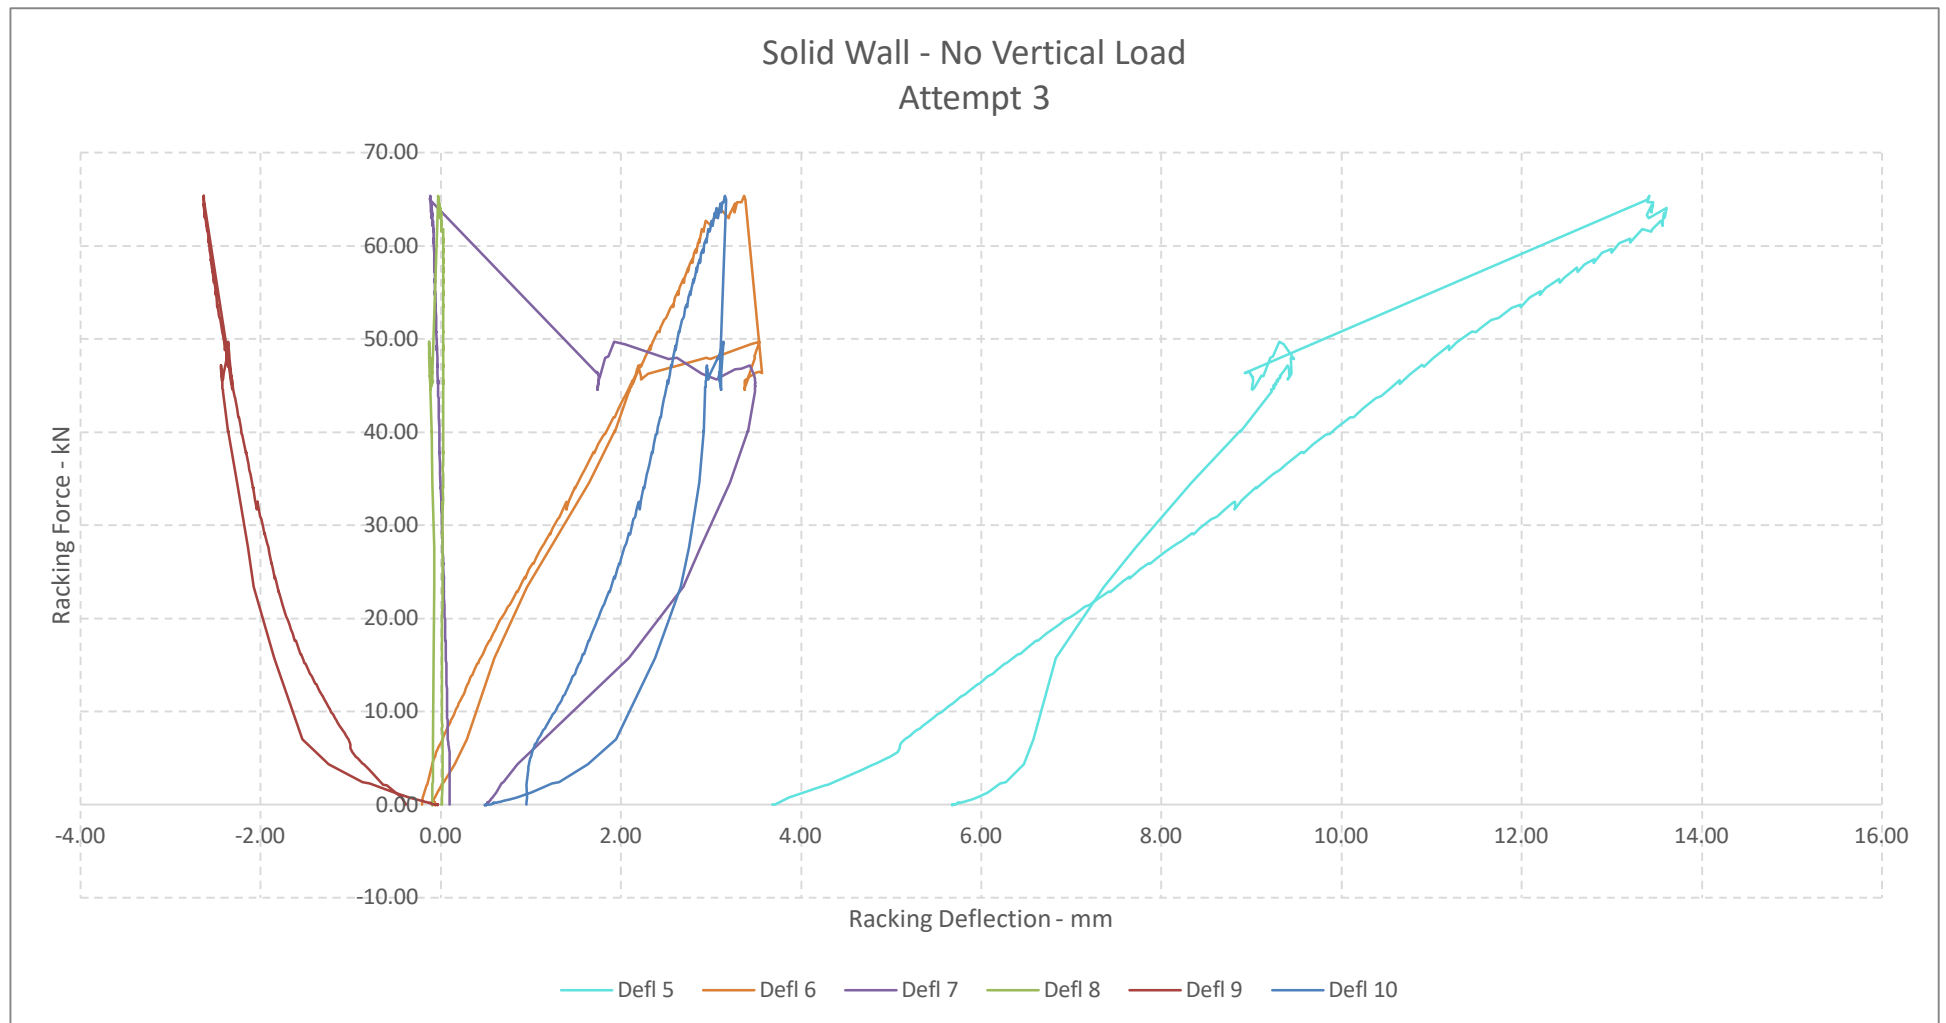
After attempt 2, the wall as repaired at the loading point with components from the previously tested window wall and then loaded direct to failure without the intermediate steps outlined above. There was no reset of datums after first failure attempt. During attempt 3, there was abrupt failure of the wall to foundation beam uplift connection and bow tie plates.

Graph 7 – Solid Wall without Vertical Loading Attempt 3: Deflections 1-4

Graph 8 – Solid Wall without Vertical Loading Attempt 3: Deflections 5-10

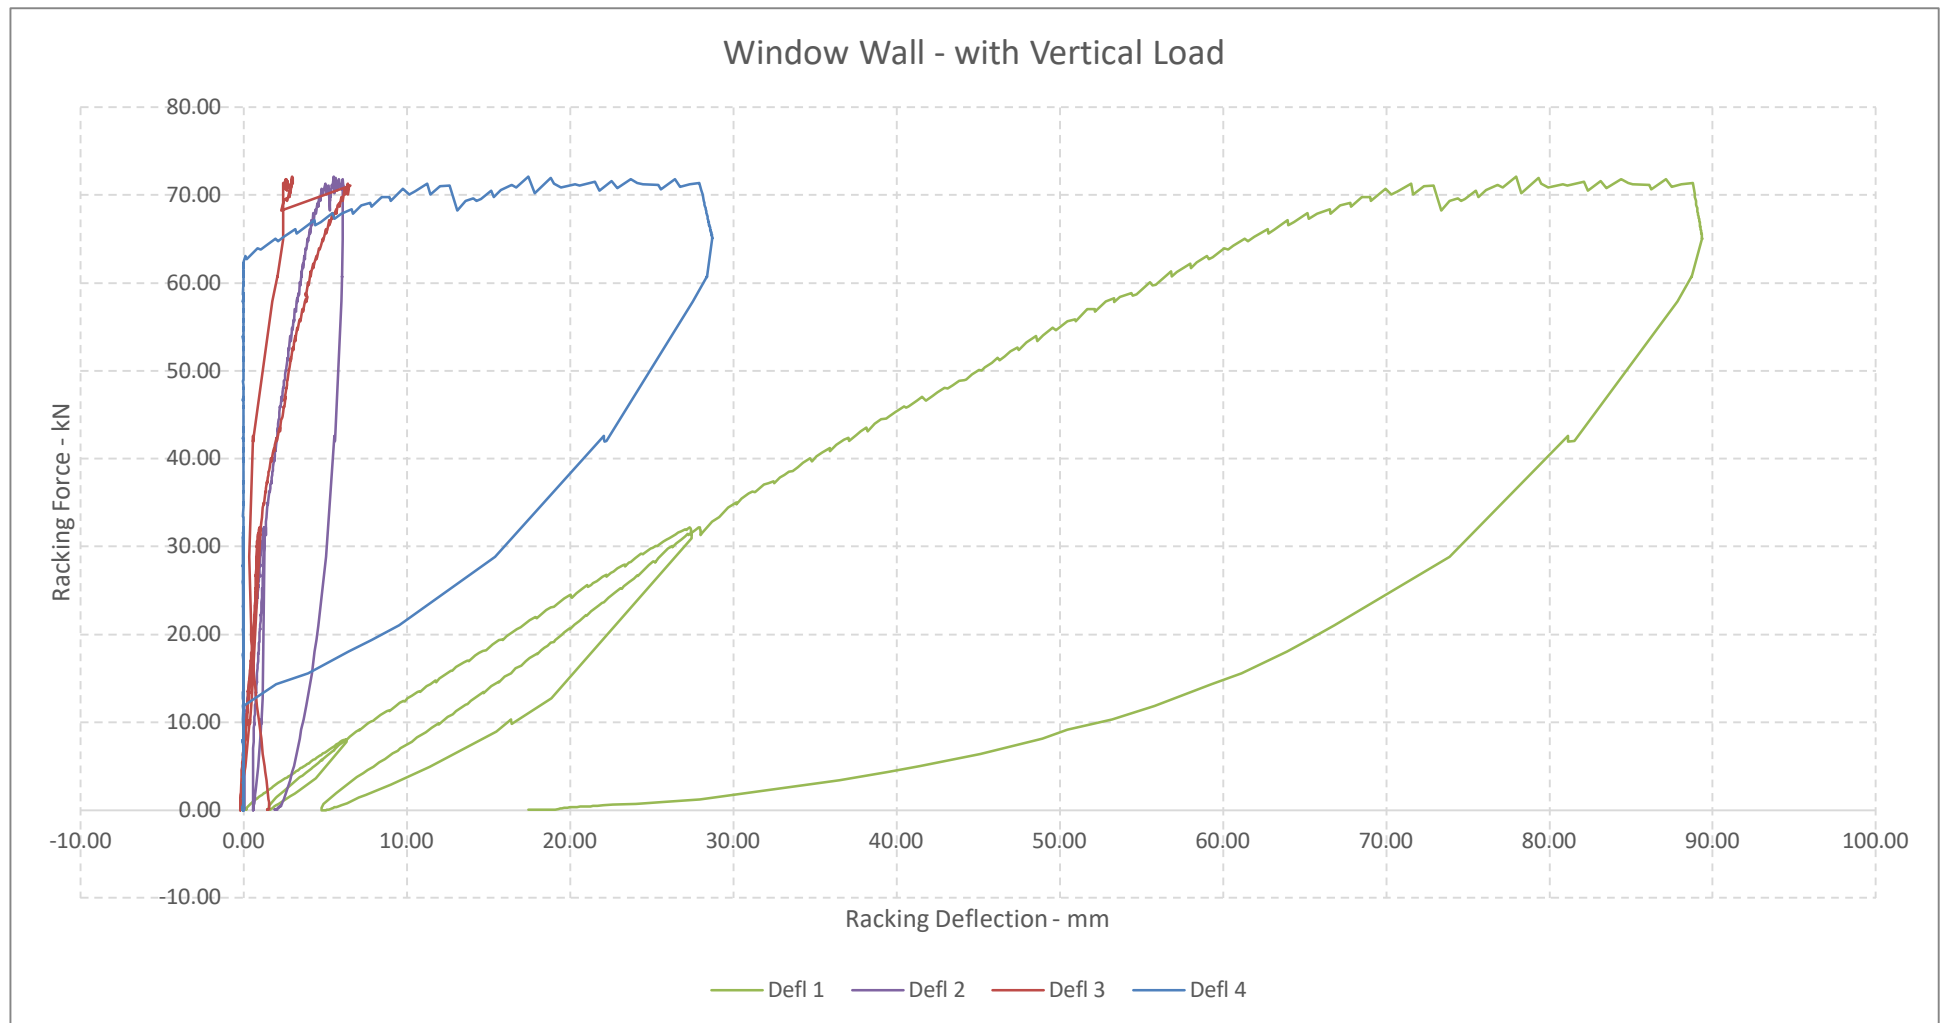
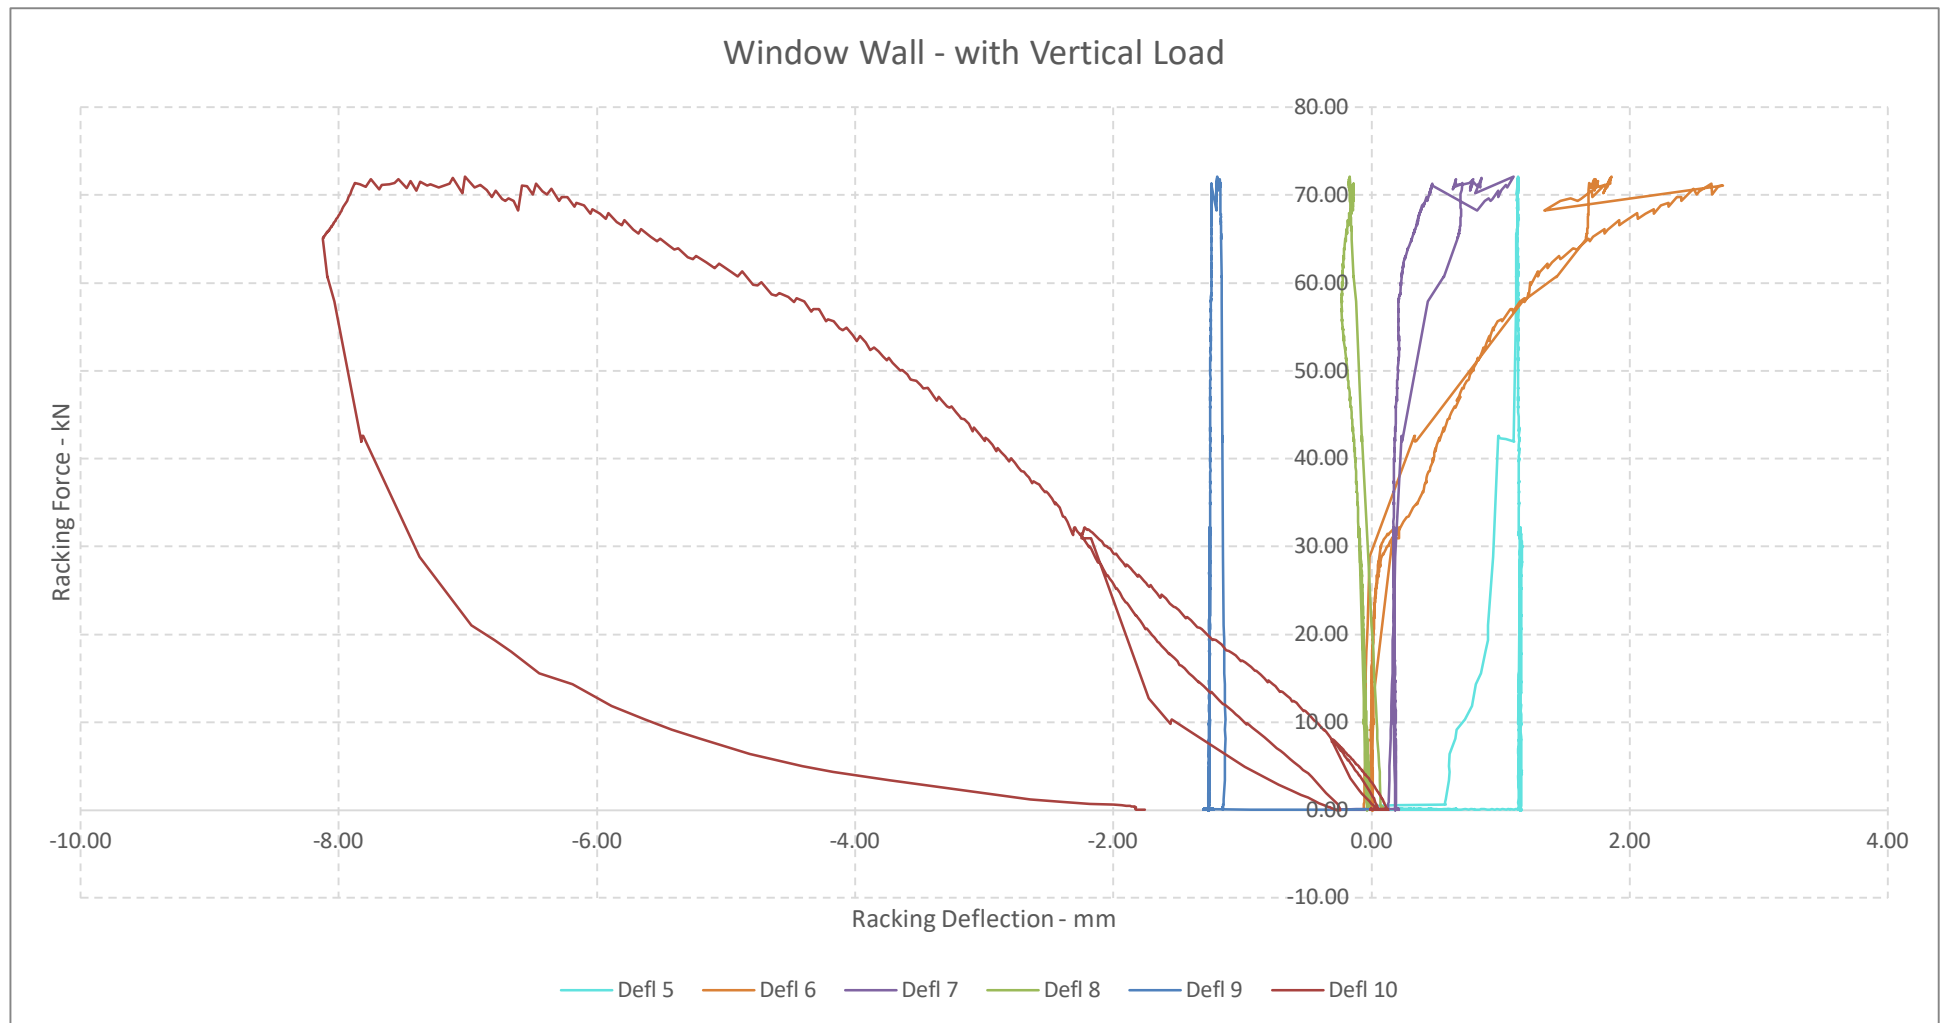
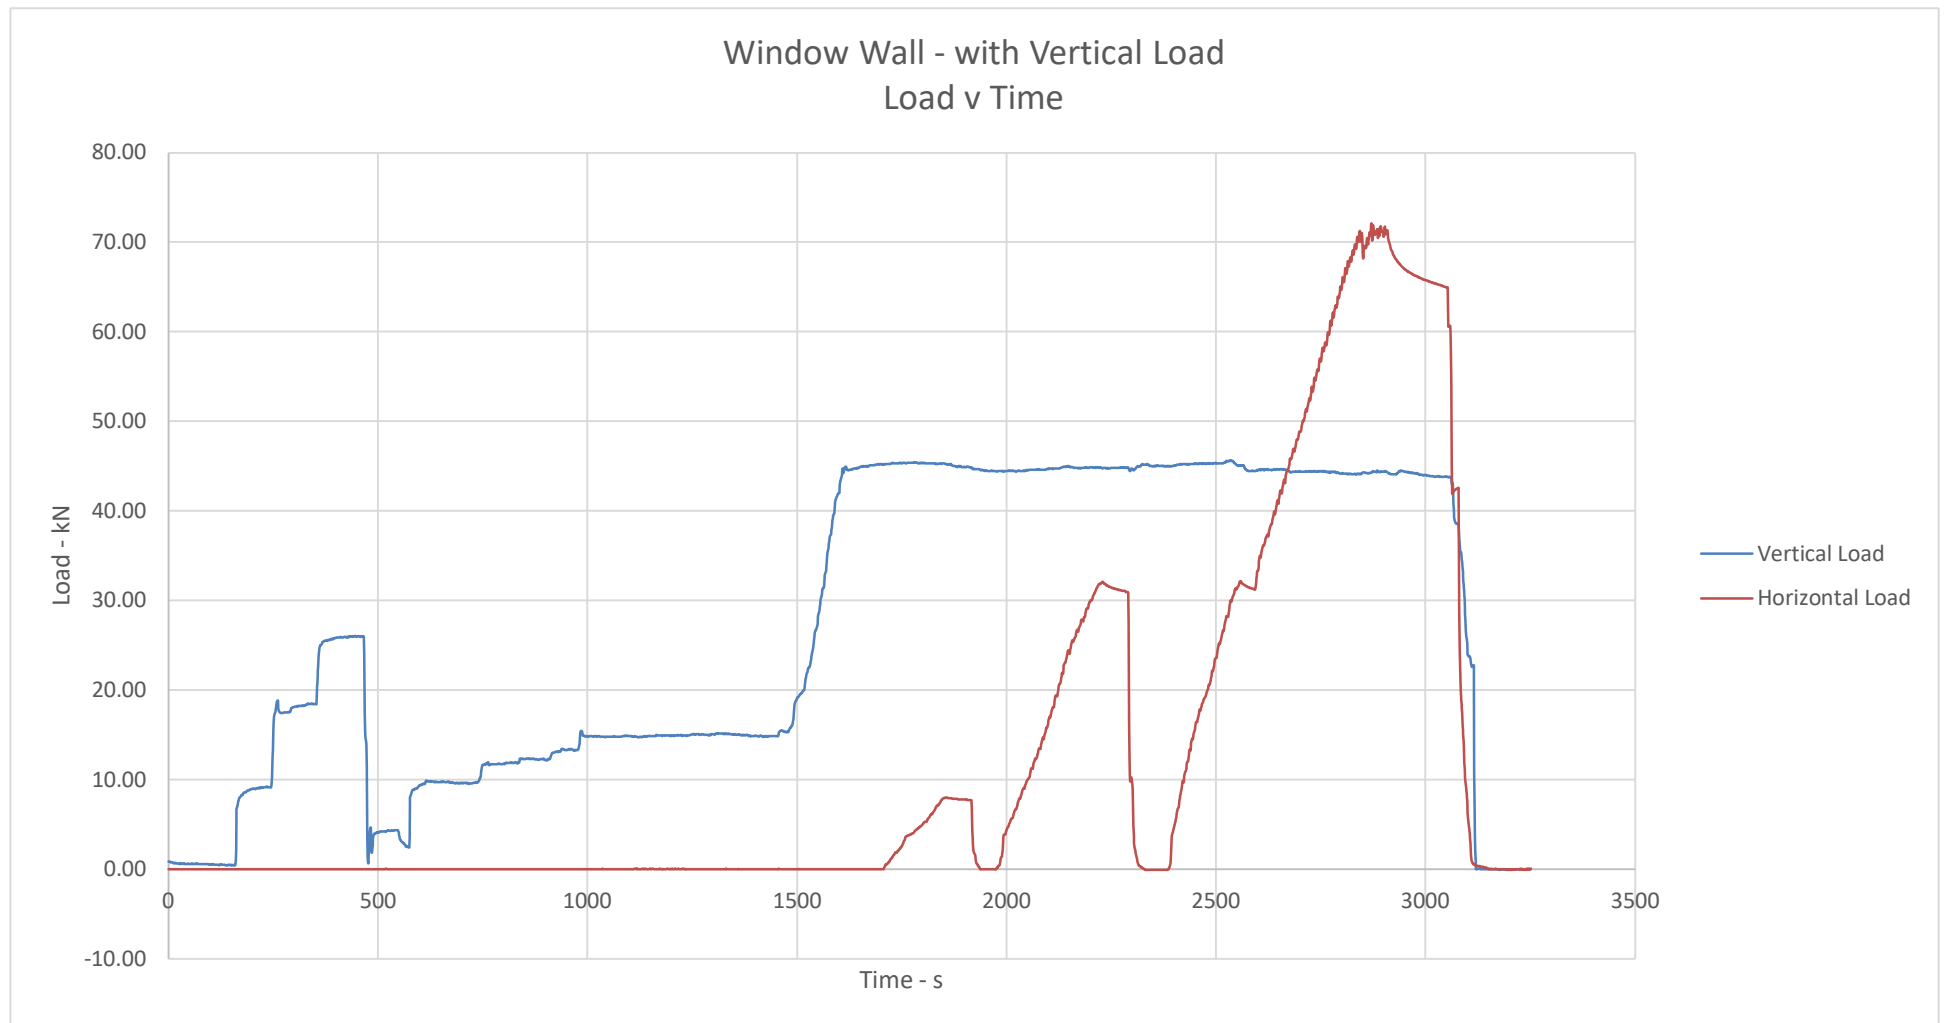
The third cycle to 0.4F then failure, the load was raised to 32kN as for previous cycle and held for at least 30 seconds then increased until failure. At approximately 72 kN horizontal load there appeared to be a drop in the load sustained by the specimen. Loading continued, however a significant increase in the magnitude of the applied load was not achieved and so the load was removed. There was eventual failure of the bow tie plates between the wall elements at the bottom right corner of window 1 and between the two full height units between windows. This failure can be seen in Figure 19.

Graph 9 – Window Wall with Vertical Loading: Deflections 1-4

Graph 10 – Window Wall with Vertical Loading: Deflections 5-10

Graph 11 – Window Wall with Vertical Loading: Load v Time
