# BRE Test Report

## WikiHouse Structural Testing

Prepared for: Clayton Prest  
Date: 12 July 2021  
Report Number: P120099-1000 Issue: 1

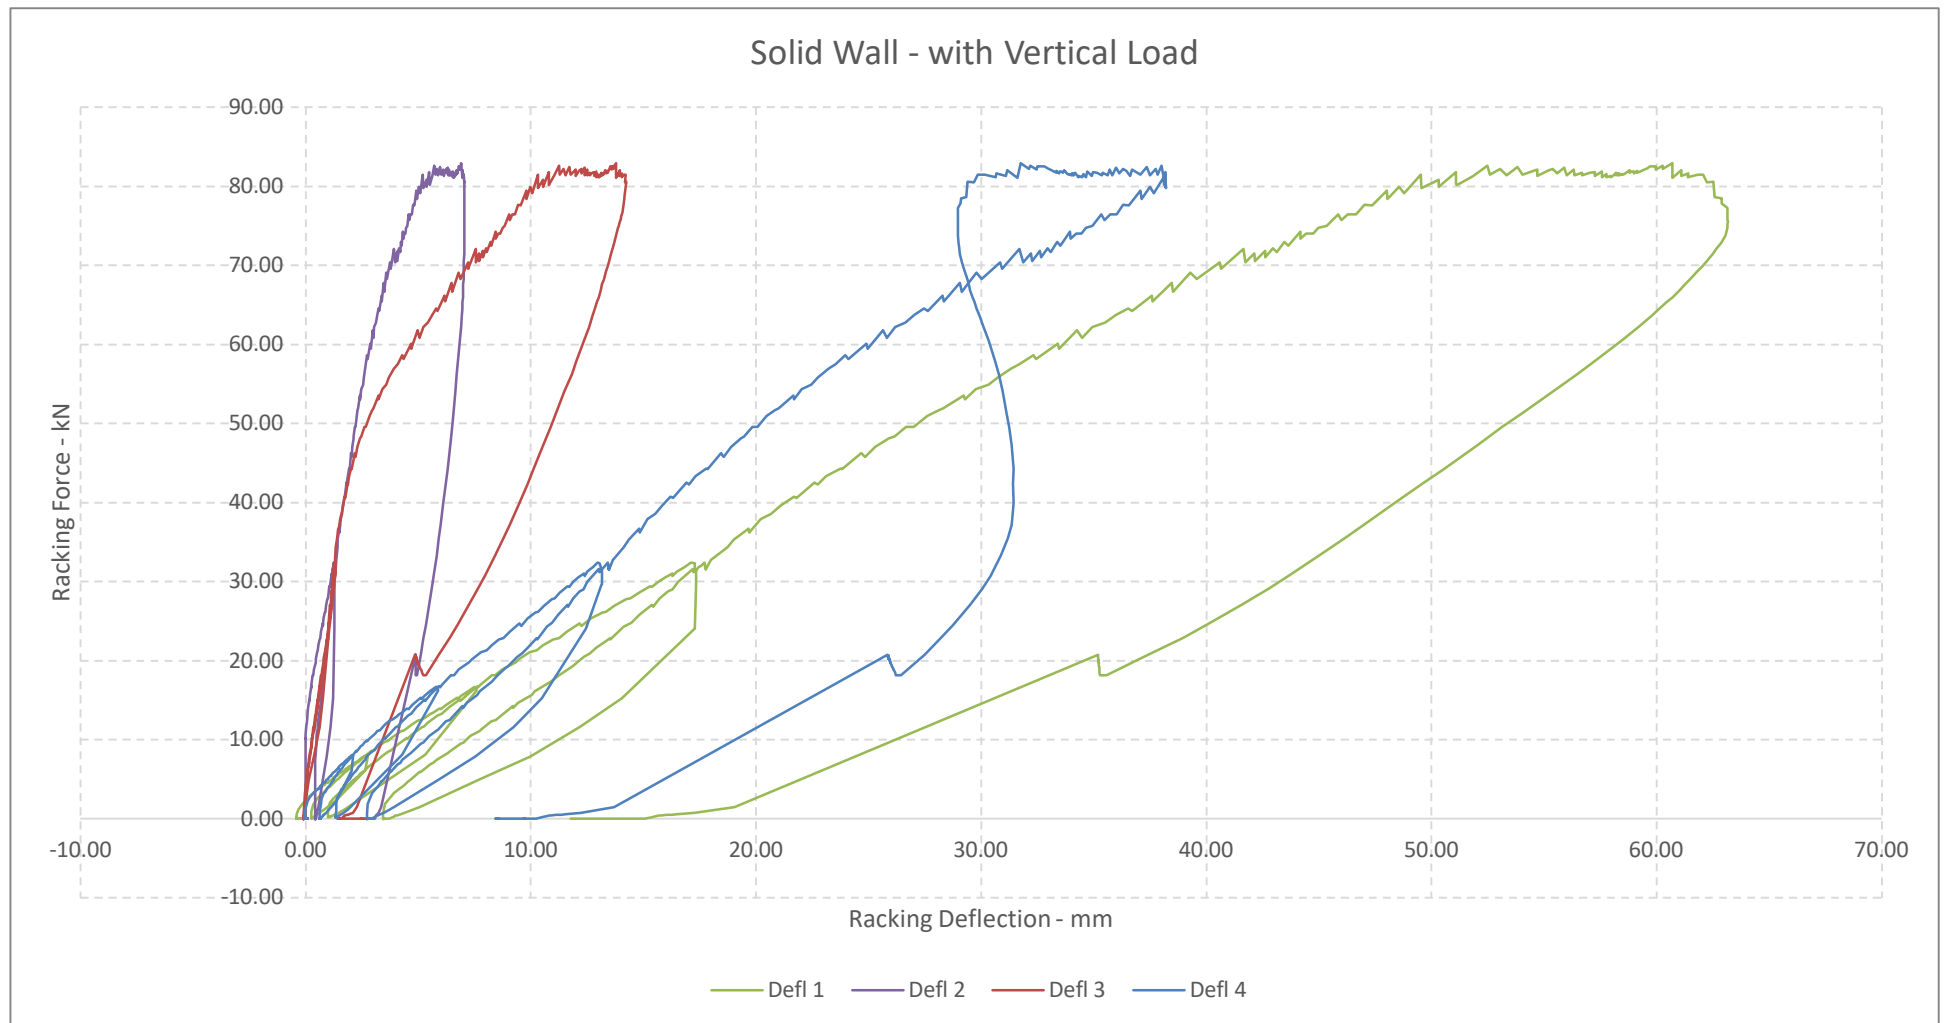
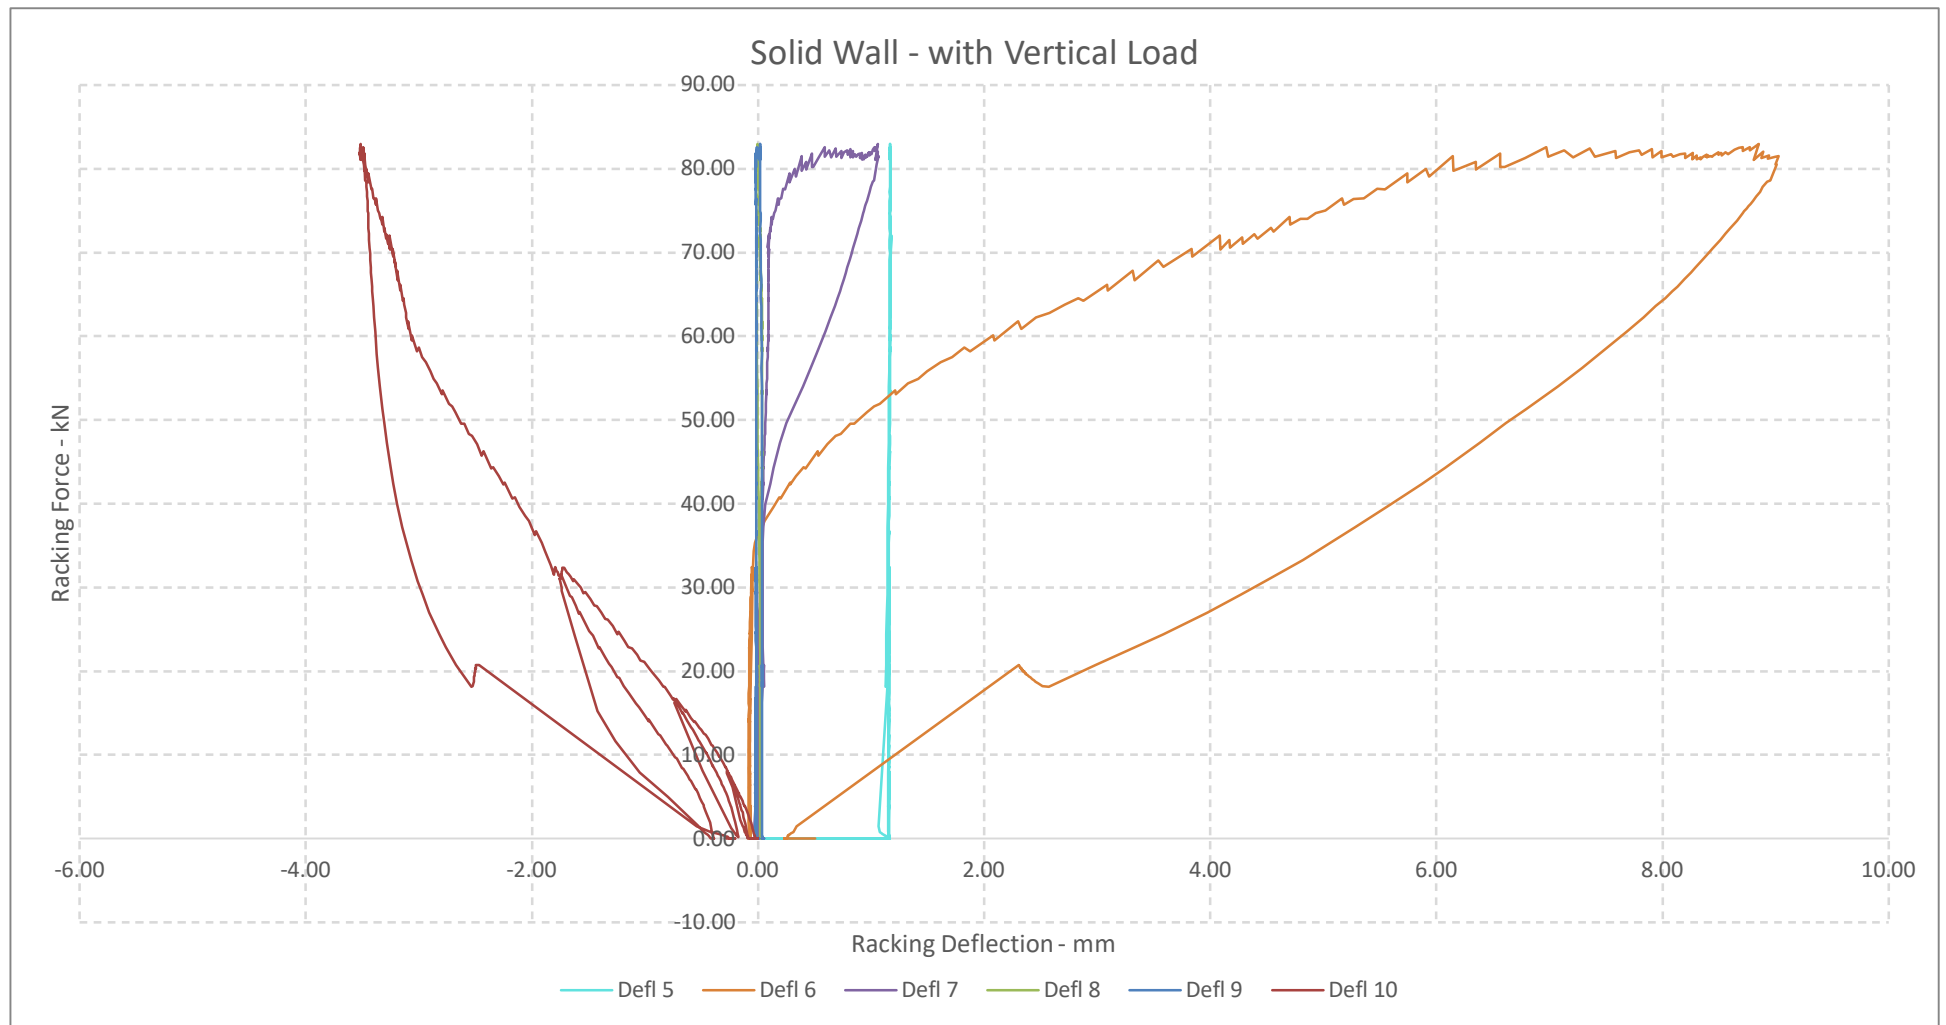
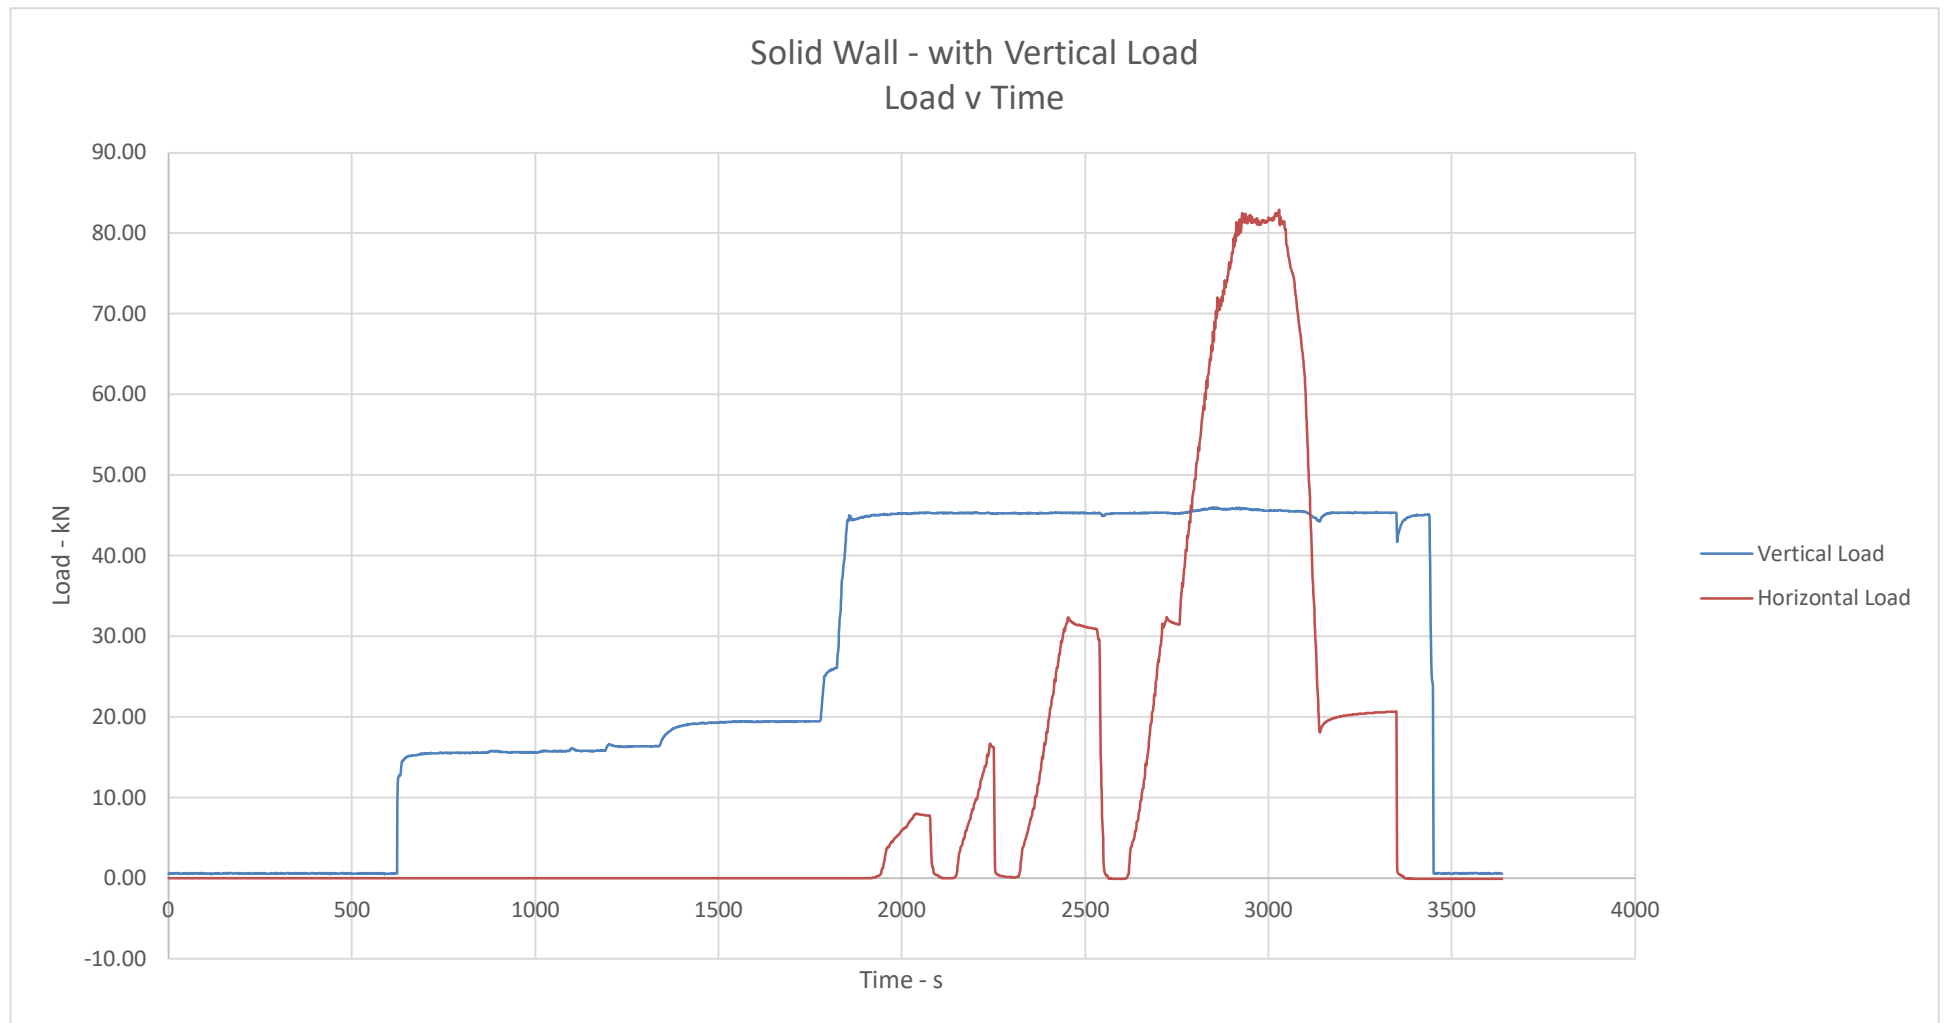
The third cycle to 0.4F then failure, the load was raised to 32kN as for previous cycle and held for at least 30 seconds then increased until failure. The test was stopped due to the wall twisting out of plane as the installed lateral restraints buckled. There was also differential movement between the base and the wall beams, which can be seen in Figure 23.

Graph 12 – Solid Wall with Vertical Loading: Deflections 1-4

Graph 13 – Solid Wall with Vertical Loading: Deflections 5-10

Graph 14 – Solid Wall with Vertical Loading: Load v Time

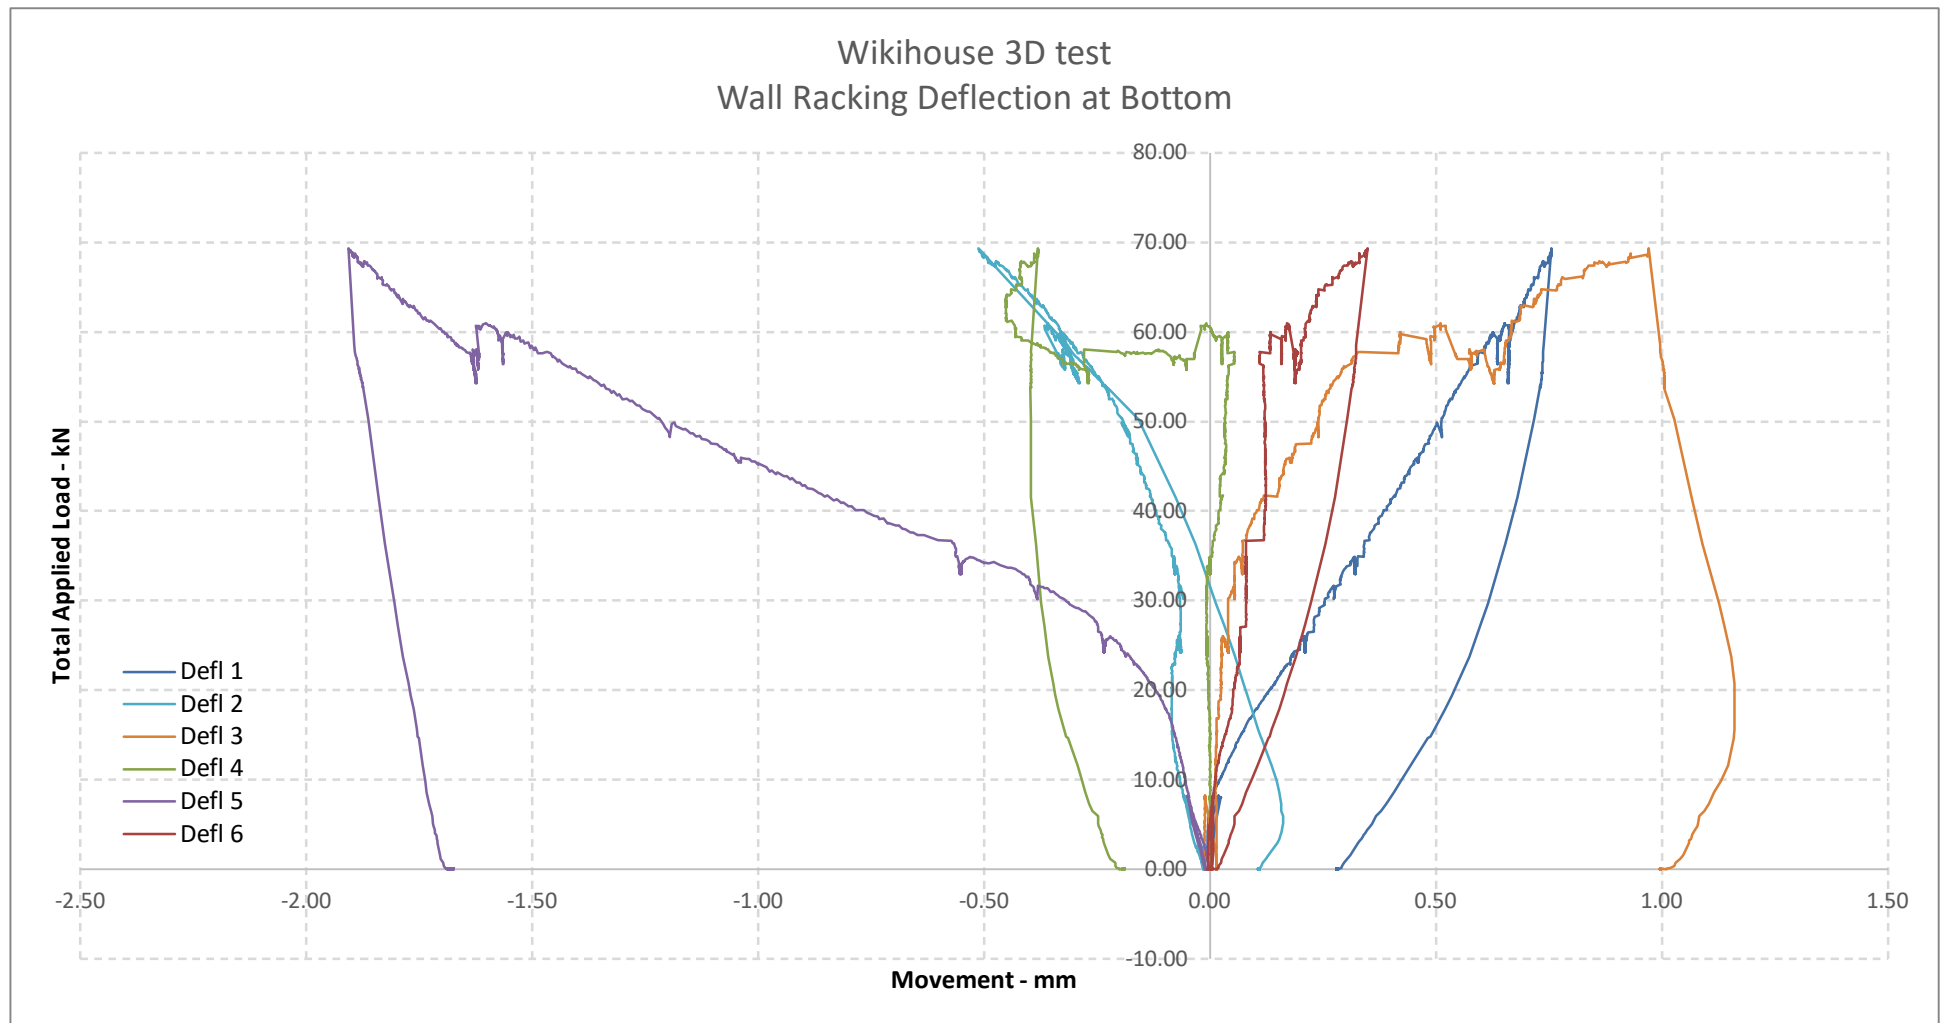
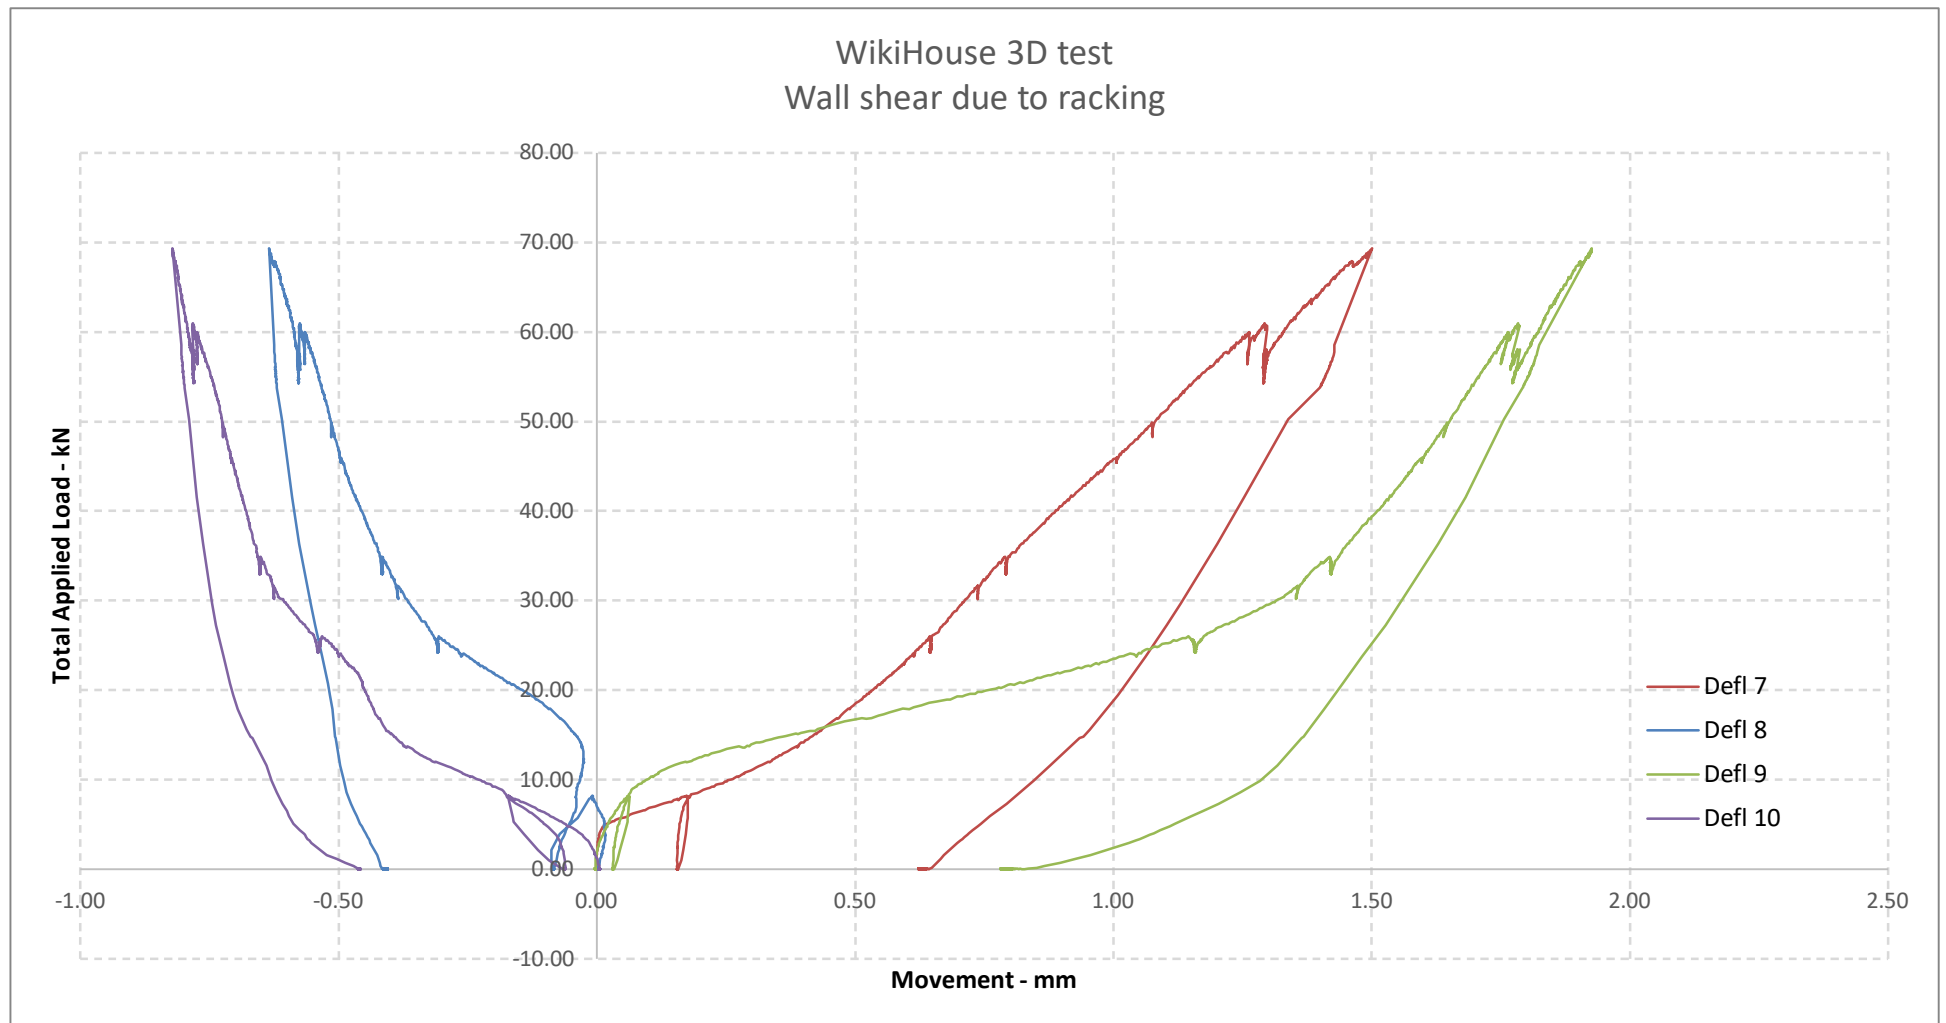
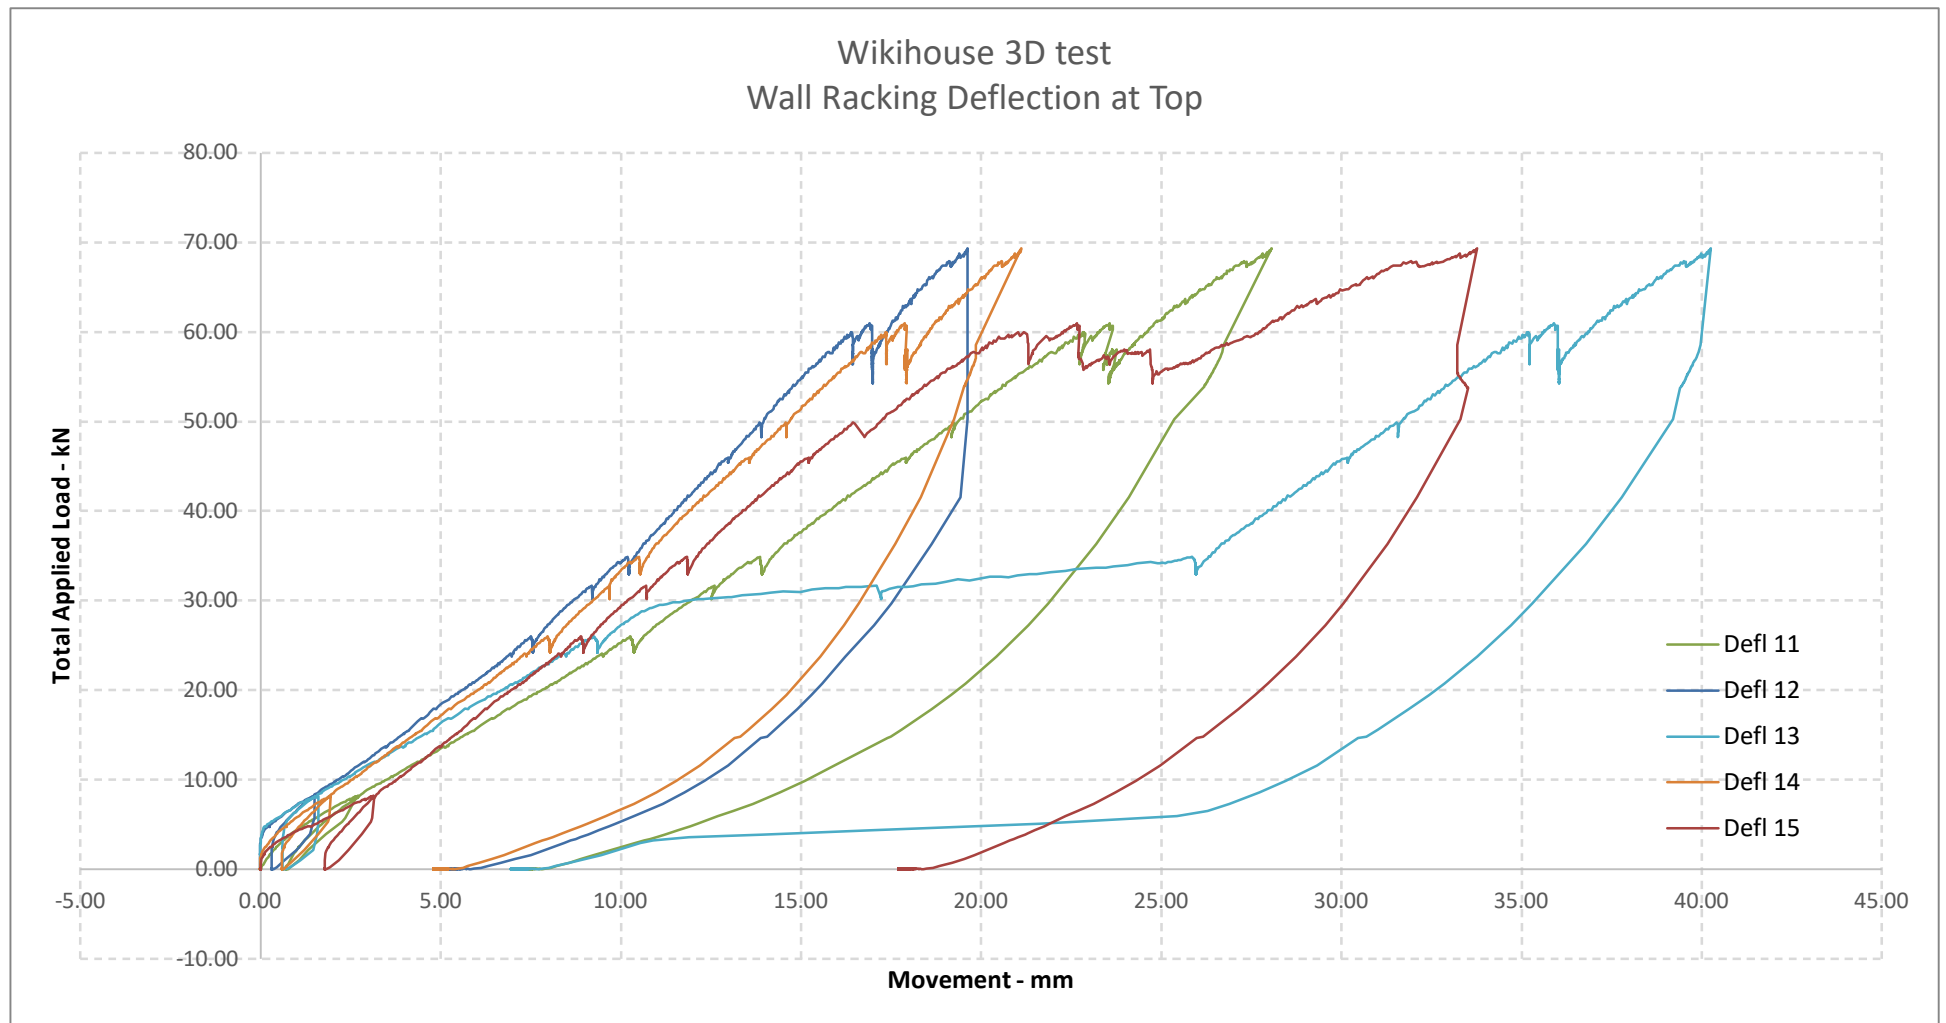
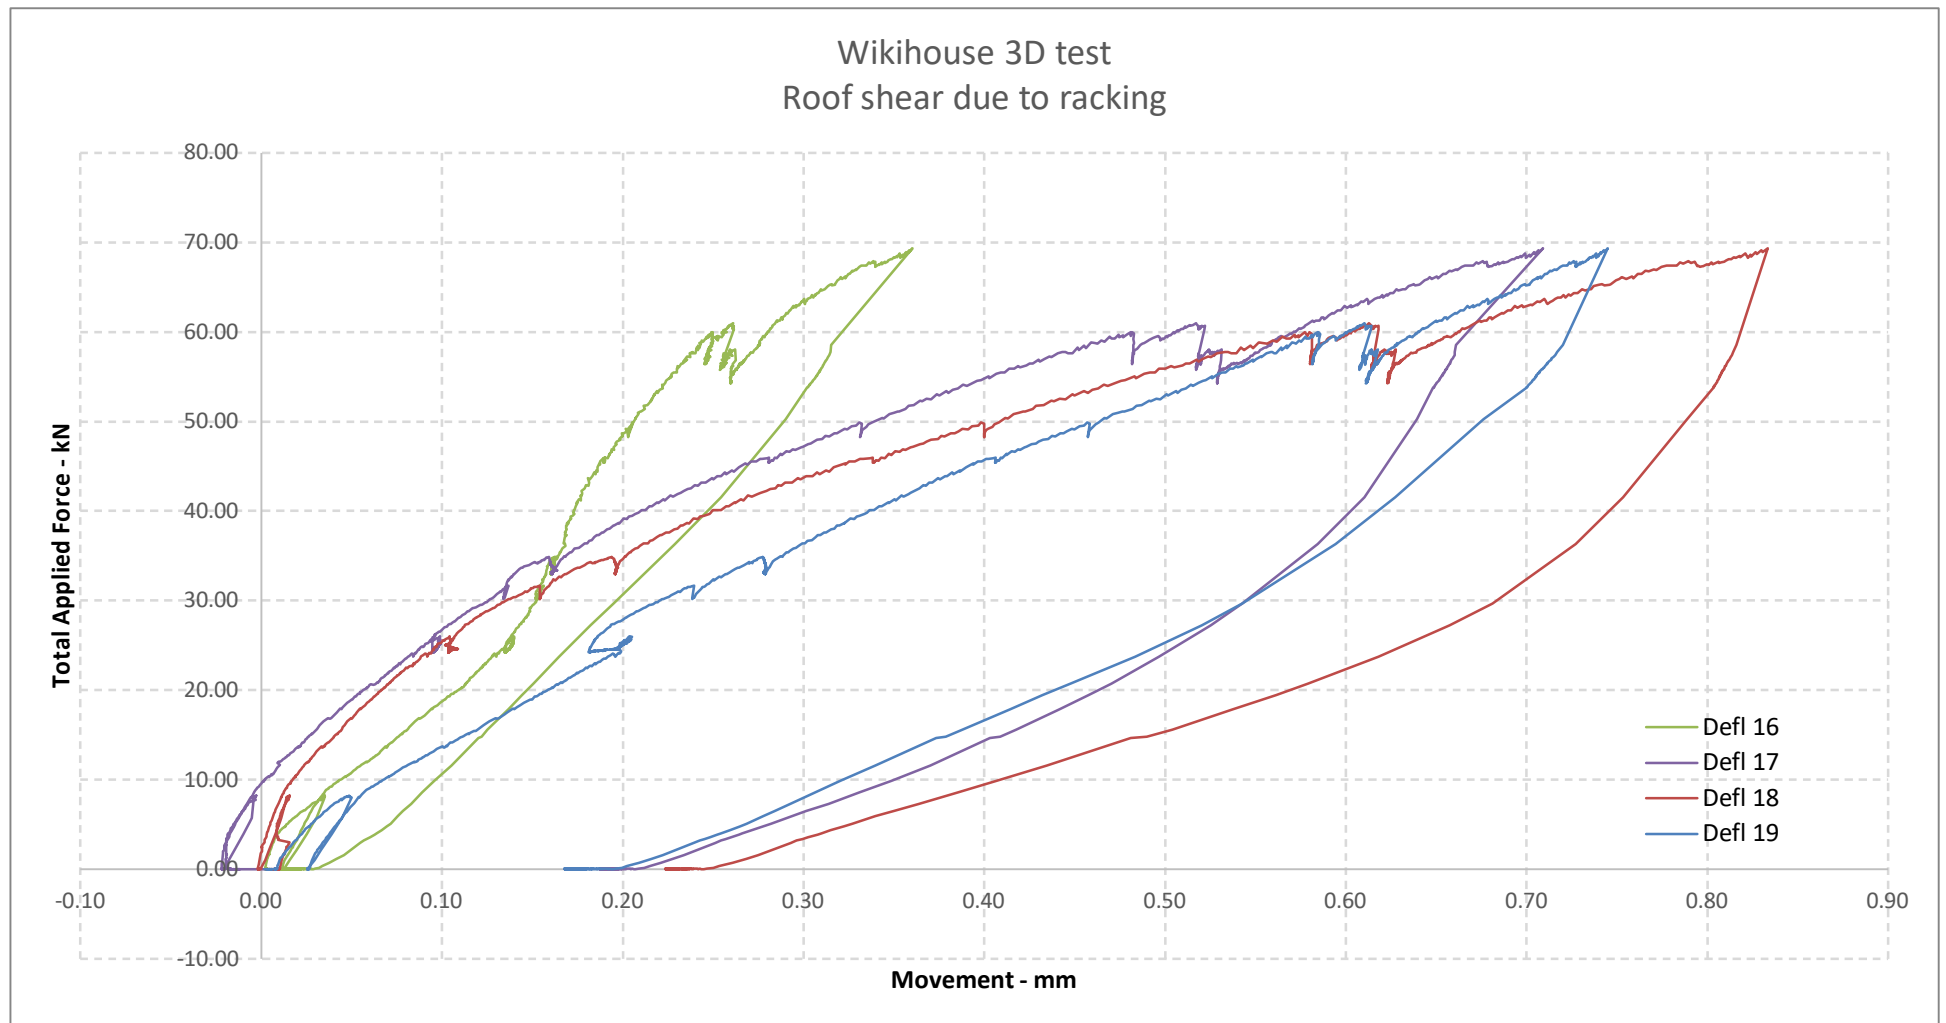
The second cycle was to 0.4F, or 20kN per jack, but stopped at ~0.3F as a shear tie near the top right of the steel spreader plate snapped and there was concern about the plate punching through the wall. At this point the load applied to the wall was gradually allowed to decay. The wall was then loaded up to 0.4F and held for 30 seconds before being allowed to decay. At this point the through wall peg at the top of the wall had disconnected (see Figure 28). Differential movement was observed between the panel being loaded and the panel to the right-hand side. There was also cracking noted internally on the face of the panel in the equivalent spot on the outside face where the shear tie had broken<sup>1</sup>.

For the third cycle, the module was loaded up to failure. At failure the through wall peg had become disconnected at the bottom on the right-hand side of the plate. In this test, the module was considered to have failed when there was loss of 20% or greater of the load. Photos of the east facing wall at the failure load can be seen in Figure 29 - Figure 31.

Graph 15 – 3D Panel: Deflections 1-6

Graph 16 – 3D Panel: Deflections 7-10

Graph 17 – 3D Panel: Deflections 11-14

Graph 18 – 3D Panel: Deflections 16-19
