Biological Fish Injury and Survival Evaluation of American Eel after Passage through the Archimedes Screw Turbine at Hanover Pond, Connecticut

Final Summary Report

Normandeau Associates, Inc.

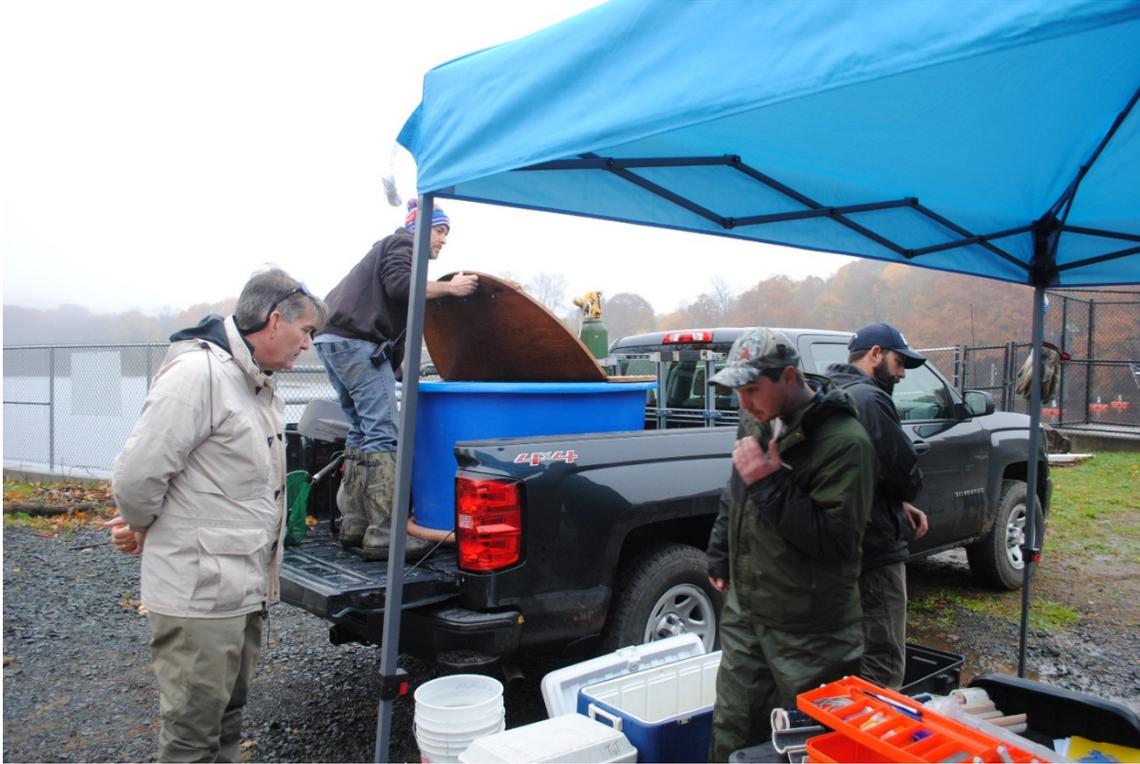
Figure 1. Transport and holding tank for eels held prior to being tagged.

Approximately 50 American Eels were transported to the dam in an oxygenated transport tank on the day of the study remained in the same tank prior to being tagged (Figure 1). Water quality (temperature and dissolved oxygen) was monitored throughout the day. Eels were randomly selected from this group to be tagged, however, any fish that displayed previous injuries or abnormal swimming behavior were not selected. To aid in tagging efforts, each eel was placed into an ice slurry for three to five minutes to reduce movement during tagging procedure.

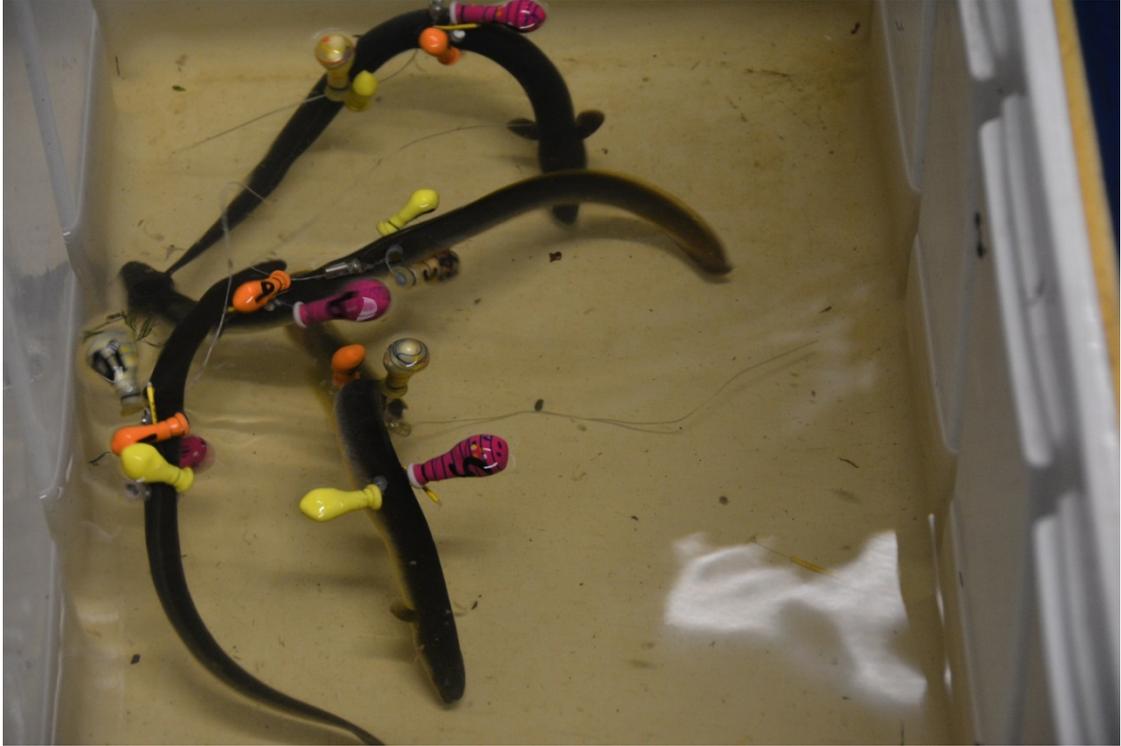
Figure 2. Eels recovering in a cooler with 4 HI-Z tags, a radio tag, and a uniquely numbered Floy tag attached to each fish.

A uniquely-numbered Floy tag was inserted into the dorsal musculature of each eel to allow for individual identification of eels during post-passage assessment. Four to six HI-Z (balloon) tags were attached along the dorsum of each eel via stainless steel pins or cable ties. A miniature radio tag was attached in combination with one of the pairs of HI-Z tags. Prior to being released into the turbine, eels were allowed to recover from tagging stress in a 50-quart cooler filled with ambient river water until they were actively swimming (Figure 2).

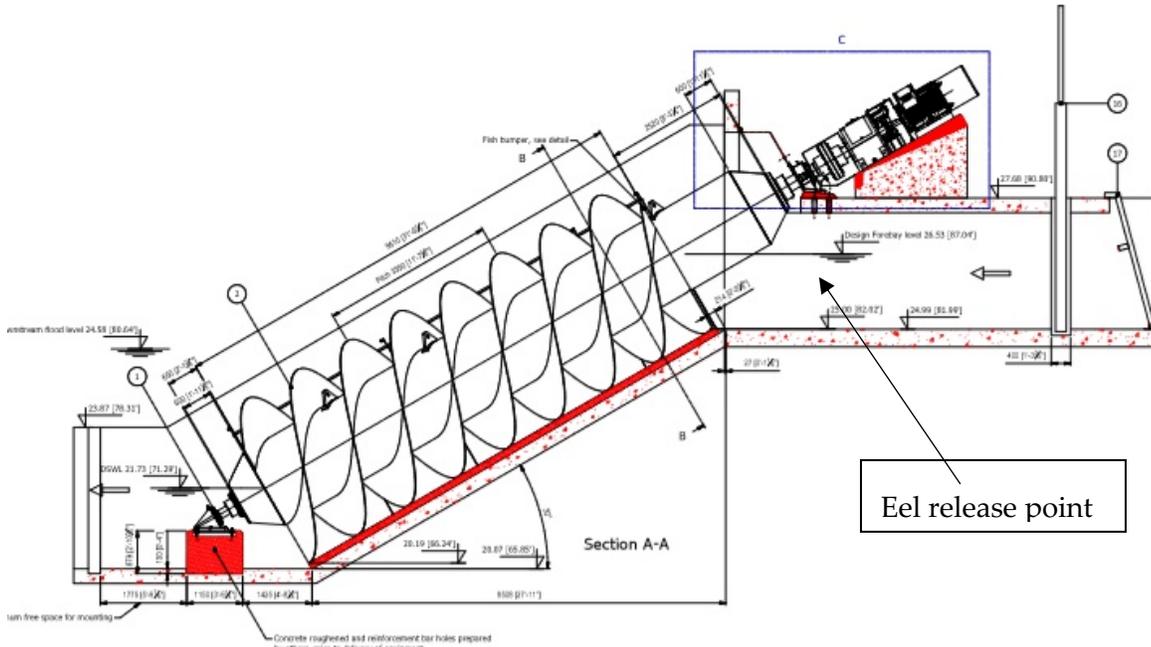
Figure 3. Cross section of the Archimedes screw turbine at Hanover Pond with the eel release point shown just upstream of the turbine runner and downstream of the trash racks.

turbine after all HI-Z tags were activated. This allowed the eels to become buoyant within 30 seconds to two minutes after release, which aided in the immediate recapture of eels in the tailrace. Treatment eels were individually released by hand into an area located immediately upstream of the turbine to ensure each was committed to passing through the turbine (Figure 3). The same handling and tagging procedures were used for a group of control eels which were released directly into the tailrace downstream of the turbine.

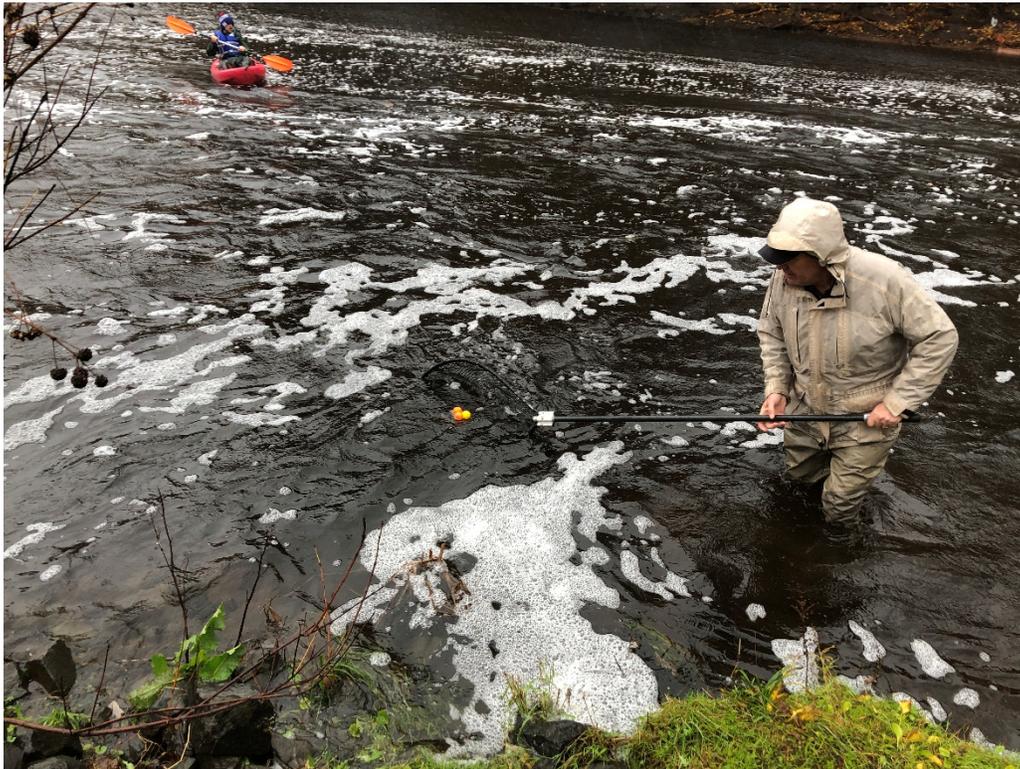
Figure 4. Eel with inflated balloons being recovered by a dip net in the tailrace of the dam.

Eels were recaptured with dip nets and transported to shore by five personnel that waded in the tailrace (Figure 4). Holding the eels for 90 seconds prior to release helped to prevent eels from getting too far downstream of the dam, which would have made recapture difficult due to fast-flowing water. Each eel was examined for immediate (1 hour) survival status and injuries prior to being placed into a holding facility. All eels were held for 48 hours in a circular holding tank (approximately 300 gallons) which was maintained with a continuous supply of ambient river water. At the end of the 48 h holding period, each eel was reassessed for delayed survival and injuries that were not detected immediately after recapture.

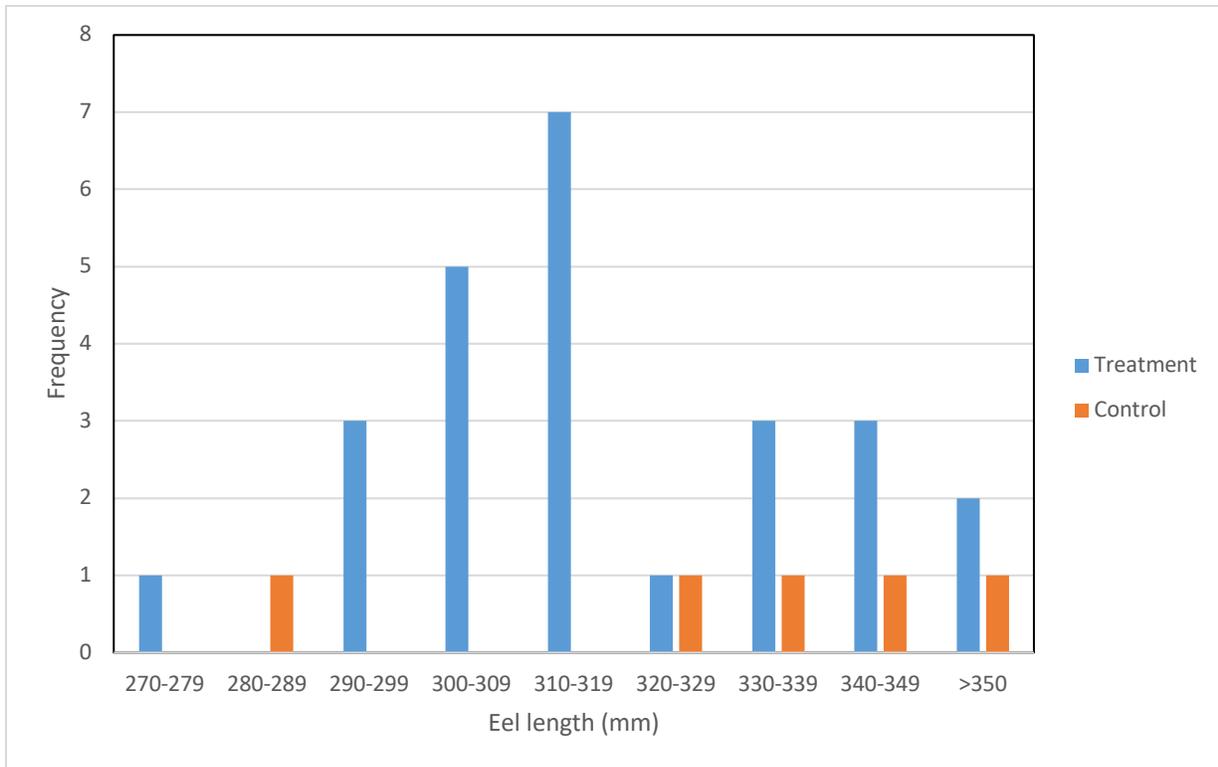
Figure 5. Length-frequency distribution for treatment and control groups of American Eels released.

The length of treatment eels ($n = 25$) ranged from 270 to 528 mm with a mean of 325 mm. Only 2 of those fish were longer than 350 mm. Control eels ($n = 5$) ranged in length from 287 to 354 mm with a mean of 329 mm (Figure 5). A total of 26 treatment eels were tagged and released into the turbine and another five were released as controls. One treatment eel drifted or swam downstream into swift water quickly and could not be recaptured; this eel was removed from the sample. All other eels were recaptured within six minutes of being released, therefore the recapture rates for both the treatment and control groups were 100%.
