CASE STUDY

QUARTZ FLASH CURE UNIT

Increasing drying speed in textile printing

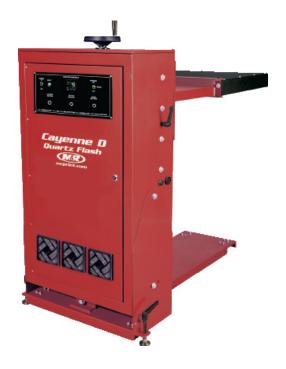
One of the products M&R develops and manufacture are Quartz Flash Cure Units. These units will be used for curing the screen printed t-shirts. Their new, most sophisticated and versatile freestanding quartz flash cure systems are the RED CHILI D and their CAYENNE D. Both offer the latest innovations in screen printing equipment by providing significantly higher speed, without compromising quality of output.
