### Theatres & Venues

# Refurbishment at Liverpool Playhouse Theatre

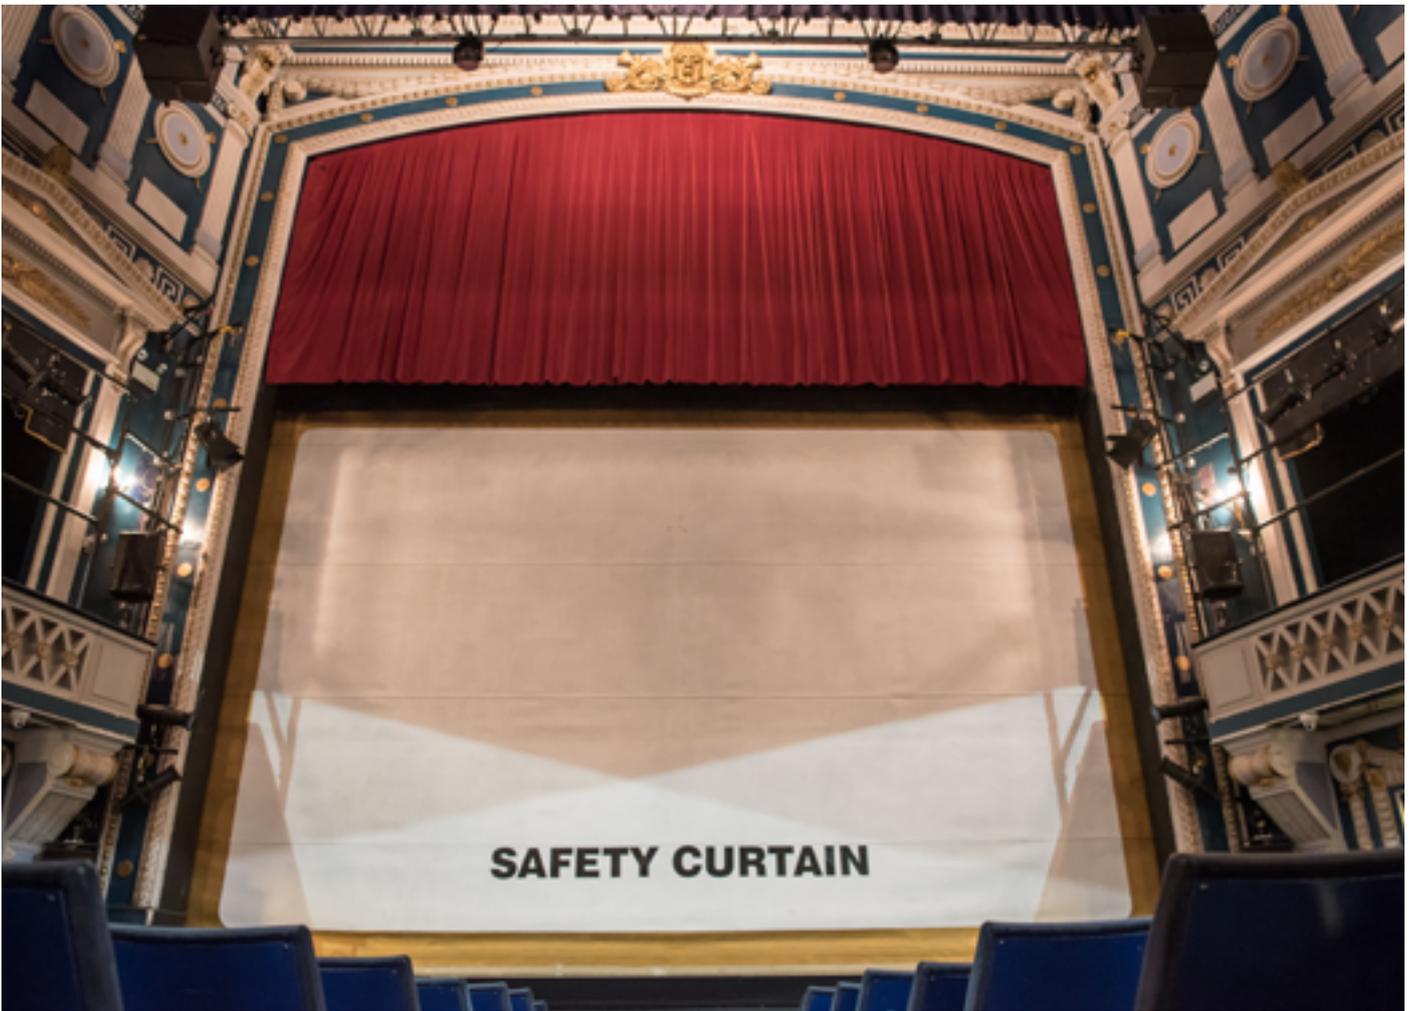
This was a total refurbishment with the safety curtain being removed from its guides and located upstage.

From this point everything was removed, including the original painted fabric front sheet, the rear cover, side guides, top and bottom seals, pulleys, steel cables, motor unit and controls.

Painstakingly, the steel safety curtain frame was re-straightened and strengthened before having a new Zetex fire and smoke prevention front cover and bottom pad installed. New pulleys were installed on stool brackets to pass over the top of the existing counterweights, with new steel cables all designed to support 3 x counterweight balance units. A new combination motor and speed buffer unit was installed on the grid with further pulleys and hauling steel cable fitted.

Before the safety curtain was put back in its guides, the front was painted with 4 layers of special white paint.

Once installed and fully operational, a decorative gold band and Safety Curtain lettering completed the original theme.
